# Service Bulletin

**Subject:** Diagnostic Tip - Steering Bind After I-Shaft Removed For Service

**Models:** 2015-2016 Chevrolet Colorado  
2015-2016 GMC Canyon  
2015-2016 Chevrolet S-10 w/LCV Engine (Brazil — South America)

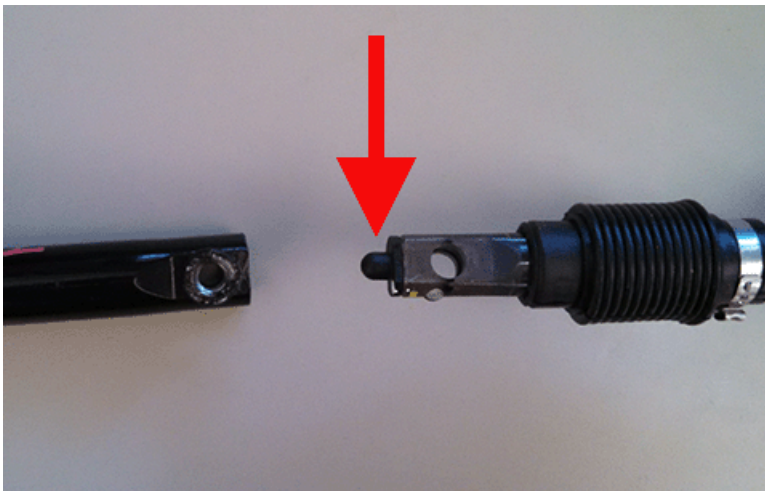
The technician may note a bind when turning the steering wheel after having removed the I-Shaft for a service procedure.

This can be caused by the I-Shaft Nose Plug sliding down the inside of the lower I-Shaft and into the joint when the shafts were separated.

1. Remove the lower I-Shaft.
2. Inspect the upper I-Shaft to determine if the plug is still installed. If still installed, remove the plug, discard and reinstall the lower shaft.
