UPDATE Technical Bulletin

February 17, 2015

37J2 UPDATE – AQ250 TCM Software (FED_EMS)

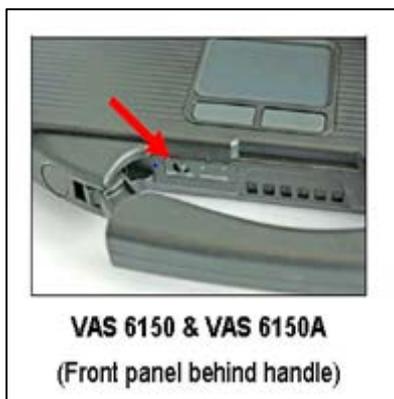
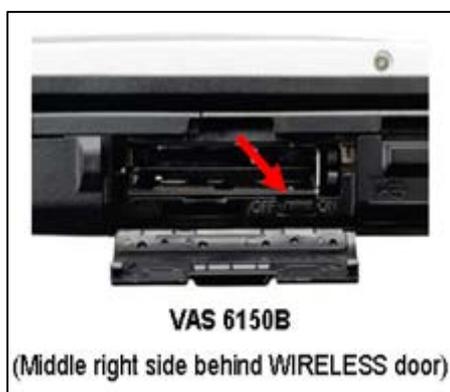
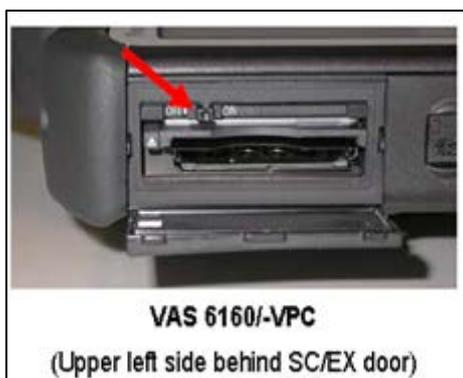
If the Bluetooth wireless VAS 5054A transmitter head is used in conjunction with a VAS tester, the transmitter head **MUST BE** connected with a USB cable to the tester.

The Bluetooth function of the scan tool **MUST BE PHYSICALLY SWITCHED OFF** prior to performing this update. <See pictures>

- Connect the tester to the on-line network using an Ethernet cable.
- Connect the VAS 5054A transmitter head to the VAS tester using the USB cable.
- Disable Bluetooth by physically turning the switch to the off position.
