# UPDATE Technical Bulletin

## 26i2 UPDATE – EGR Valve Cover (NVLW)

| Model(s) | Year | Engine Code | Trans. Code |
|---|---|---|---|
| Passat TDI | 2014 | CKRA | All |

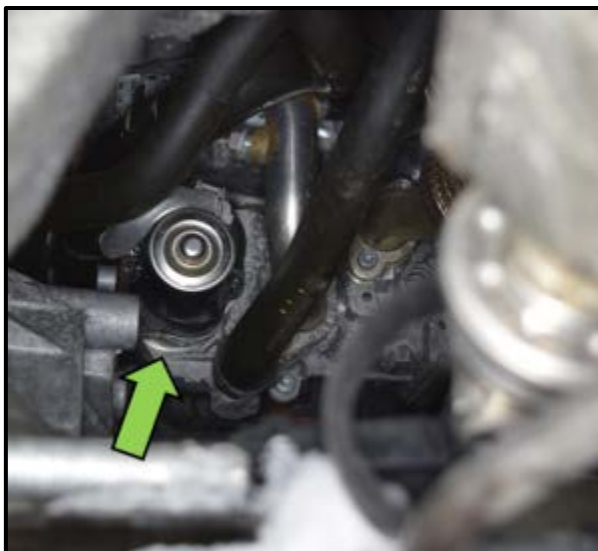
- ⇐ Locate the EGR/cooler assembly on the rear of the engine <arrow>.

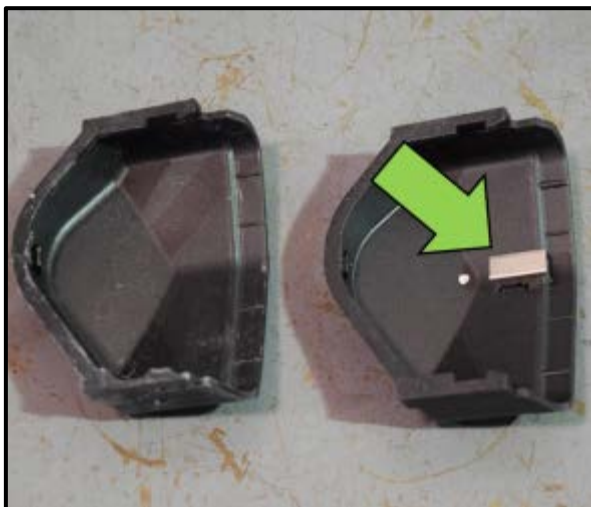
- ⇐ The replacement EGR cap, P/N 03L131540 <pictured right> can be identified by the metal insert <arrow>.
