VW Elsa Newsletter

Edition 132: April 20, 2015

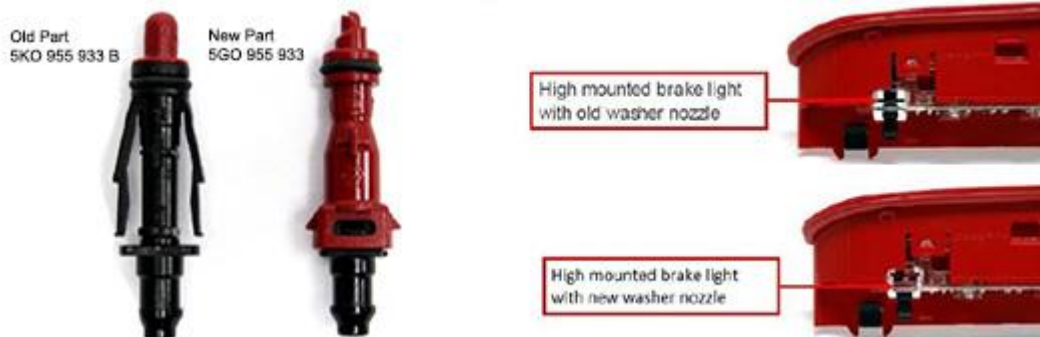
92-14-04 Rear Washer Jet Leaks - Drips After Use

For the A7 Golf with a rear washer nozzle leaking after use (Installed in the high mount brake lamp housing). An updated washer nozzle is now available. Replace with 5G0-955-993 or the latest ETKA supersession for this part number available.
