# VW Elsa Newsletter

Edition 134: May 5, 2015

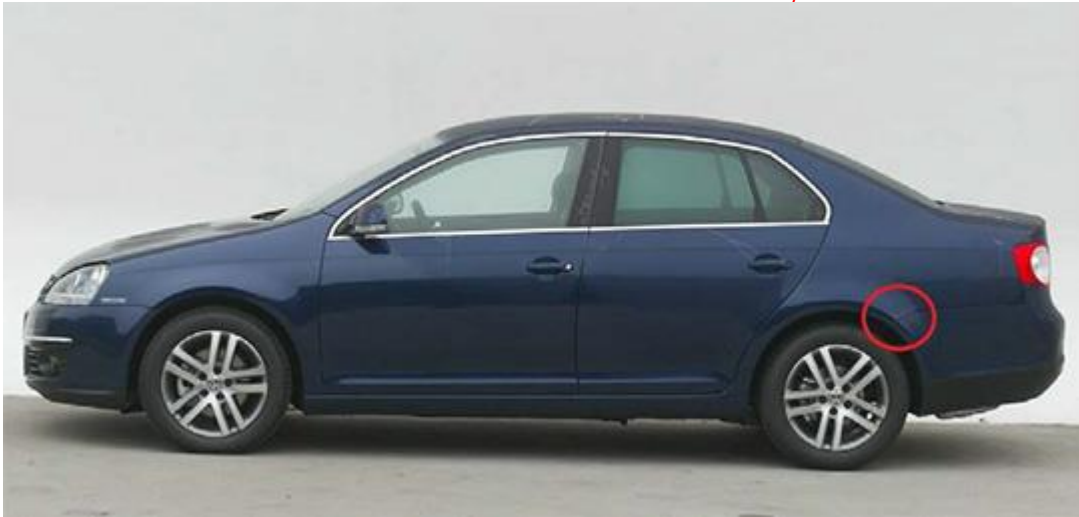
**53 15 01 - 2040536 Rear Quarter Panel Corrosion (U.S. Only)**

Corrosion is found where the rear bumper cover meets the quarter panel.

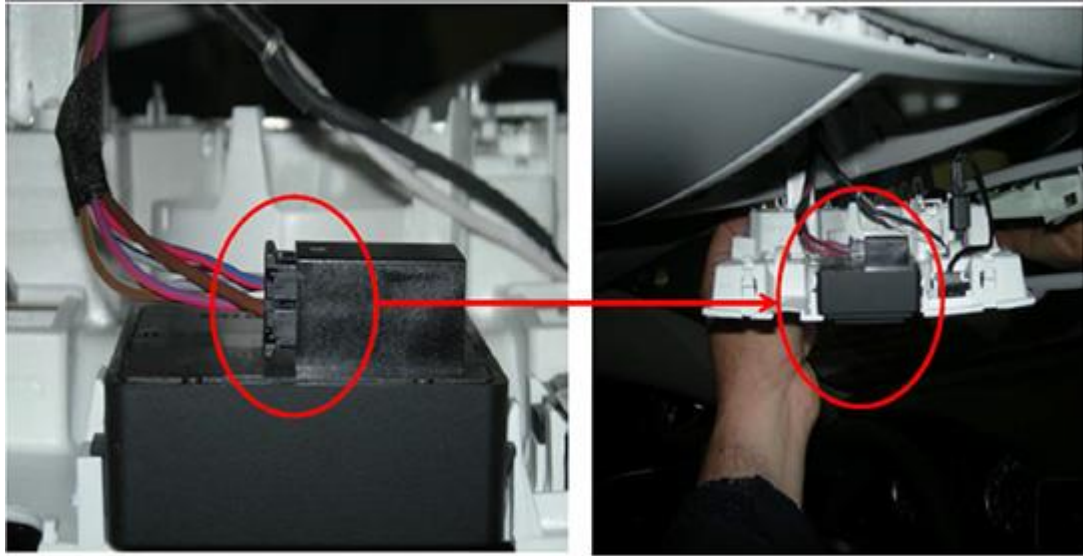
**91-14-01 Car Net™ Equipped Vehicles False Outbound Calls - Date: January 17, 2014**

If a 2014 Model Year vehicle equipped with the Car Net™ system experiences a customer complaint where the system is placing false outbound calls, it is possible that the cause is a loose or unplugged connector at the 3-Button Assembly in the overhead console. If this concern is verified and there is no damage to the terminal(s) or connector(s), simply secure or plug in the loose connector.

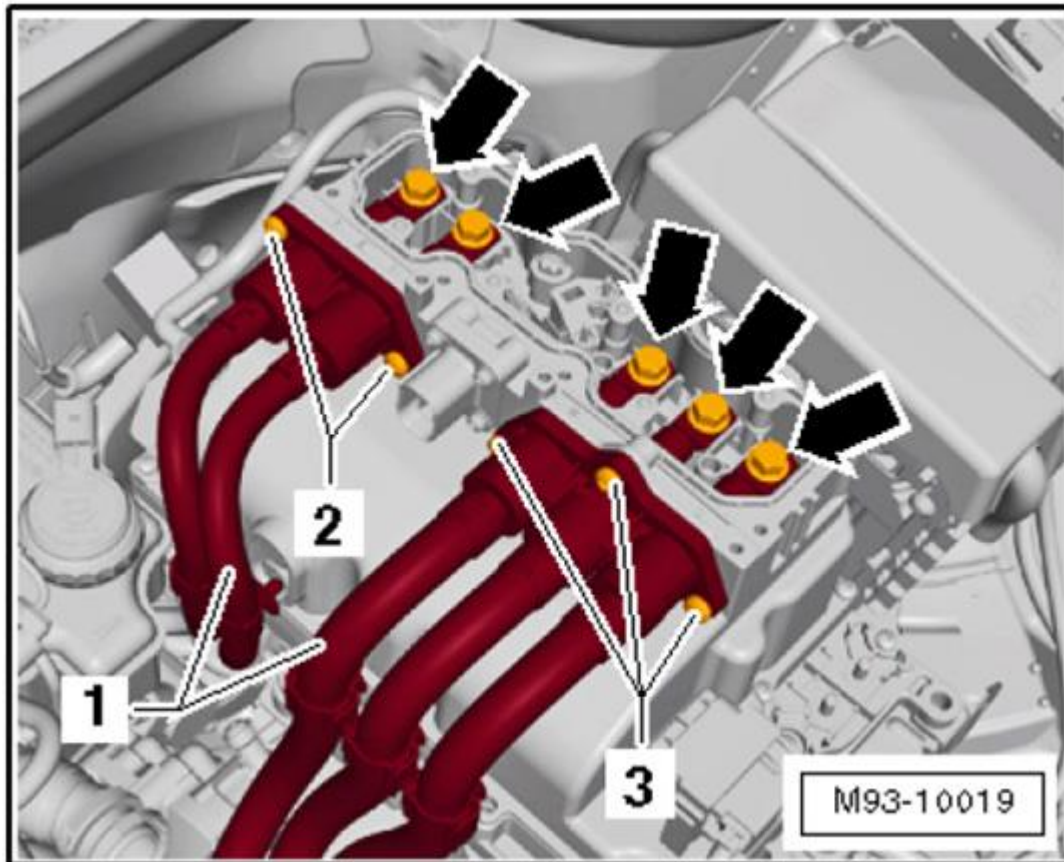
#### Tightening Specifications, High Voltage Contacts

When replacing or reinstalling High Voltage cables into the Electric Drive Power and Control Electronics JX1, insure proper torque specification of 20 Nm is used. Too much torque can cause damage to the mounting tabs within the JX1 requiring replacement of the unit.

High voltage contacts -arrows-: 20 Nm

Threaded connection -2 and 3-: 5 Nm
