# VOLKSWAGEN DEALERSHIP COMMUNICATION

Subject: **Touareg Module Scan Lockup Workaround**

Application: **2004 – 2010 Touareg**

Date: 05.06.15

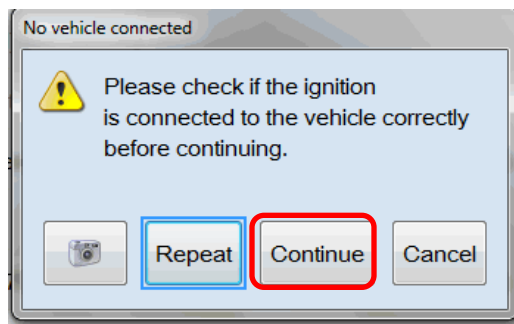
1. Connect the VAS 5054A to vehicle Data Link Connector (DLC) and turn on ignition.
2. Initiate GFF session in ODIS Service. The scan lockup typically occurs at 29% completion:

3. **Remove** the VAS 5054A from the vehicle DLC.
4. **Wait** until the following prompt is displayed, **and then reconnect the VAS 5054A to the DLC:**
5. Select **Continue** (it may be necessary to select **Continue** more than once):

The module scan process resumes.
