Date 12.15 Group **373** No. **022** Release **03** Page 1(6)

Engine Harness Repair  
D11 US2015  
VAH, VHD, VN

## FSB 373-022, Engine Harness Repair

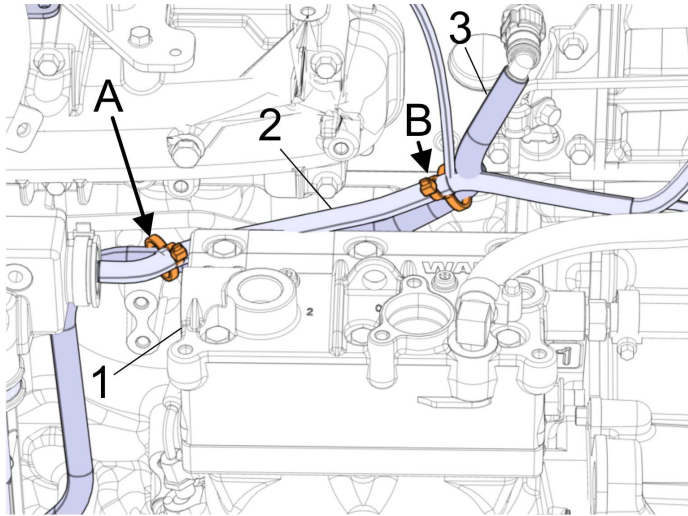
W3107068

The engine harness on VOLVO D11 US2015 engines built between March 1, 2015 and August 31, 2015 may be making contact with the air compressor head and rubbing through. When diagnostic trouble codes (DTC) P0201 to P0206 FMI 13 are logging, look in this area first. If this is found to be the root cause of the DTC, it is recommended that the harness be repaired using a splice kit. On reassembly, protect and support the harness in this area.

- 17 Relocate the engine harness (2) and install double tie retainers (part number 20885496) as shown (A and B) to secure harness to cylinder head fuel line (3) between the air compressor and the engine block. Ensure harness is not touching air compressor. Make sure the ties are snugged tight.

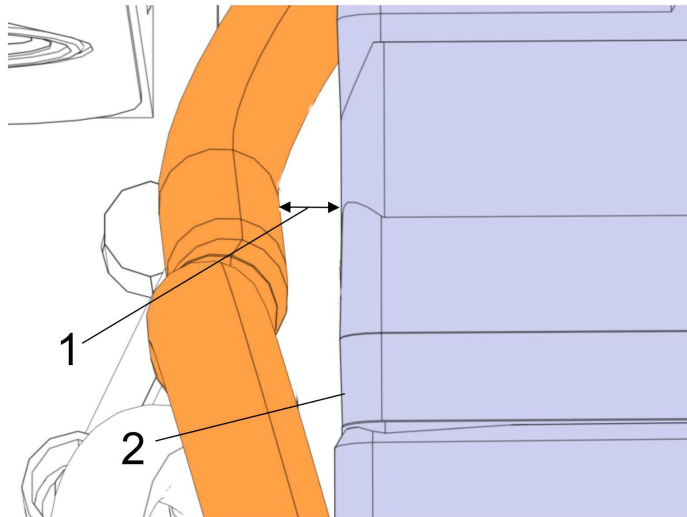
W2107161

- 1. Clearance
- 2. Air Compressor
