Engine Harness Relocation  
D11 US2015  
VAH, VHD, VN

## SP 373-021, Engine Harness Relocation

(December 2015)

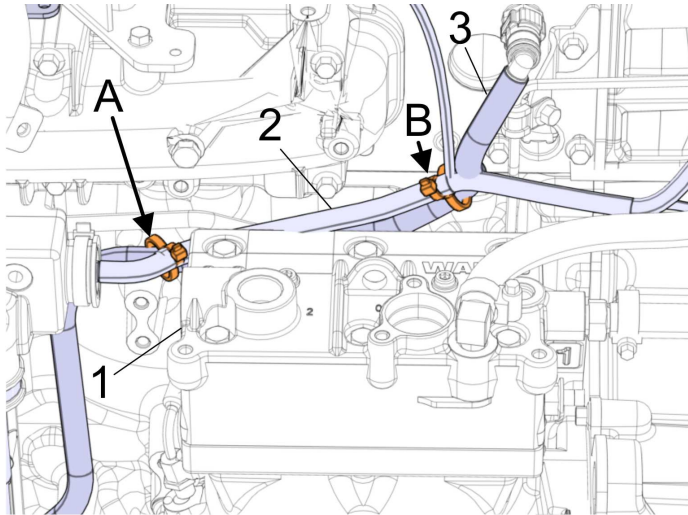
W3107068

The engine harness on VOLVO D11 US2015 engines built between March 1, 2015 and August 31, 2015 may be making contact with the air compressor head and rubbing through. It will be necessary to relocate the harness in this area. If wire damage is noted during the harness relocation, reference FSB 373-022 for the repair instructions and continue with the harness relocation after the repairs are done.

- 1. Air Compressor
- 2. Engine Harness
- 3. Cylinder Head Fuel Line

- 6 Relocate the engine harness (2) and install double tie retainers (part number 20885496) as shown (A and B) to secure harness to cylinder head fuel line (3). Ensure harness is not touching air compressor. Make sure the ties are snugged tight.

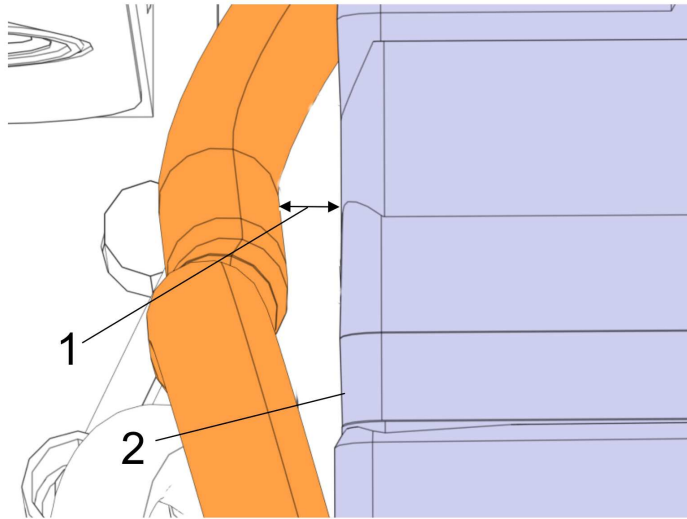
W2107161

Front View

- 1. Clearance
- 2. Air Compressor
