# VW Elsa Newsletter

Edition 146: July 27, 2015

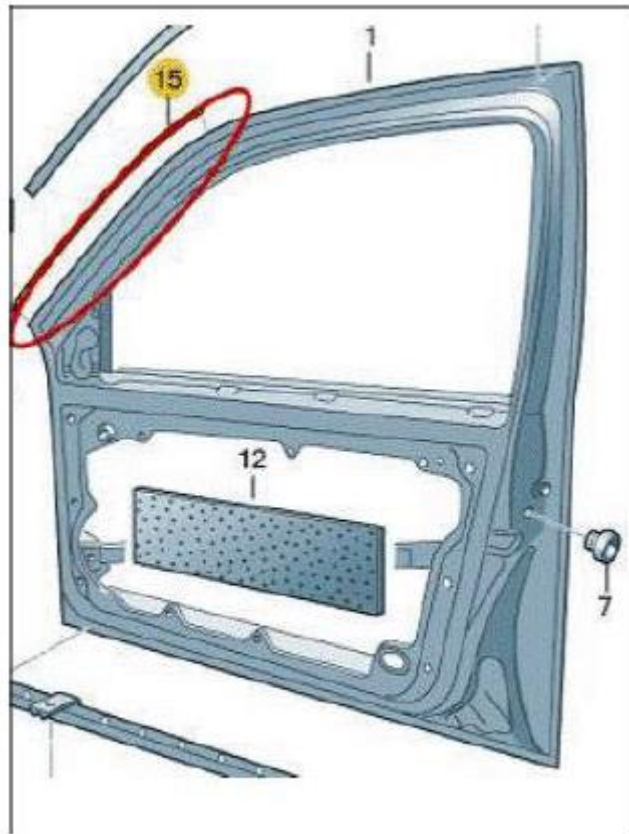
**Figure 1**

**US. ONLY: 57 15 03 - 2038887 Supersedes Technical Bulletin V571405 dated November 10, 2014 to update service number.**  
**Corrosion on the Fold of the Front Inner Door**

Model(s)	Year	Eng. Code	Trans. Code	VIN Range From	VIN Range To
Golf, Jetta Wagen	2000– 2006	All	All	All	All
<p>Corrosion on the fold of the front inner door in the extra seal area.</p> <p><b>Note:</b></p> <p>To determine if this procedure is covered under Warranty, always refer to the Warranty Policies and Procedures Manual.</p> <p>Documentation required per Warranty Policies and Procedures Manual.</p> <p>For vehicles outside of the Limited Warranty Against Corrosion Perforation this Technical Bulletin is for information only.</p>

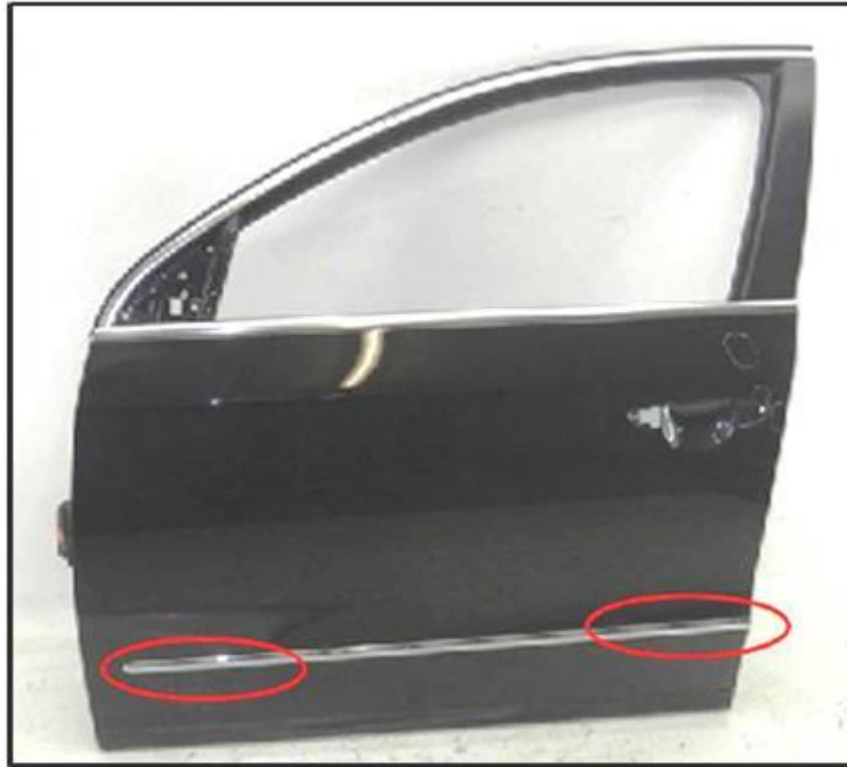
Corrosion on the Front Door in Trim Strip Area

Figure 1 (the red ellipses show the area which can be affected by the corrosion)

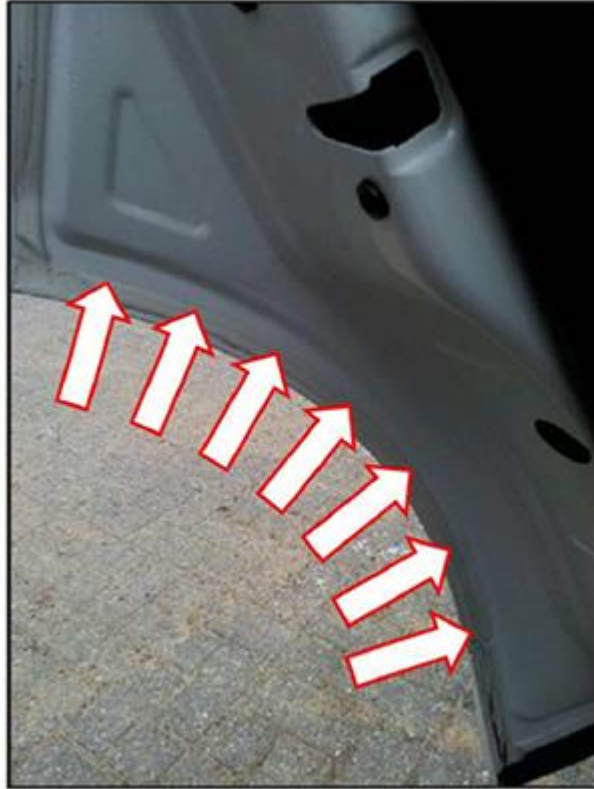
**US. ONLY: 58 15 01 - 2039001 Supersedes Technical Bulletin V581402 dated December 16, 2014 to update the service number.**  
**Corrosion, Rear Inner Doors in Door Fold Area**

Corrosion in the fold of the rear door.

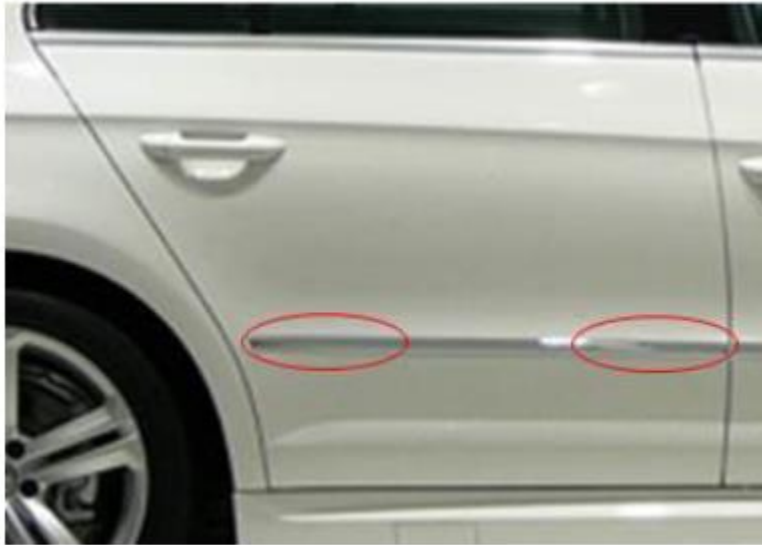
Corrosion on Rear Door in Trim Strip Area
