Technical Service Bulletin

91 Droning noise from engine compartment from about 3500 rpm in S3 vehicles

91 15 23 2042374/1 November 6, 2015.

Model(s)	Year	VIN Range	Vehicle-Specific Equipment
S3	2015 - 2016	All	Not Applicable

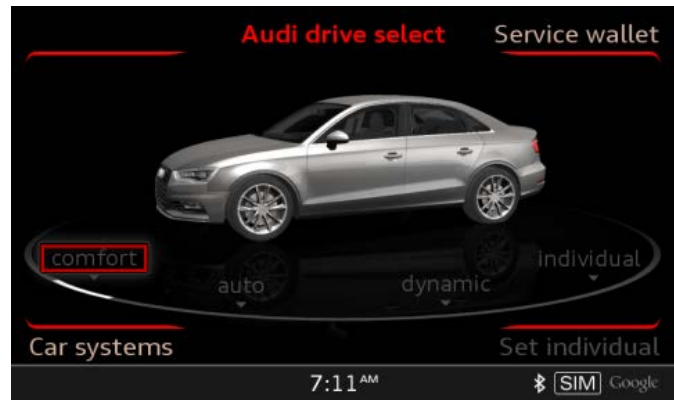
Figure 2. Audi drive select mode selection.

1. Verify the complaint by checking for the sound with the engine speed between 3,500 and 4,000 rpm, only after the engine has reached operating temperature. This can be done while the vehicle is stationary.
 - First, check for the sound with Audi drive select in comfort mode (*MMI>>Menu>>Car>>Audi drive select>>comfort* or select using the dash panel button) (Figure 2).
 - Next, verify that the sound is more noticeable with Audi drive select in dynamic mode (*MMI>>Menu>>Car>>Audi drive select>>dynamic* or select using the dash panel button).

If the sound became more noticeable with Audi drive select in dynamic mode, then the source is the harness contacting the body structure. Proceed to the next step.

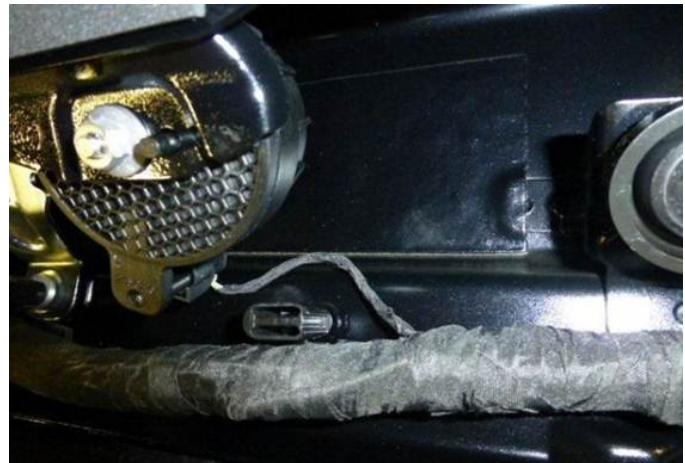
In S3 vehicles, there is an electronic sound amplification system (actuator for impact sound) that changes depending on the selected Audi drive select mode. The harness for the sound actuator can make contact with the vehicle body structure and the noise can be amplified by the sound actuator. This noise is only noticeable at higher speeds due to the calibration of the sound actuator system.

Figure 3. Sound actuator R214 in the plenum chamber.

2. Loosen the connector on sound actuator R214 (Figure 3) according to the Elsa Repair Manual.

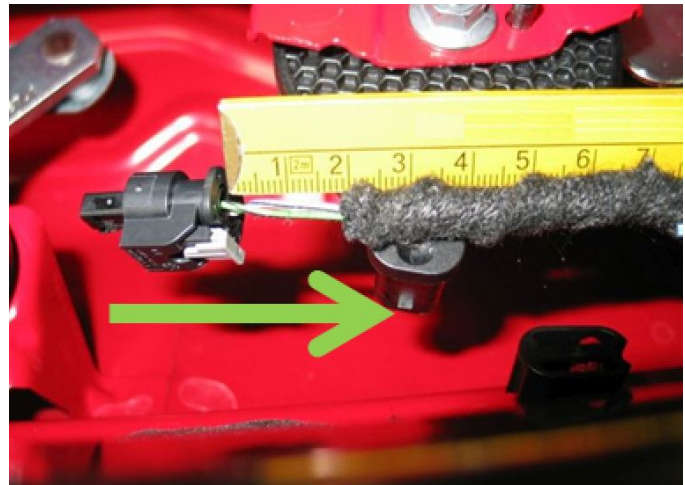
Figure 4. Direction in which to start wrapping the tape (arrow).

3. Wrap fleece tape (part number D 373125A2) from approximately 2 cm away from the connector housing to the exit of the main wiring harness (Figure 4).

The new tape can be placed over the existing insulation. The added bulk will dampen vibrations.
