Technical Service Bulletin

87 Air conditioning does not cool and / or compressor is noisy

87 15 71 2038023/7 October 14, 2015. Supersedes Technical Service Bulletin Group 87 number 15-68 dated August 21, 2015 for reasons listed below.

Model(s)	Year	VIN Range	Vehicle-Specific Equipment
A3, A3 Cabriolet	2015	000001 - 106816	Not Applicable

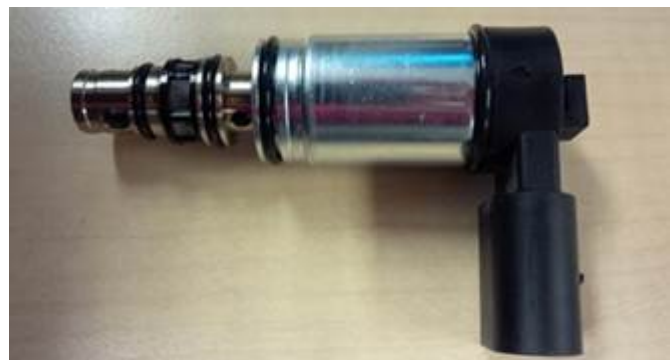
This condition is most likely caused by a faulty N280 valve (Figure 1). The internal components of the valve can be obstructed and incapable of full function. This loss of refrigerant regulation from N280 can cause noise from the A/C compressor and/or affect the HVAC cooling.

Figure 1. N280 Refrigerant Regulating Valve.

An improved N280 valve for the Sanden A/C compressor is now available as a replacement part (5Q0 260 839 A). Replacement of the entire A/C compressor is not necessary in most cases.

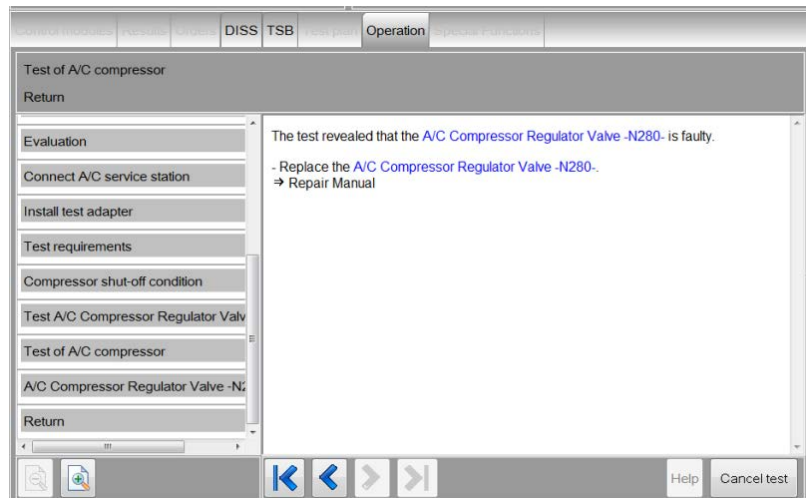
Figure 9. Checking for N280 valve contamination.

- Recover the refrigerant from the system. Remove the N280 valve using the procedure in the Elsa Repair Manual.

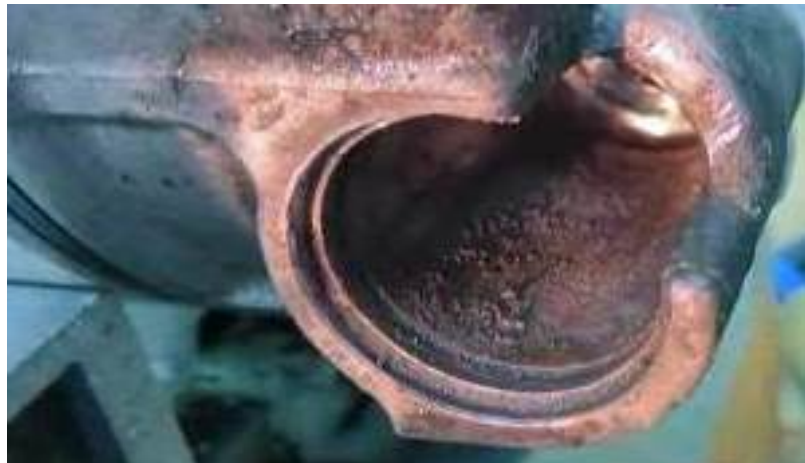
- Assess the condition of the N280 valve bore and the valve filter screen (Figure 10). If severe contamination or corrosion is found in the valve bore there is a risk of damaging the replacement valve on installation. In these cases, the A/C compressor must be replaced. A slight amount of debris or corrosion does not present a risk and does not justify replacement of the A/C compressor.

Figure 10. Corrosion in the N280 valve bore.

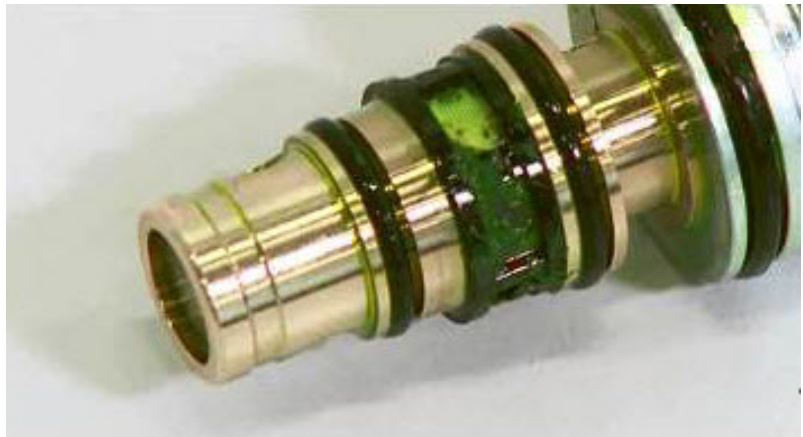
- Should severe contamination be found at the valve filter screen (Figure 11) and A/C compressor replacement becomes necessary, ensure that the refrigerant circuit is flushed in the course of repair. The presence of small random particles on the filter screen does not constitute 'severe' contamination and does not justify replacement of the A/C compressor.

Figure 11: Severe contamination at the N280 valve filter screen.

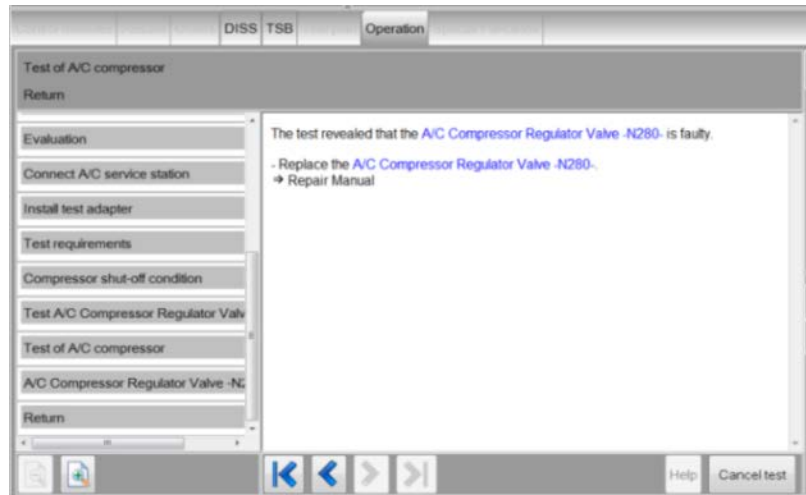
Figure 12: Test plan confirming that the N280 is faulty.

- If little or no contamination is found, the test plan will direct to replace the N280 regulating valve (Figure 12). Replace the valve using the instructions in the Elsa Repair Manual.
