Technical Service Bulletin

87 Air conditioning inoperative

87 15 69 2020124/13 August 24, 2015. Supersedes Technical Service Bulletin Group 87 number 14-49 dated April 25, 2014 for reasons listed below.

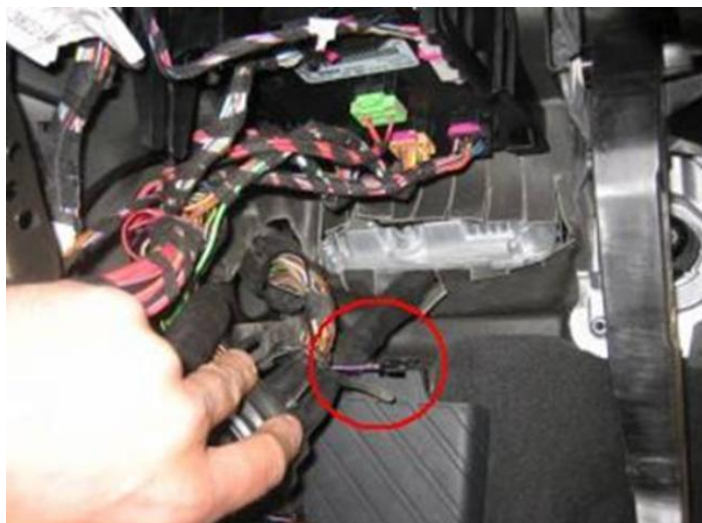
There are two known sections in the wiring harness that can be affected, but the potentially affected areas are not limited to these two known sections. One of the known sections is in the driver's footwell area where the wire harness enters the interior of the car from the engine bay (Figure 1).

Figure 1. Wire harness in driver footwell area.

6. If a cut wire is found, install an overlay wire for the LIN bus signal. Do *not* attempt to repair the existing wire harness.

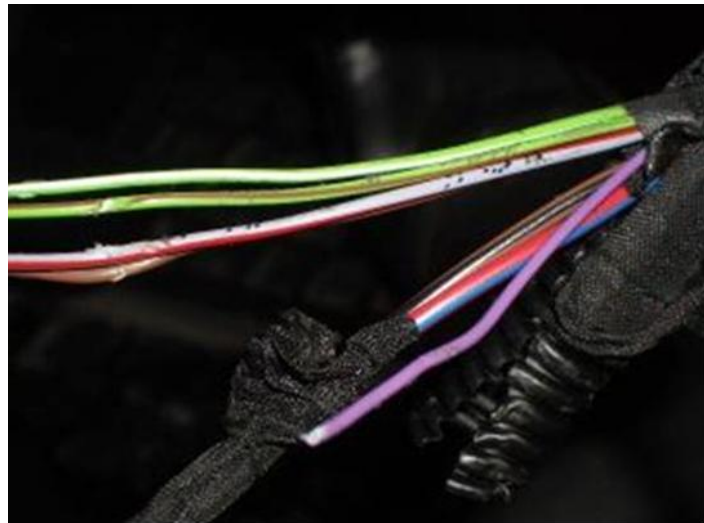
The second known section is in the wire harness located under the driver's side headlight (Figure 2).

Figure 2. Wire harness under driver's side headlight.

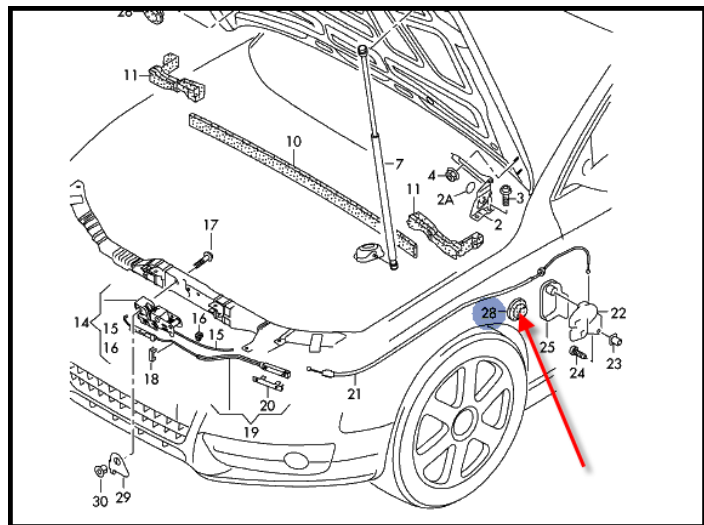
Figure 3. Grommet in driver's side fender/lower A-pillar area used for pass-through for new overlay wire.

a. Route the new LIN bus wire from the vehicle electrical system control module, J519, to the sender for sensor G395 so that it enters the interior of the vehicle through the driver's side fender/lower A-pillar area through the grommet indicated in the images at right (Figures 3 and 4).

Tip: Do *not* route the wire through the same opening used by the existing wire harness.

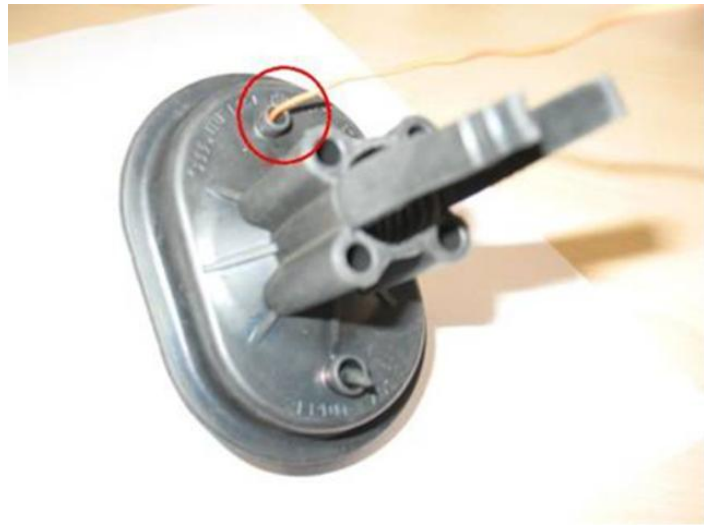
Figure 4. Access hole in grommet.

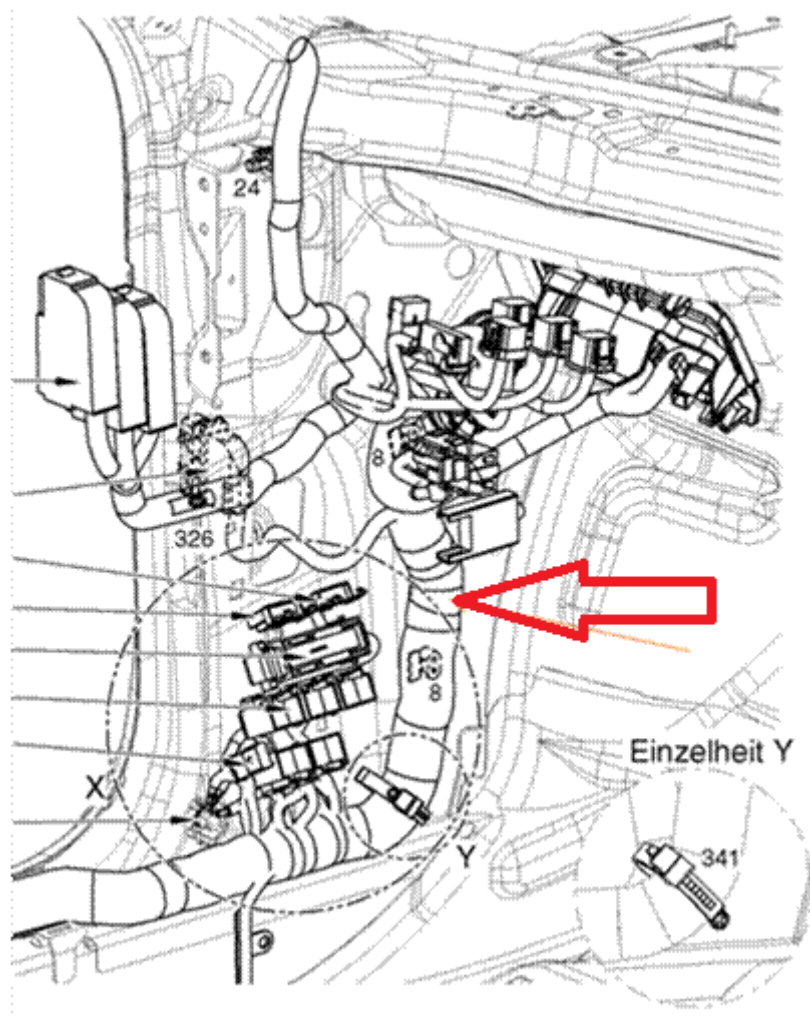
Figure 5. Cable routing with charisma switch option.

On vehicles with a charisma switch (ride selection switch located on the instrument panel) route the new cable of the sender for sensor G395 to junction B549 (Figure 5, red arrow).

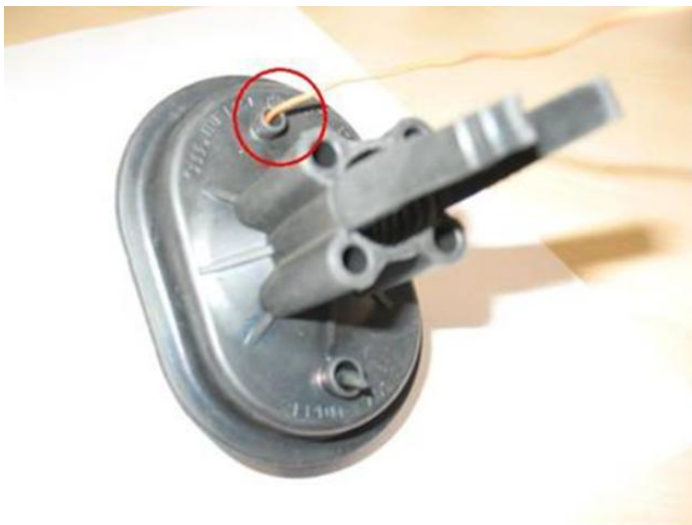
Figure 6. Access hole in grommet to be sealed with Butyl sealant.

- b. Seal off the opening around the wire with Butyl sealant to prevent water intrusion (Figure 6).
