# Technical Service Bulletin

## 01 MIL on due to lambda sensor malfunction

01 15 40 2014825/4 August 19, 2015. Supersedes Technical Service Bulletin Group 97 number 08-29 dated December 22, 2008 for reasons listed below.

| Model(s) | Year | VIN Range | Vehicle-Specific Equipment |
|---|---|---|---|
| A8 | 2005 - 2007 | All | W12 engine |

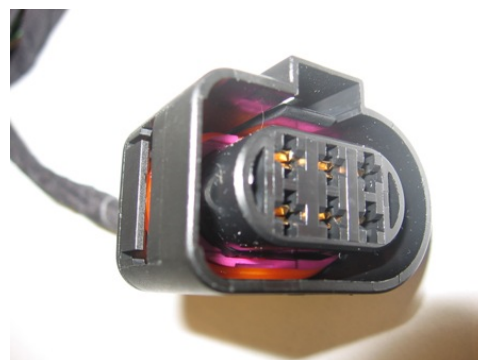
**Figure 1.** Lambda sensor connector.

1. Replace the lambda sensor that triggered the fault memory entry.
2. Solder the electrical contacts for all lambda sensors to their respective wires (engine harness side only) by performing the procedure below:
  - a. Disconnect engine harness from sensor (Figure 1).

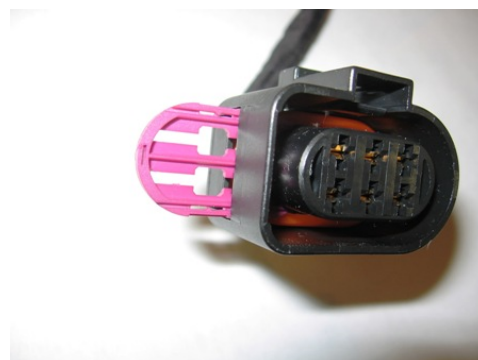
**Figure 2.** Secondary lock, shown partially removed from the lambda sensor connector.

- b. Remove secondary lock from connector (Figure 2).

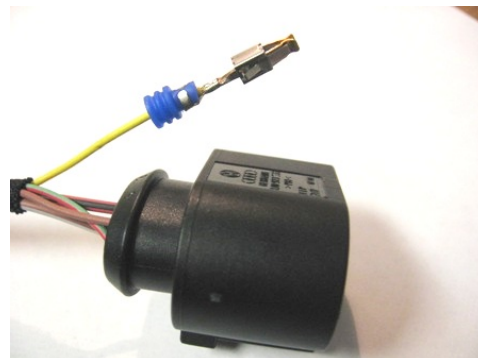
**Figure 3.** Contact, shown removed from connector.

- c. Remove contact from connector using VAS 1978/4A tool (Figure 3).

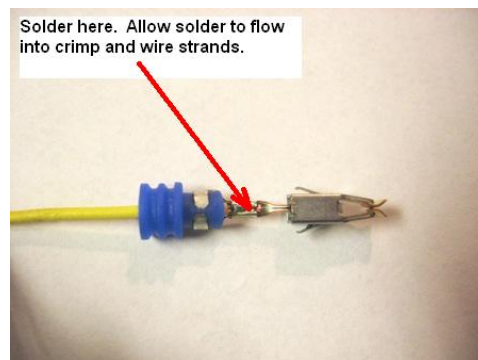
**Figure 4.** Location to solder.

- d. Solder crimp connection while making sure solder area is clean, is heated thoroughly, and that an appropriate amount of solder is used (Figure 4).

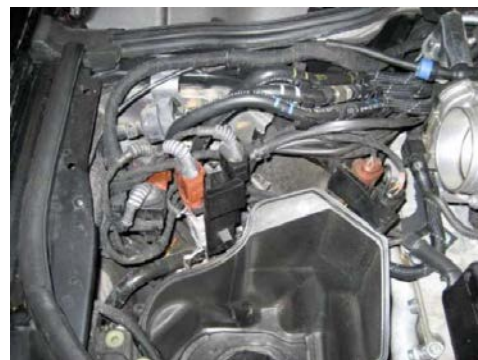
**Figure 5.** Sensor, reconnected.

- e. Allow contact to cool. Reinstall contact with secondary lock and reconnect to sensor (Figure 5)
