Technical Service Bulletin

21 MIL on (DTC P029900 - wastegate linkage disconnected)

21 15 22 2039006/3 August 4, 2015. Supersedes Technical Service Bulletin Group 21 number 14-21 dated November 26, 2014 for reasons listed below.

Model(s)	Year	VIN Range	Vehicle-Specific Equipment
A4, A5, A5 Cabriolet, A6, Q5, TT	2013 - 2014	All	2.0 TFSI

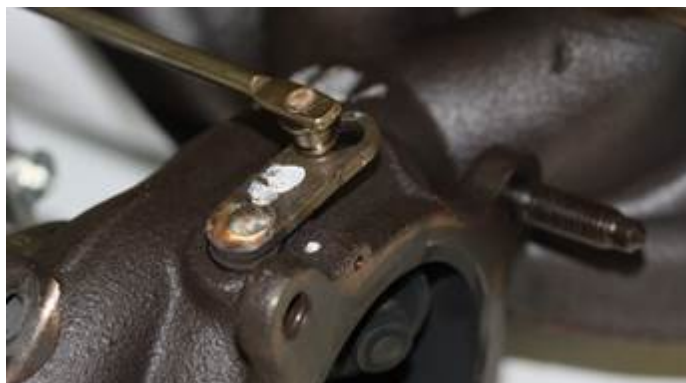
The circlip connecting the turbo wastegate actuator rod and the wastegate flap lever can fall off due to low tension of the clip. Consequently, the wastegate linkage becomes disconnected, causing MIL on and DTC P029900.

Figure 1. Disconnected wastegate linkage.

2. Remove catalyst according to ELSA instructions to gain access to turbocharger wastegate linkage.
3. Reconnect wastegate linkage and secure with a new circlip (separately available in ETKA).
