Technical Service Bulletin

87 Air conditioning does not cool and / or compressor is noisy

87 15 68 2038023/6 August 21, 2015. Supersedes Technical Service Bulletin Group 87 number 15-66 dated July 29, 2015 for reasons listed below.

Model(s)	Year	VIN Range	Vehicle-Specific Equipment	
A3, A3 Cabriolet	2015	000001 - 106816	Not Applicable

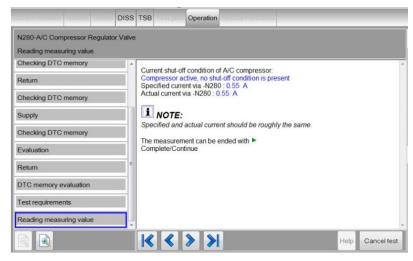
Figure 5. Checking N280 signal value Measuring Value Block.

- With the engine at idle, switch the climate control unit to full cold and full fan.
- 2. Using the diagnostic tester, go to Guided Functions.
- Monitor the measuring value for the air conditioner compressor regulating valve N280 signal (Figure 5).

The actual and specified values will be plausible and will show a normal regulating range of current for cooling request (0.400 A - 0.680 A).

However, there will be equalized pressure readings on the high and low sides of the circuit (no pressure generation from the compressor).

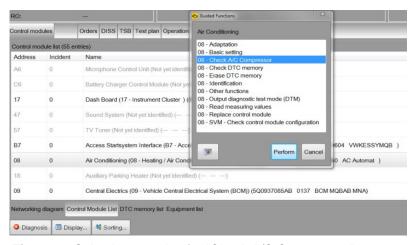
Figure 6. Selecting test plan for "Check A/C Compressor".

Continuing in Guided Functions, select the test plan for "Check A/C Compressor" (Figure 6).

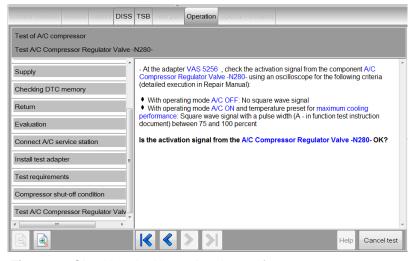
Figure 8. Checking the N280 signal wave form.

Next, the signal wave form will be checked (Figure 8). The square wave signal should be between 75% and 100%.

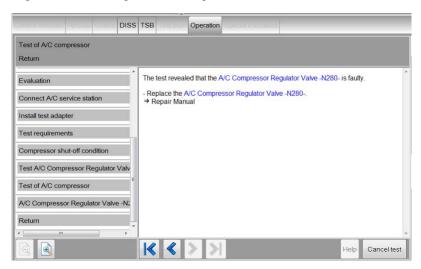
Figure 9. Checking for N280 valve contamination.

If the wave form signal is good, the mechanical integrity of the N280 valve will be inspected next (Figure 9).

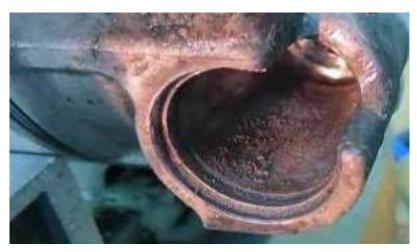
9. Assess the condition of the N280 valve bore and the valve filter screen (Figure 10). If severe contamination or corrosion is found in the valve bore there is a risk of damaging the replacement valve on installation. In these cases, the A/C compressor must be replaced. A slight amount of debris or corrosion does not present a risk and does not justify replacement of the A/C compressor.

Figure 10. Corrosion in the N280 valve bore.

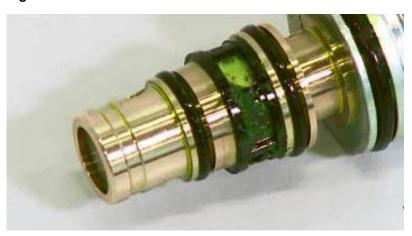
10. Should severe contamination be found at the valve filter screen (Figure 11) and A/C compressor replacement becomes necessary, ensure that the refrigerant circuit is flushed in the course of repair. The presence of small random particles on the filter screen does not constitute 'severe' contamination and does not justify replacement of the A/C compressor.

Figure 11: Severe contamination at the N280 valve filter screen.

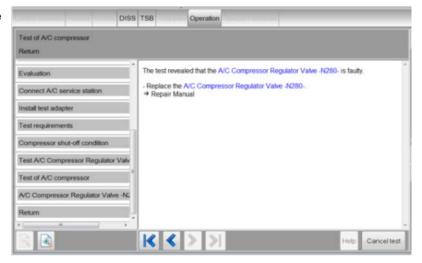
Figure 12: Test plan confirming that the N280 is faulty.

If little or no contamination is found, the test plan will direct to replace the N280 regulating valve (Figure 12). Replace the valve using the instructions in the Elsa Repair Manual.
