Technical Service Bulletin

90 Overhead view camera - picture from side cameras in rear area distorted

90 15 56 2041636/1 August 6, 2015.

Model(s)	Year	VIN Range	Vehicle-Specific Equipment
A6, A8	2016	Applies only to specific VINs	Not Applicable

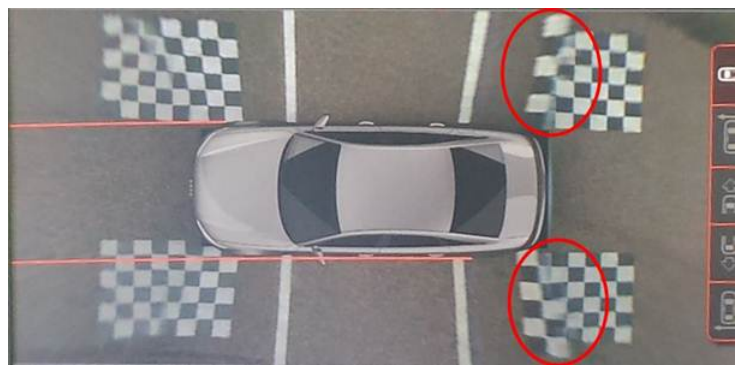
The picture from one or both of the cameras in the exterior mirrors is distorted in the rear area (Figure 1 and Figure 2).

Figure 1. Example of distortion.

There are deviating calibration values in the camera.

Improved cameras with updated calibration values.

2. Check the serial number of the camera against the list of serial numbers in the attached PDF.
Use CTRL+F to open the search window in the PDF document.
3. If the camera's serial number is on the list, replace the camera.

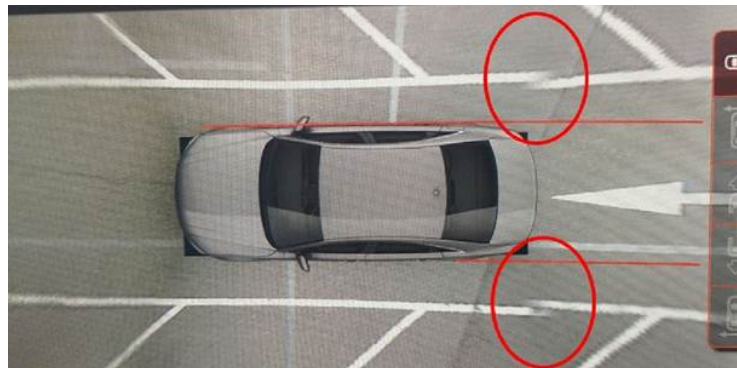
Figure 2. Example of distortion.

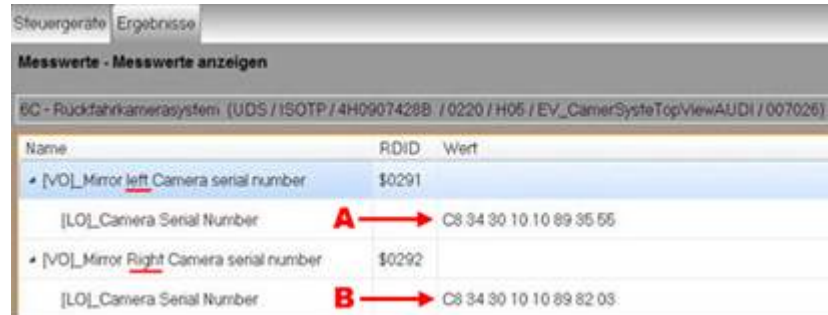
Figure 3. Left mirror camera serial number (A); right mirror camera serial number (B).

1. Find the serial number of the camera(s). The serial numbers can be found in the measured values of the rearview camera system control module, J772 (address word 6C) (Figure 3).
