Technical Service Bulletin

91 MMI tutorial videos cannot be played or stop playing

91 15 09 2040393/3 August 17, 2015. Supersedes Technical Service Bulletin Group 91 number 15-99 dated June 30, 2015 for reasons listed below.

Model(s)	Year	VIN Range	Vehicle-Specific Equipment
A6, A7	2016	All	Not Applicable

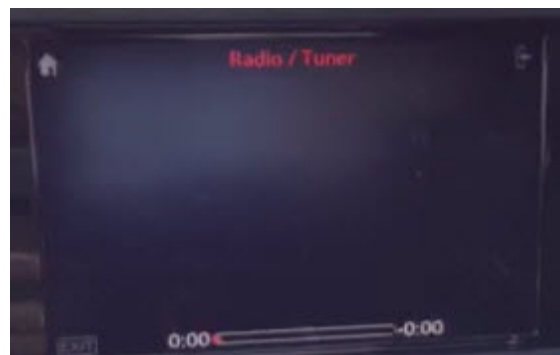
- The tutorial videos in the MMI do not play or stop playing after some time (Figure 1). The condition may only occur with certain videos.
- Turning the ignition off and back on may correct the condition.

Figure 1. Unplayable tutorial video.

- An updated video tutorial DVD was sent to Audi dealers in June 2015. The updated version number is 162.565.4G0.23. Discard the existing DVDs for model year 2016 A6/S6 and A7/S7/RS 7 with version number 161.565.4G0.23.
- If the disc was not received, or if it was lost or damaged, the videos can be downloaded or a replacement DVD can be ordered.
To download the videos:
The videos and installation instructions are available on the Audi intellect site at <http://audi-intellect.com/resources.php> (Figure 3). An SD Card (1GB or larger) or USB drive (1GB or larger) is needed.
To order a replacement DVD by mail:
Send an email to audidvdreorder@audi.com. Include the dealer contact name, dealer number, address and quantity required.
- A warranty claim can only be submitted if the update is being performed due to a customer complaint that occurred after the initial PDI was completed.

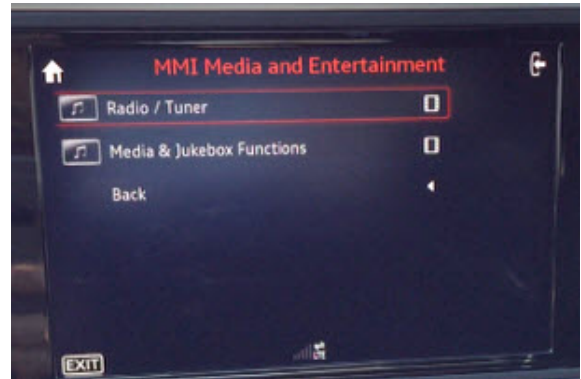
Two of the tutorial videos for the 2016 A6 and A7 are not correct. When the user attempts to play these videos a cascading effect can occur, causing all other videos to cease playing after some time.

The incorrect video files are “Radio / Tuner” and “Media & Jukebox Functions” (Figure 2).

Figure 2. Incorrect video files.
