Technical Service Bulletin

91 MMI3G+ GPS navigation location inaccurate or navigation takes a very long time to acquire location

91 15 10 2040406/3 August 25, 2015. Supersedes Technical Service Bulletin Group 91 number 15-90 dated June 5, 2015 for reasons listed below.

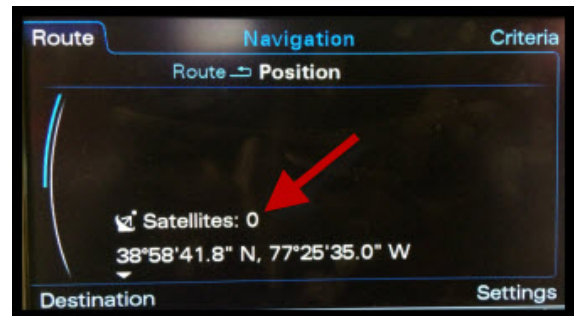
Figure 1. No satellite reception.

- When the issue occurs, the GPS navigation system satellite reception shows 0 satellites. Due to the infrequency of the issue, this might not be verifiable. (To view the number of satellites being received, go to *Nav >> Route >> Select Current Position* (first item in list) and scroll up (Figure 1)).

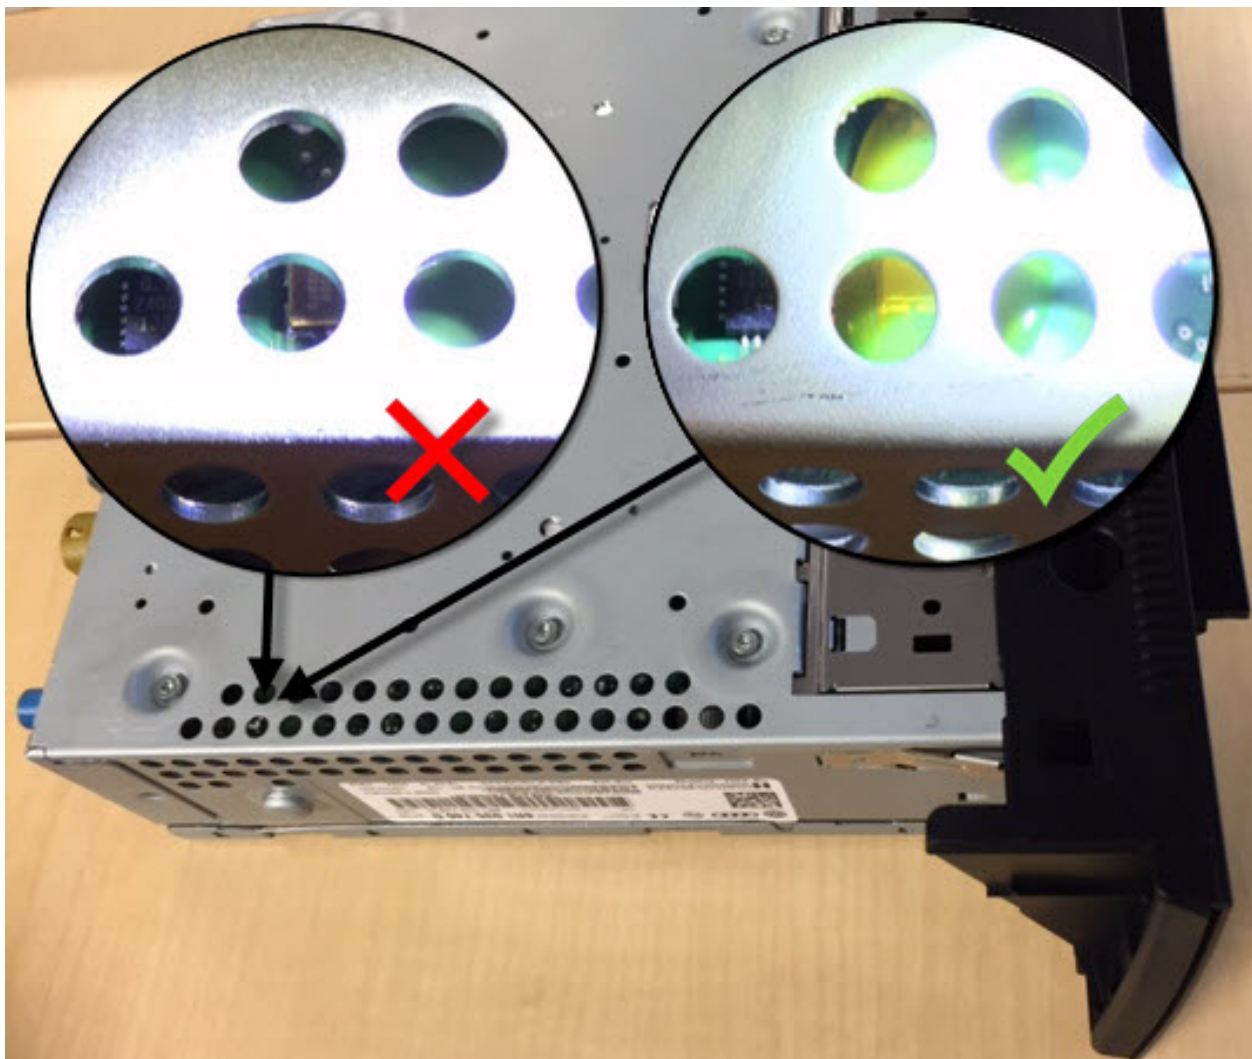
Figure 2. Example of integrated circuit chip without coating (left) and with coating (right). Parts without the coating over the integrated circuit chip are not okay and should be replaced.

3. Check the integrated circuit chip of the GPS oscillator on the internal circuit board. The chip should have a

translucent yellow coating (Figure 2).

Some early service parts did not have the coating despite the updated hardware part number (G suffix) and build date. All parts built after November 08, 2014 should have the coating over the integrated circuit chip. If the part does not have the coating over the integrated circuit chip, return the part and order a replacement.

If the parts department has problems getting updated parts with the integrated circuit chip coating, contact TAC. A small amount of specially modified parts are available for shipping directly from Audi of America.

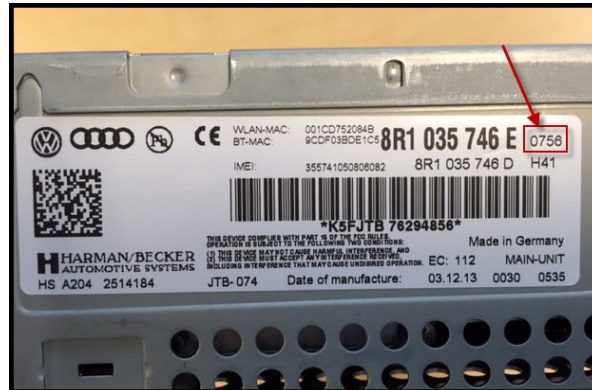
4. Check the label (Figure 3) on the side of the new part to verify that it contains software at level 0901 or higher. Install the replacement MMI main unit (information electronics control module 1, J794 (address word 5F)).

Figure 3. Main unit part label.

5.
 - If the software level is less than 0901, perform component protection removal, **repeat steps 1 and 2** and then move to step 6.
 - If the software is at 0901 or above (A6, A7, and A8 can have 0902), perform component protection removal and **repeat step 2**, then move to Step 6. Repeating step 2 will allow SVM to accept the new control unit with the updated part number.
