## 91 MMI3G+ GPS navigation location inaccurate or navigation takes a very long time to acquire location (Q7/Q3)

91 15 11 2041608/1 August 25, 2015.

Model(s)	Year	VIN Range	Vehicle-Specific Equipment
Q3	2015	All	MMI3G+
Q7	2014 - 2015	All	MMI3G+

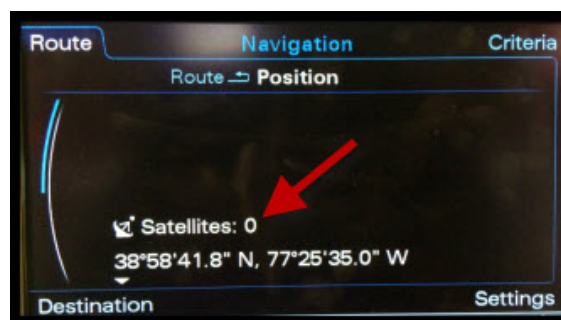
- The vehicle is a Q7 or Q3.
- When the vehicle is started, the GPS location or vehicle direction indicated on the MMI navigation map does not match the vehicle's actual location or direction of travel for a long period of time (often as long as 10 minutes):
  - The issue occurs in open sky, with no large buildings obstructing the sky view.
  - The issue is intermittent, but it can occur for long periods of time during a single day. The issue may or may not resolve itself.
  - When the issue occurs, the GPS navigation system satellite reception shows 0 satellites. Due to the infrequency of the issue, this might not be verifiable. (To view the number of satellites being received, go to *Nav >> Route >> Select Current Position* (first item in list) and scroll up (Figure 1)).
- A DTC related to the GPS antenna or MMI system may be or may not be present

Figure 1. No satellite reception.
