Technical Service Bulletin

92 Rear wiper motor inoperative

92 15 11 2040221/2 August 6, 2015. Supersedes Technical Service Bulletin Group 97 number 15-46 dated April 2, 2015 for reasons listed below.

Model(s)	Year	VIN Range	Vehicle-Specific Equipment
Q5	2010 - 2016	All	Not Applicable

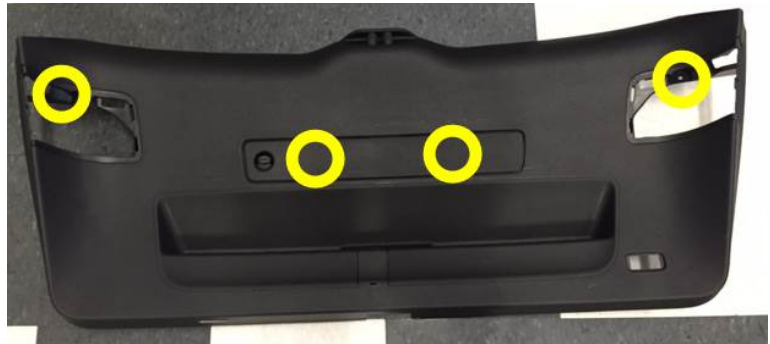
Figure 1. Screw location on lower tailgate trim.

1. To access the rear wiper motor, remove the lower tailgate trim. See the illustrations at right for the locations of the screws and clips (Figure 1 and Figure 2).

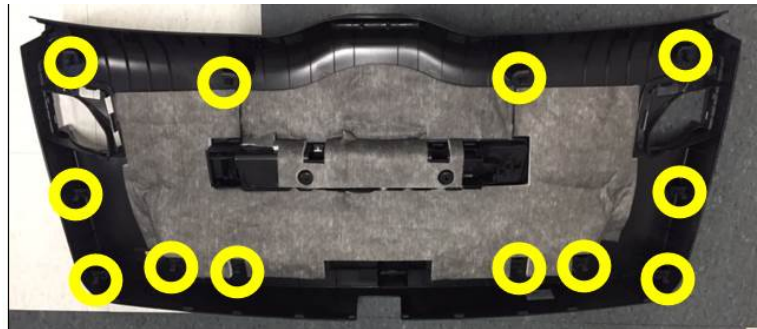
Figure 2. Clip location on lower tailgate trim.

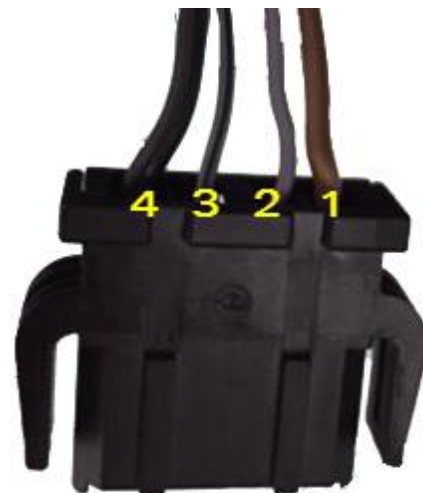
Figure 3. Rear wiper motor connector.

2. With key on, check voltage at pin 1 and pin 4 of the rear wiper motor connector (Figure 3 and Figure 4).
The voltage reading should show battery voltage (approximately 12.4V). If battery voltage is not found, continue diagnosis outside this TSB.

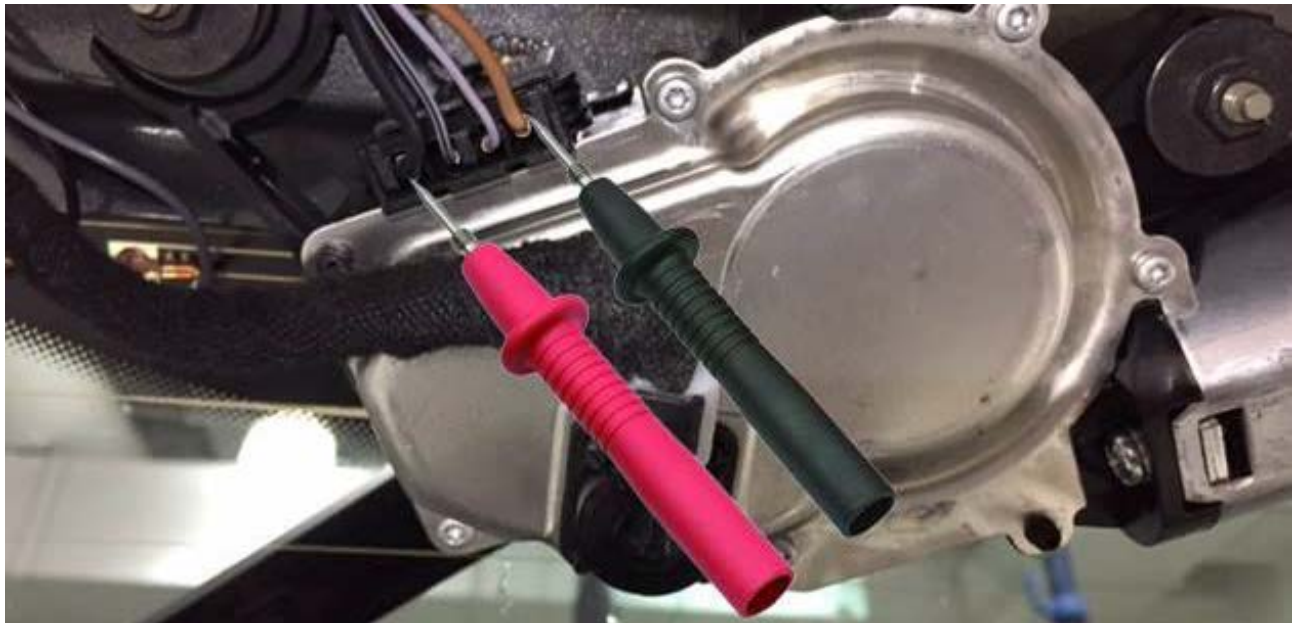
Figure 4. Check voltage at pin 1 and pin 4.

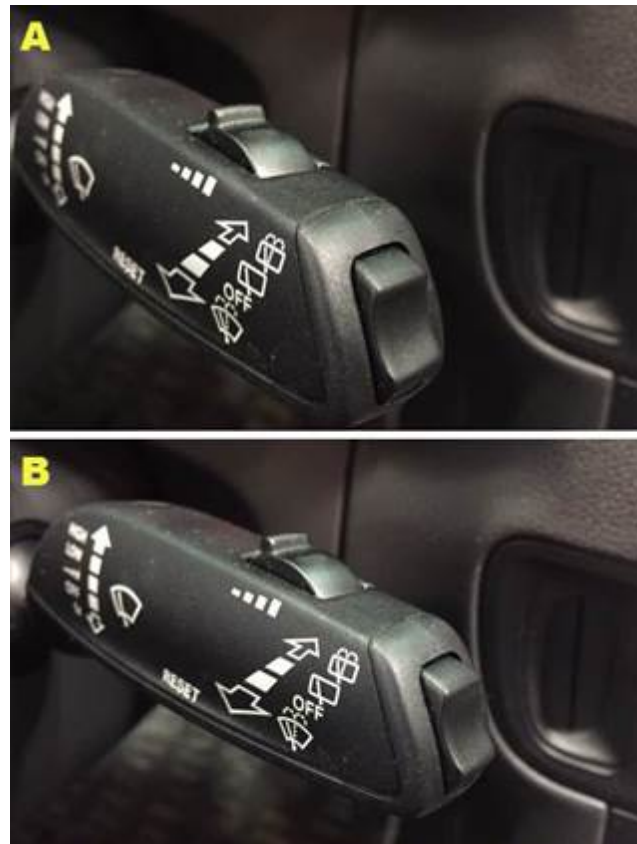
Figure 5. Rear wiper in “off” position (A) and in “on” position (B).

3. Move the windshield wiper lever forward to turn on the rear wiper function (Figure 5).

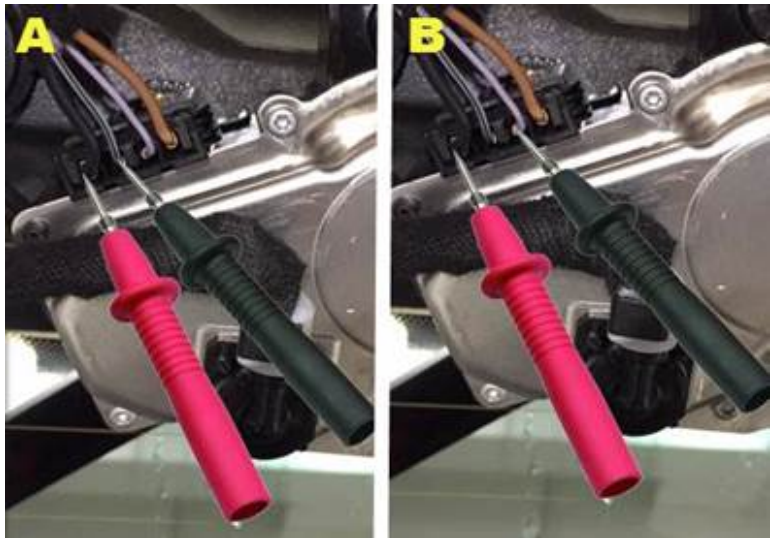
Figure 6. Compare voltage readings between pin 4 and pin 3 (A) and between pin 4 and pin 2 (B).

4. Compare the voltage readings between pin 4 and pin 3 with the voltage readings between pin 4 and pin 2 (Figure 6).
 - If the voltage reading between pin 4 and pin 3 is more than .5V DC when compared to pin 4 and pin 2, continue to the next step.
 - If the voltage readings are identical, continue diagnosis outside of this bulletin.

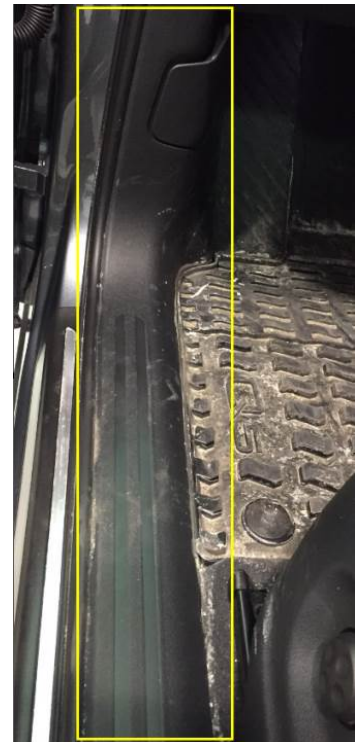
Figure 7. Driver's side kick panel.

5. To access the wiring harness, remove the driver's side kick panel (Figure 7).

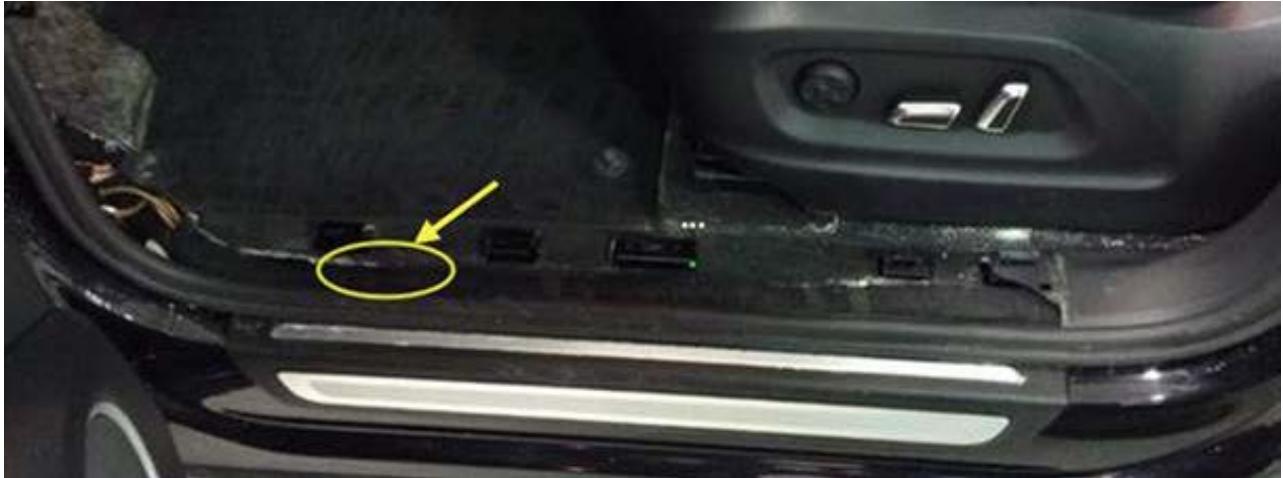
Figure 8. Open the wiring harness.

6. Open the wiring harness (Figure 8) to access splice B536 (Figure 9).

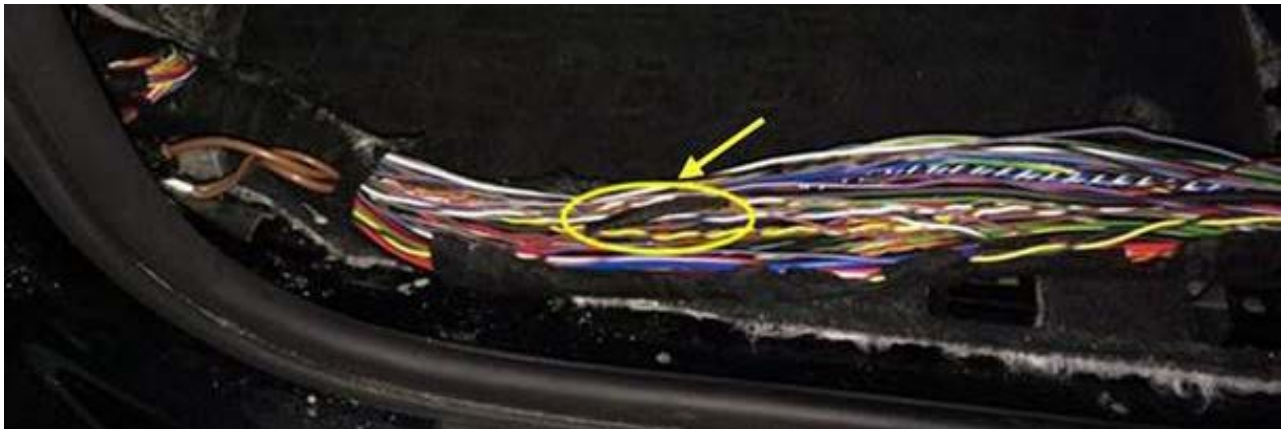
Figure 9. Access splice B536.

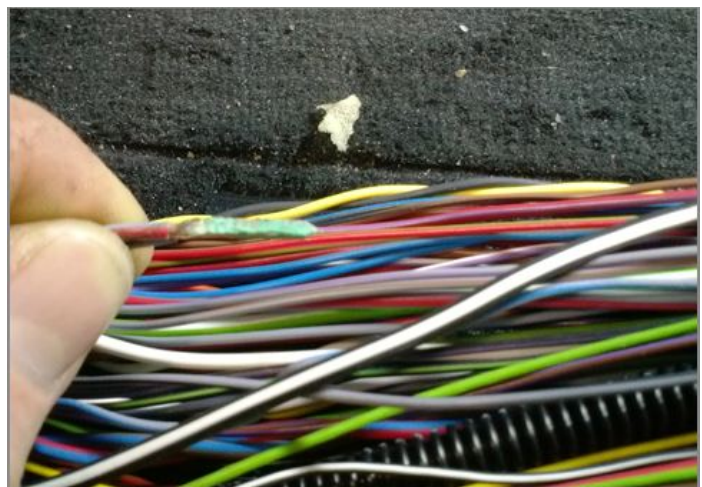
Corrosion at the B536 splice of the rear wiper motor control circuit can cause an excessive voltage drop, resulting in an out of range control signal.

Figure 10. Example of corroded wire.

7. Open the splice to check for corroded wires (Figure 10).

8. Use wiring harness repair kit VAS 1978B to repair the splice, then reassemble the wiring harness.

Tip: Utilize the proper connectors from the repair kit as the heat shrink will seal out future corrosion. The adhesive-lined inner layer will keep moisture out.
