Technical Service Bulletin

94 Taillight warning appears in instrument cluster

94 15 71 2039584/2 August 3, 2015. Supersedes Technical Service Bulletin Group 94 number 15-59 dated January 29, 2015 for reasons listed below.

Model(s)	Year	VIN Range	Vehicle-Specific Equipment
A6	2012 - 2015	All	Not Applicable

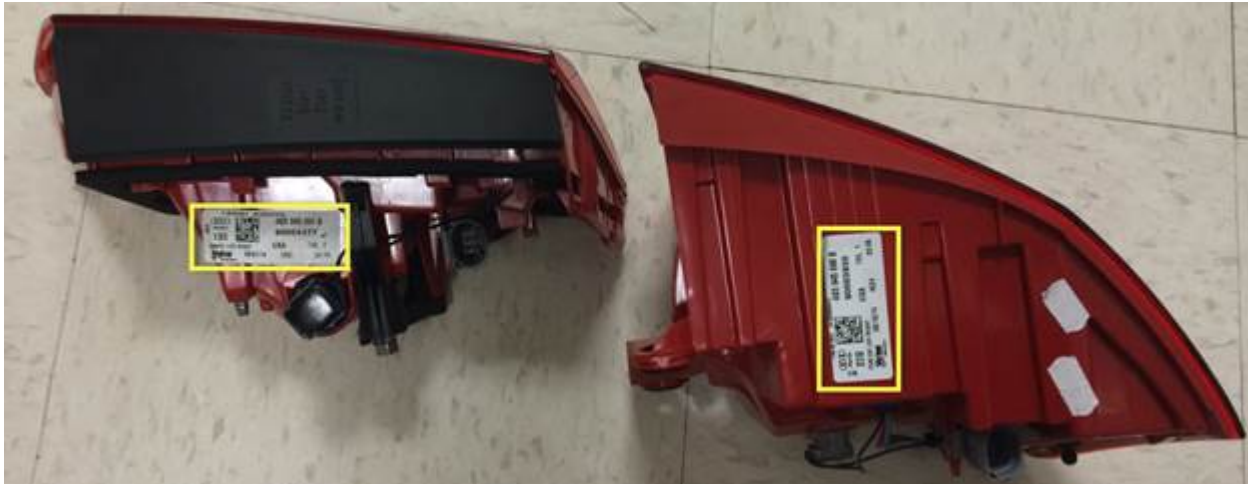
Figure 1. Location of date information.

Replace any taillights with logged DTC entries. Ensure that the updated taillights with the optimized transistor are used. The updated taillights have production date August 11, 2014 or newer, written as 11/08/2014 (DD/MM/YYYY) (Figure 1, Figure 2, Figure 3).

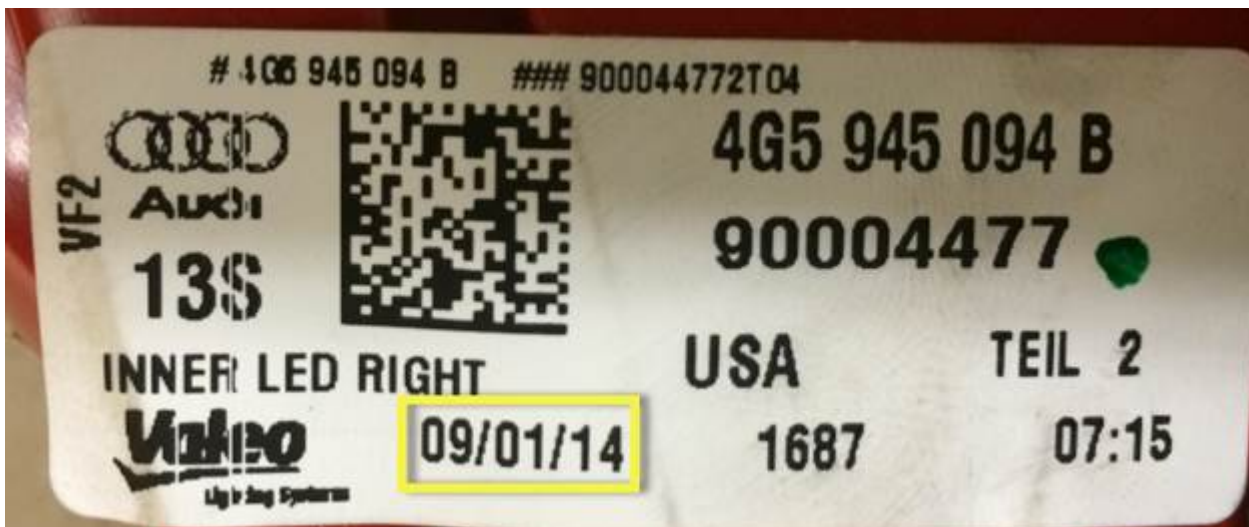
Figure 2. Location of production date, shown as DD/MM/YYYY. The production date of this taillight is January 9, 2014.

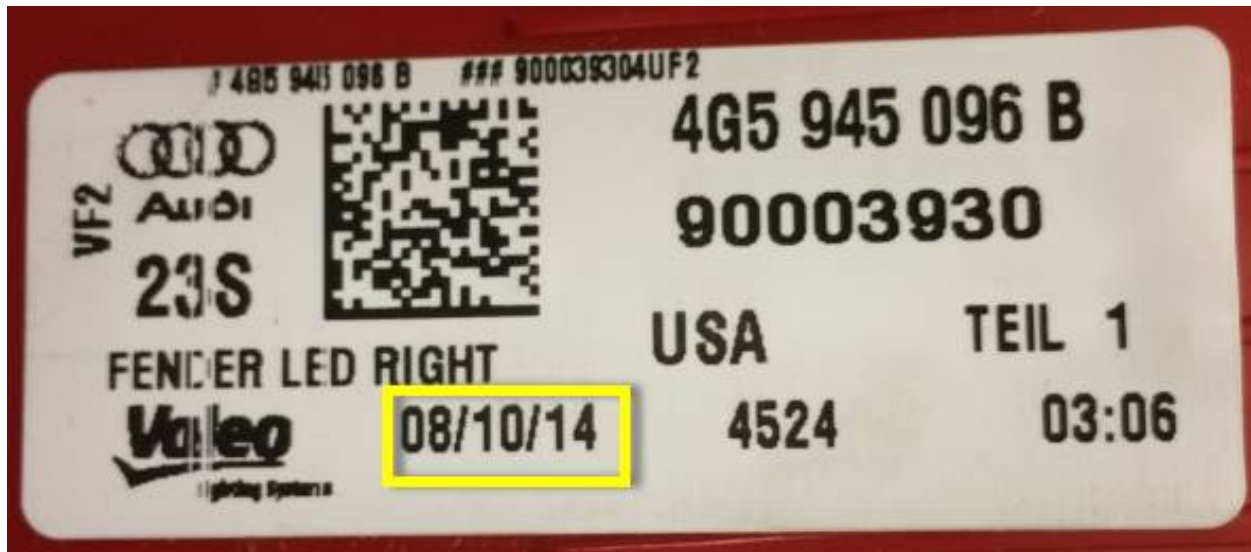
Figure 3. Location of production date, shown as DD/MM/YYYY. The production date of this taillight is October 8, 2014.
