Technical Service Bulletin

94 Daytime running light (DRL) inoperative (DTC 02895 or 02897)

94 15 72 2032184/6 August 19, 2015. Supersedes Technical Service Bulletin Group 94 number 15-68 dated June 29, 2015 for reasons listed below.

Model(s)	Year	VIN Range	Vehicle-Specific Equipment
Q5	2013 - 2016	All	Not Applicable

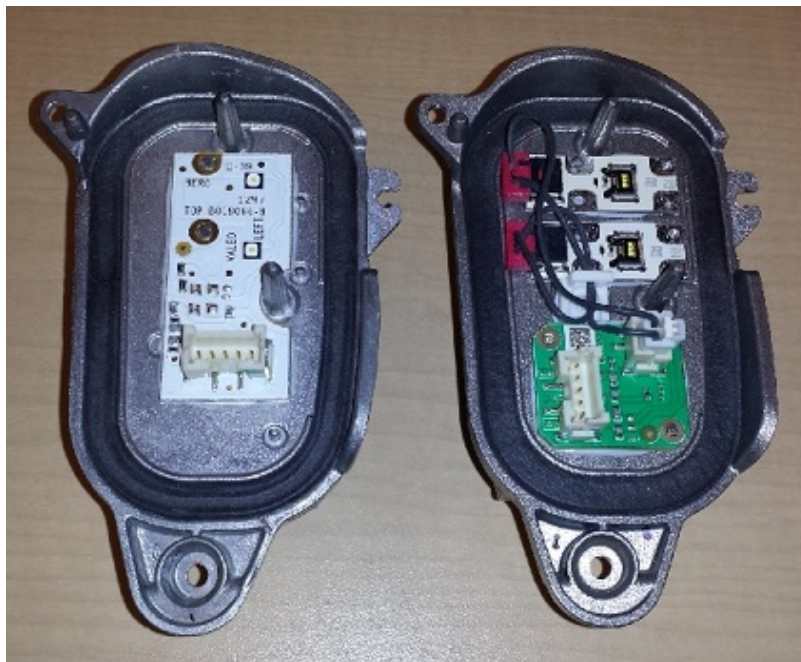
As of March 12th, 2013 production, the LED unit with heat sink has been updated (Figure 3). If a failure occurs, these parts do *not* need to be replaced in pairs.

Figure 3. Current (left) and early (right) style LED DRL units.

6. The appearance of the replacement part for the LED DRL has changed, but functionality is the same. If an LED DRL needs to be replaced, they do not need to be replaced as a pair.

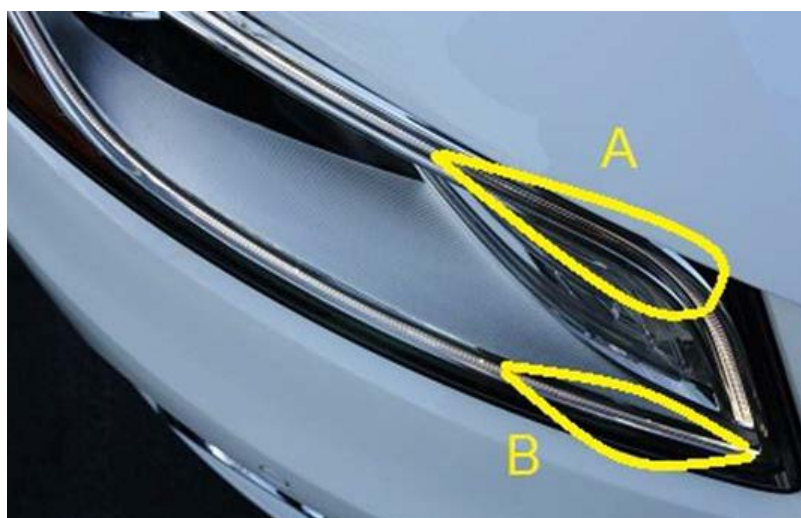
- A defect may be perceived for top-down viewing angle (Figure 4).

Figure 4. Upper light pipe perceived defect (A). Lower light pipe perceived defect (B).

Explain to the customer that the LED illumination appears differently to someone standing in front of the vehicle than it appears to oncoming traffic. The viewing angle of someone standing in front of the vehicle will give a visual effect of an LED DRL inoperative or partially-inoperative condition.

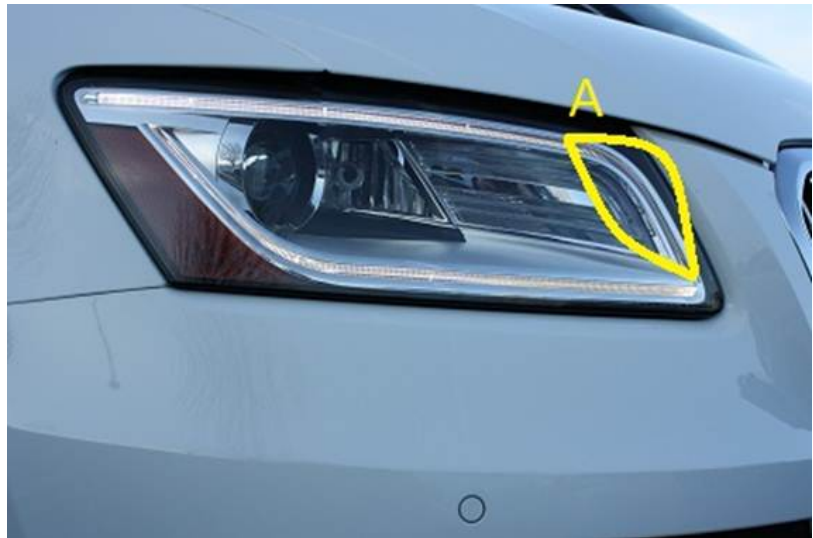
- A defect may be perceived for corner viewing angle (Figure 5).

Figure 5. Upper light pipe perceived defect (A).

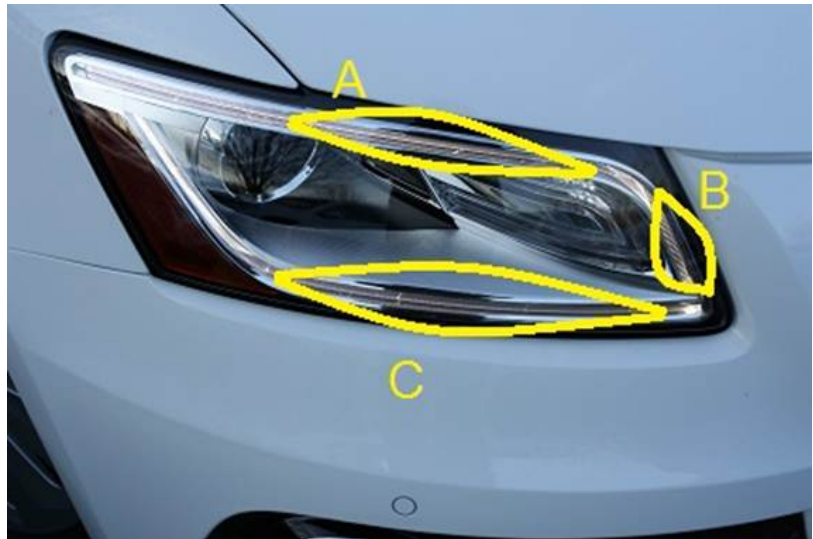
- A defect may be perceived for acute corner viewing angle (Figure 6).

Figure 6. Upper light pipe perceived defect (A, B). Lower light pipe perceived defect (C).

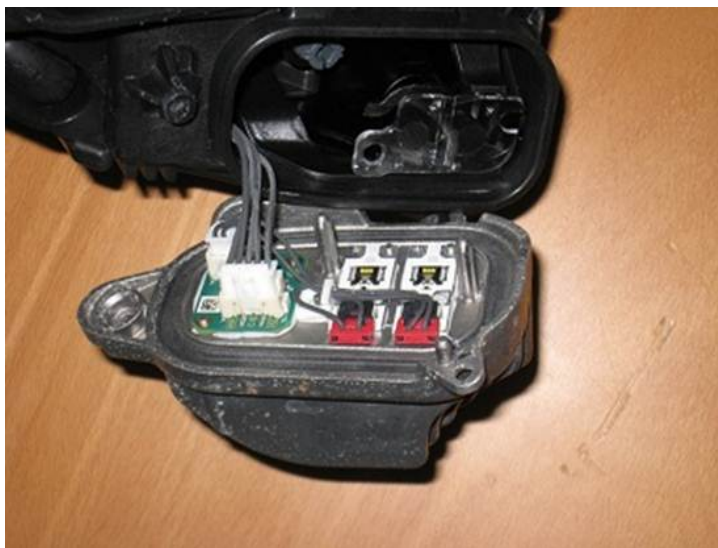
Be extra careful with red surface mount connectors. In general, a repair kit is not available for any internal headlight connectors.

Figure 7: Dual surface mount LED unit exposed.

1. With ignition off, remove DRL control module and check red connector at module. Secure it, if loose. If necessary, remove red connector and reinstall to be sure connector is engaged properly. The wiring harness guide of the red terminal housing may impede connector engagement.
2. Turn ignition on to see if DRL is now operating to specifications. If it is not, proceed to step 3.
3. Remove headlight(s) according to the instructions in Elsa. See *Repair Manual >> Electrical System >> Electrical Equipment >> 94 Exterior Lights, Switches >> Removal and Installation*.
4. With ignition off, remove LED DRL unit with heat sink from headlight housing (Figure 7).
5. With ignition off, inspect and secure all electrical connectors, if loose. Remove and secure the white connectors, even if they do not appear to be loose.
