Technical Service Bulletin

01 MIL on (DTC P0011 and/or P0021 - camshaft position)

01 15 29 2041097/1 July 1, 2015.

Model(s)	Year	VIN Range	Vehicle-Specific Equipment
All	2013 - 2014	All	4.0 TFSI

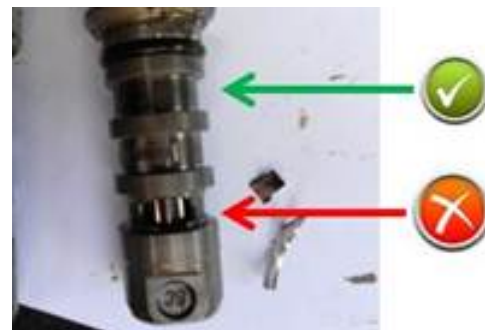
- On the camshaft adjustment valve, the filter element can loosen (Figure 1).
- There is no consequential damage from loosened particles in the oil circuit. They are gathered by the oil filter.

Figure 1. Two top filters are okay, bottom filter is missing.

1. The camshaft adjustment valve is fitted in four different positions. Check the affected camshaft adjustment control valve (see DTC entry). The following list shows which component is affected, based on event entry:
 - N205 – cylinder bank 1, inlet side
 - N318 – cylinder bank 1, exhaust side
 - N208 – cylinder bank 2, inlet side
 - N319 – cylinder bank 2, exhaust side
2. Remove connector (Figure 2) from control valve with DTC.
3. Remove bolt (Figure 2) from control valve with DTC, then remove valve.
4. Install O-ring on new control valve. Replace hex collar bolt and tighten new bolt to 5 Nm.

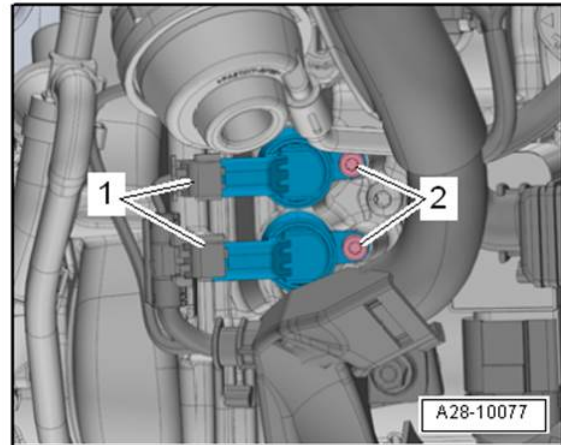
Figure 2. Connector (1) and bolt (2) to be removed from affected control valve.
