Technical Service Bulletin

46 Q5 squealing from front brakes, 2.0T, & 3.2L (PR-1LA)

46 15 18 2033102/6 July 15, 2015. Supersedes Technical Service Bulletin Group 46 number 15-12 dated June 29, 2015 for reasons listed below.

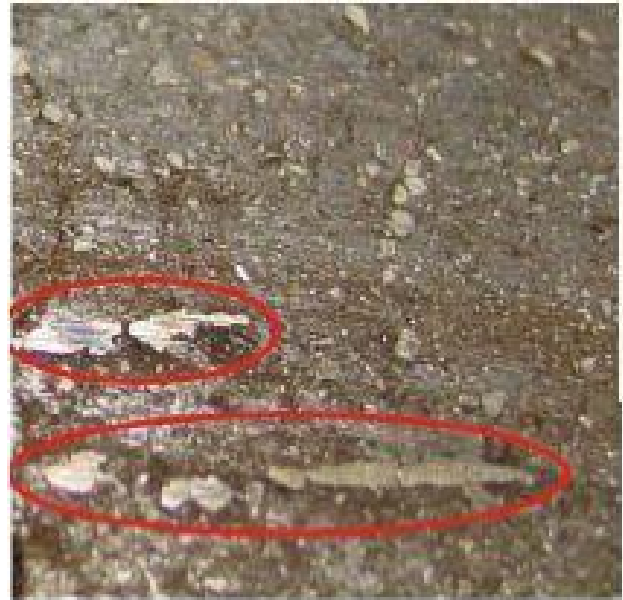
1. Front brake discs or brake pads are close to their wear limit (disc wear limit: 28 mm and pads wear limit with backing plate and dampening late: 10 mm).
2. Foreign objects between brake disc and brake pad, such as small stones, grit, rust build-up, or sand.
4. Un-ground or corroded friction materials.
5. Metallic deposits from disc material in brake pad (Figure 1).

Figure 1. Metallic deposits.

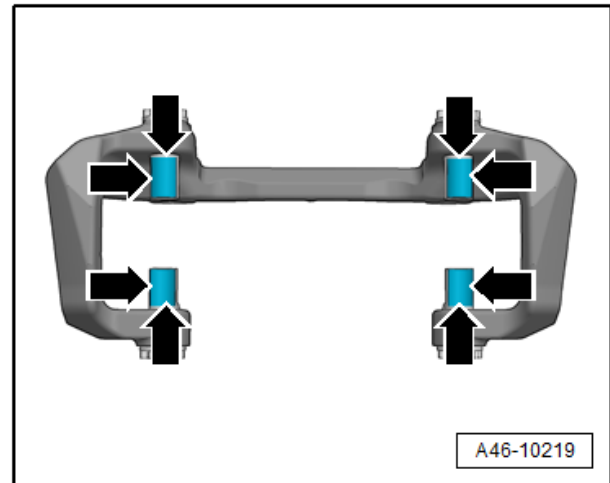
Figure 2. Caliper carrier guide pins with anti-seize (G 052560A2) lubricant applied where the pads make contact.

1. Install parts kit part number **8R0698998A** according to Elsa.
2. Apply a thin coat of anti-seize (G 052560A2) lubricant to the guide pins of the front caliper carriers prior to installing the brake pads (Figure 2).

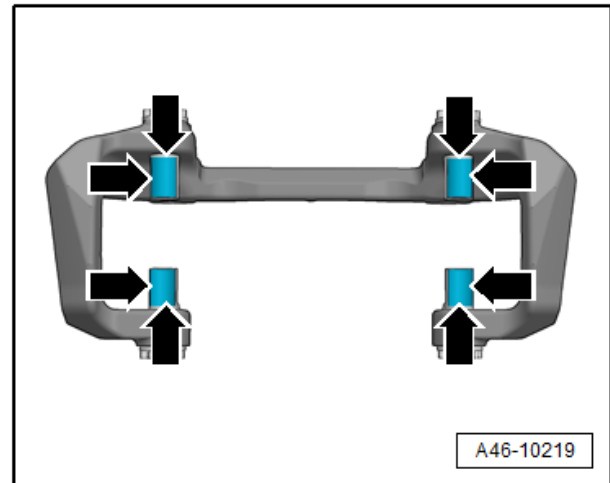
Figure 2. Caliper carrier guide pins with anti-seize (G 052560A2) lubricant applied where the pads make contact.

1. Apply a thin coat of anti-seize (G 052560A2) lubricant to the guide pins of the caliper carrier prior to installing the brake pads (Figure 2).
