**Freightliner
Service Bulletin**

General Information

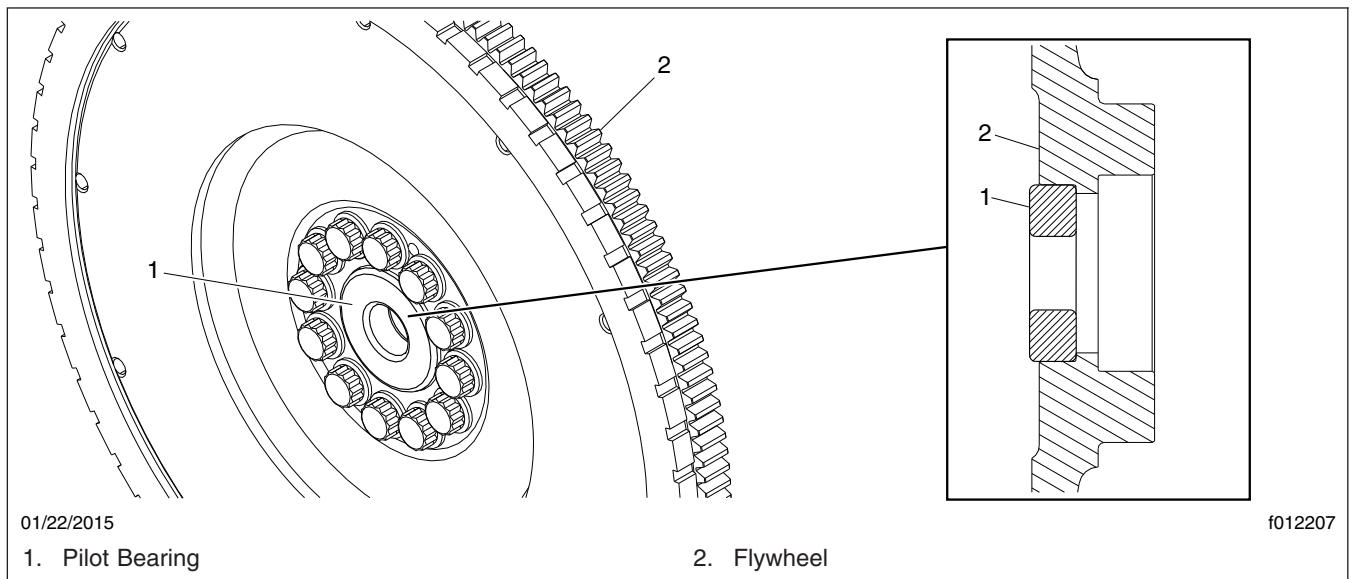
The input shaft on Eaton transmissions does not extend fully into the pilot bearing on DD-series engines built before March 5th, 2015. DD-series engines built on or after March 5th, 2015 have a revised flywheel with the pilot bearing positioned for full engagement with the input shaft.

On vehicles that do not have a pilot bearing spacer installed, the pilot bearing will be flush with the flywheel. On vehicles that already have the spacer, the bearing will protrude approximately 1/4 inch from the flywheel, as shown in [Figure 1](#).

Fig. 1, Position of Pilot Bearing When Spacer Is Not Needed

A spacer, part number 02-14069-000, is now available to reposition the pilot bearing within the flywheel by the same amount as the revised flywheel.

If input shaft wear exceeds Eaton specifications for normal wear, replace both the input shaft and pilot bearing.
