Subject: Freightliner Cascadia SAM Chassis

Models Affected: Specific Freightliner Cascadia vehicles manufactured March 26, 2007, through September 1, 2010, and equipped with SAM Chassis.

May 2015
INT FL679
NHTSA #15V-127
Transport Canada #2015-113
INTERIM RECALL BULLETIN
REVISED NOTICE

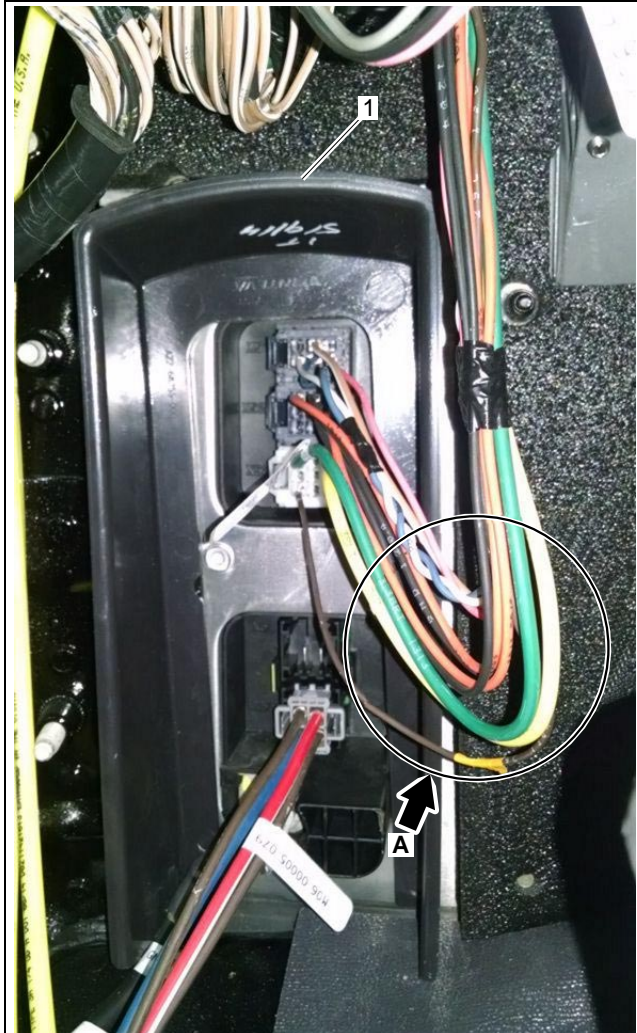
Fig. 1, SAM Chassis with a Drip Shield and a Drip Loop

- A. A drip loop prevents water from collecting at the connectors.
1. Drip Shield

5. Replace the SAM Chassis. Refer to **Section 54.02, Subject 100** in the *Cascadia Workshop Manual* for replacement instructions.
6. Remove the liner on the back of the drip shield to expose the adhesive, then position the drip shield over the SAM Chassis connectors and press securely. Ensure that there is sufficient clearance at the frontwall for the drip shield to stick directly to the metal and not to any other material. See **Fig. 1**. (if a drip shield is already present, skip this step.)

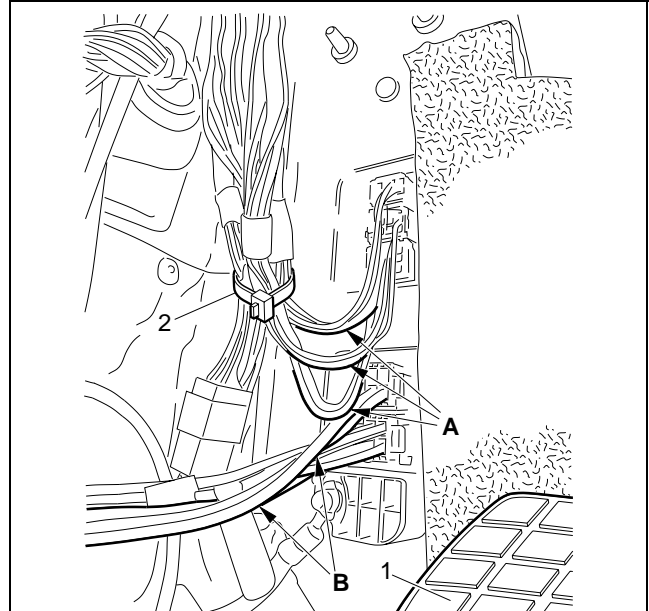
Fig. 2, SAM Chassis Wiring with a Drip Loop

- A. Harnesses formed into a drip loop.
- B. Wiring is routed down and away from the SAM Chassis.
1. Clutch Pedal (for reference)
 2. Tie Strap

7. Create a drip loop for the SAM Chassis wiring harness. See **Fig. 2**. Attach a jumper harness (06-73835-000) if necessary to create additional length. Once the drip loop is created, use a tie strap to secure the harnesses. (If a drip loop is already present, skip this step.)

8. As previously marked, connect the cab wiring to the SAM Chassis. Make sure that the wiring is routed down and away from the SAM Chassis to prevent the entrance of moisture.
