Technical Service Bulletin

26 Refill AdBlue warning comes on prematurely with no faults stored

26 15 26 2038295/2 November 17, 2015. Supersedes Technical Service Bulletin Group 26 number 14-24 dated September 16, 2014 for reasons listed below.

| Model(s) | Year | VIN Range | Vehicle-Specific Equipment |
|---|---|---|---|
| Q7 | 2009 - 2015 | All | TDI clean diesel |

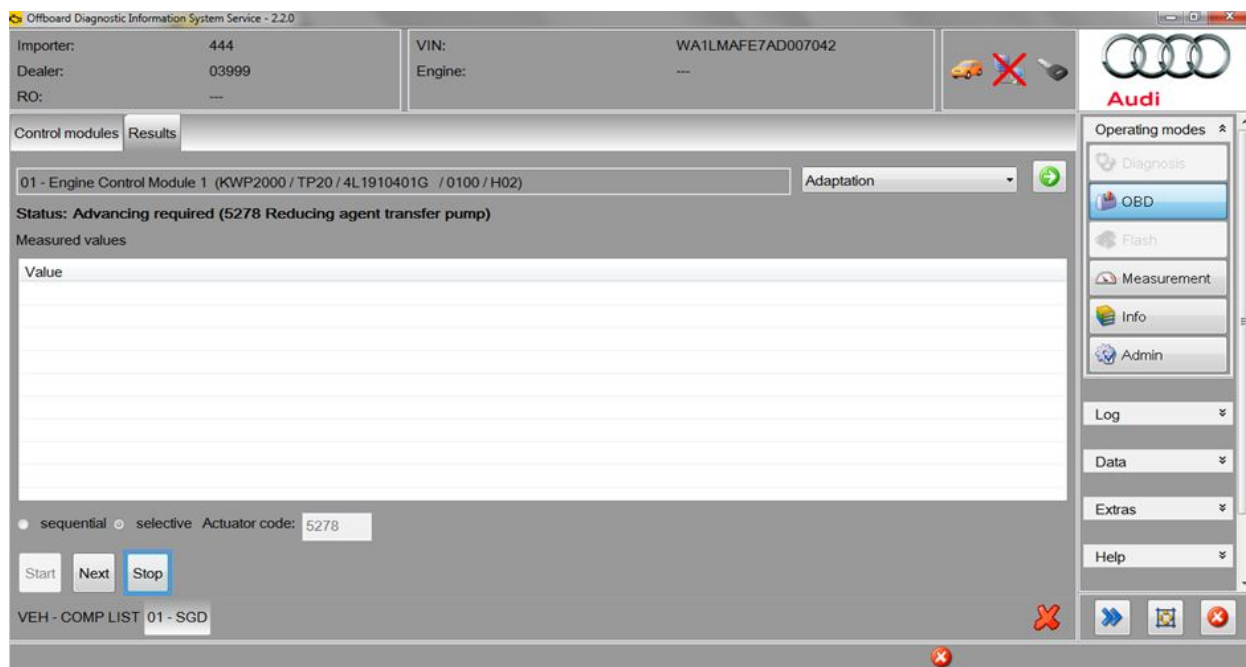
Figure 1. Output test of SCR transfer pump in ODIS for KWP2000 vehicles.

1. Locate the output test in ODIS under *OBD >> 01 Engine Control Module 1>> Output Diagnostic Test Mode*.
2. Click the dot next to *selective*, then enter actuator code 5278.
3. Click Start to begin the output sequence (Figure 1).
4. If the transfer pump fails to function (see Tip below for video of typical clicking noise made during normal operation) or fails to transfer fluid (which can be verified by disconnecting transfer pump line), see *Repair Manual >> Engine >> Engine Mechanical >> 26 Exhaust System, Emission Controls >> Reducing Agent Metering System>> Reducing Agent Transfer Pump V436, Removing and Installing*.

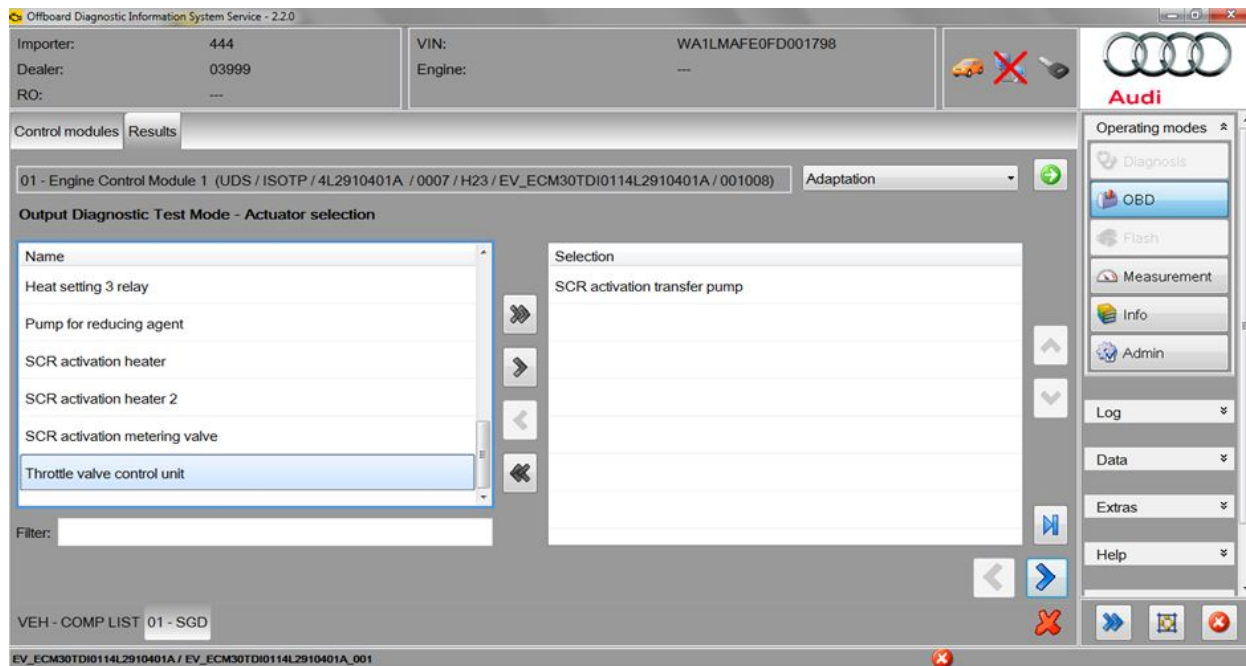
Figure 2. Output test of SCR transfer pump in ODIS for UDS vehicles

1. Locate the output test in ODIS under *OBD >> 01 Engine Control Module 1>> Output Diagnostic Test Mode>> Actuator selection>> SCR activation transfer pump* (Figure 2).
2. If the transfer pump fails to function (see Tip below for video of typical clicking noise made during normal operation) or fails to transfer fluid (which can be verified by disconnecting transfer pump line), see *Repair Manual >> Engine >> Engine Mechanical >> 26 Exhaust System, Emission Controls >> Reducing Agent Metering System>> Reducing Agent Transfer Pump V436, Removing and Installing*.
