Constellation  
Heritage  
4700 Models

> 4800 Models  
> 4900 Models  
5700 Models

Western Star  
Service Bulletin

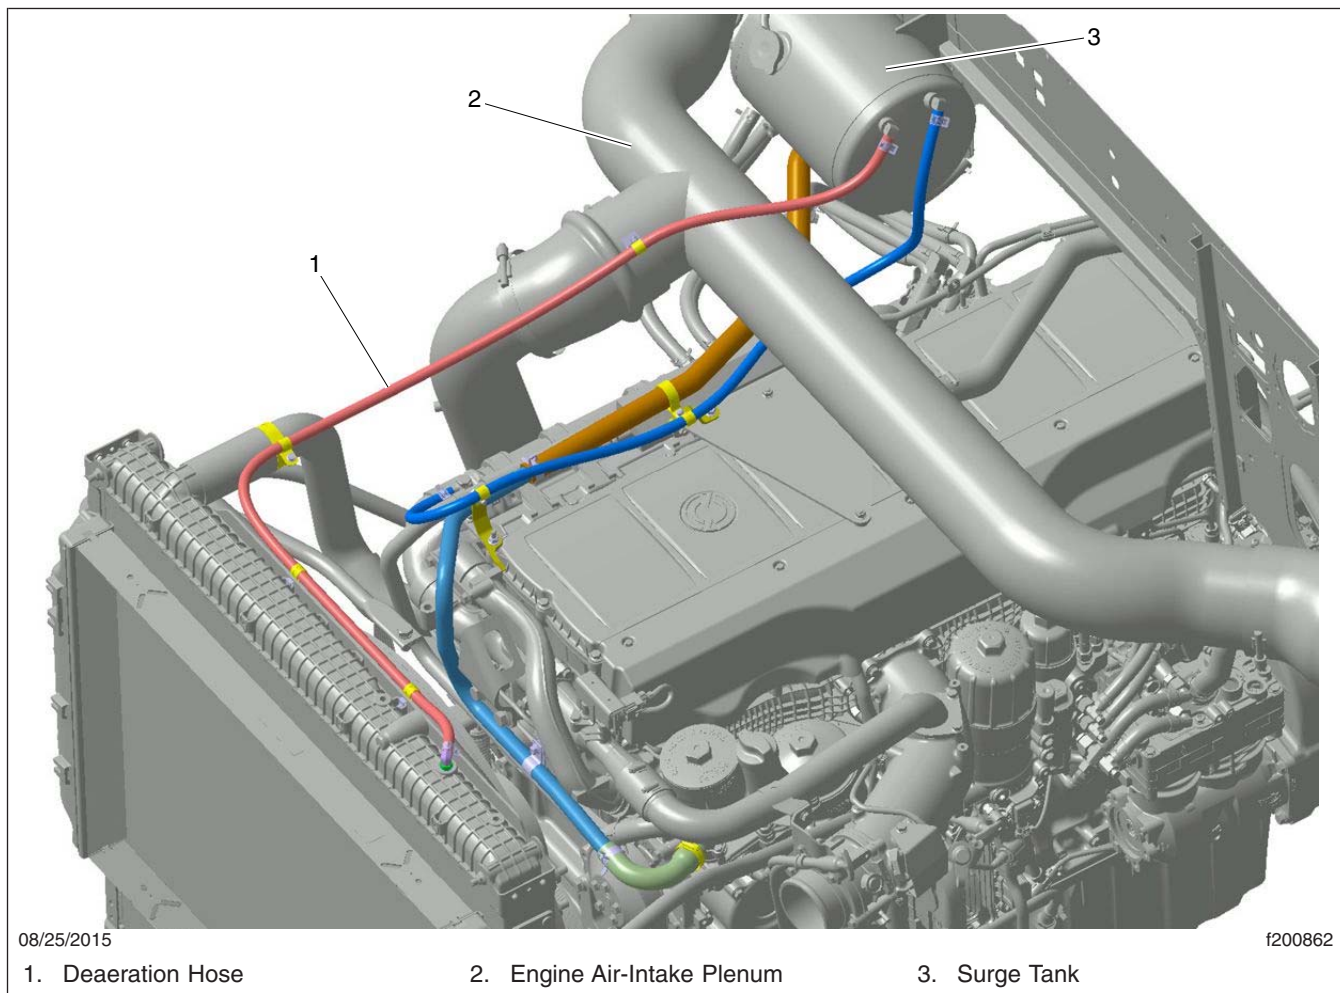
**Fig. 1, Old Deaeration Hose Routing (typical)**

Interference between the hood insulation, the surge-tank deaeration hose, and the engine air-intake plenum has been reported on some Western Star 4800 and 4900 models, with Detroit engines, built between start of production and June 15, 2015. This interference may cause a leak or damage to the affected components.

The hose routing has been revised at the manufacturing plant to address this issue. There are no part number changes. If a leak or rubbing issue is found, follow the instructions below to repair and reroute the hose. The replacement hose will be longer to accommodate the new routing.
