**Western Star
Service Bulletin**

88-13

Reducing Excessive Hood Opening Effort, 4900 Models

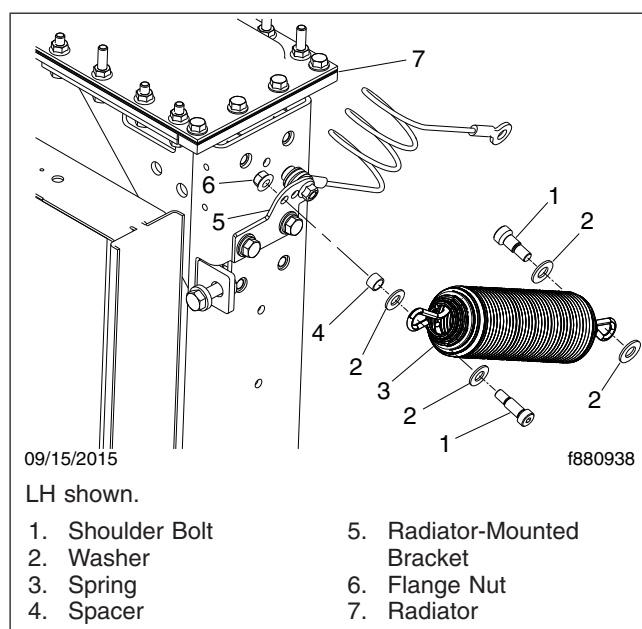
Fig. 1, Hood Tilt-Assist Spring Installation

On some Western Star 4900SF 123BBC vehicles, the hood may be too heavy for one person to open. This is caused by variation in hood material thickness, which can increase the hood weight. A new hood tilt-assist spring is available to reduce the hood opening effort. If the hood is too heavy to open, replace the hood tilt-assist springs using the procedure in this bulletin.

1. Park the vehicle on a level surface, shut down the engine, and chock the tires. Open the hood.
2. Tip the hood back about-half-way, until it is balanced over the pivot. Prop the hood in this position or have another person support it there.
3. Detach the hood tilt-assist springs from the radiator-mounted brackets and the hood. See [Fig. 1](#).

4. Attach the new springs (BTS 300156) to the radiator-mounted bracket and the hood. Tighten the fasteners 16 lbf-ft (21 N-m).
