# Technical Service Bulletin

## 48 Creaking or squeaking noises from steering column (sealing boot)

48 15 66 2034351/5 July 30, 2015. Supersedes Technical Service Bulletin Group 48 number 15-65 dated March 23, 2015 for reasons listed below.

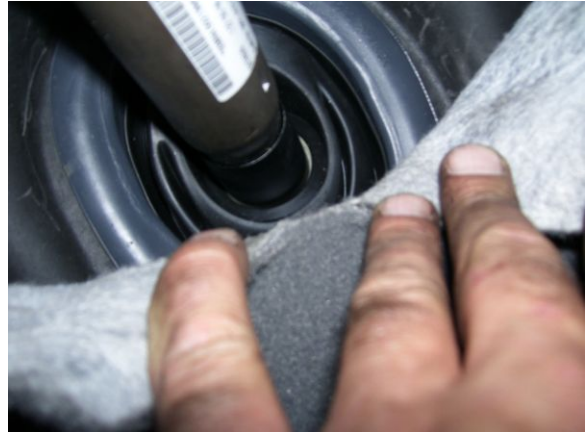
Insufficient lubrication of the intermediate steering shaft in the area of the sealing sleeve.

*Figure 1. B8 sealing sleeve on the bulkhead.*

1. Check the correct fit of the sealing sleeve (Figure 1 and Figure 2).

2. Spray the intermediate steering shaft in the area of the bearing ring with special lubricant spray (**G 052172A2**). While spraying, turn the steering wheel side-to-side and adjust the steering column axially and vertically until the noise disappears.

**Note:** Do not lubricate the u-joints of the steering shaft.

3. If the noise persists, replace the intermediate steering shaft.

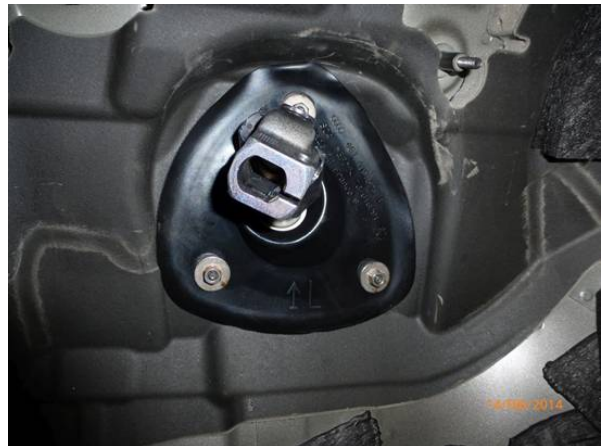
*Figure 2. C7 sealing sleeve on the bulkhead.*
