Technical Service Bulletin

91 MMI3G+ Audi connect only reaches 2G service - Telephone module replacement instructions for A6 & A7

91 15 07 2039515/4 July 28, 2015. Supersedes Technical Service Bulletin Group 91 number 15-00 dated June 30, 2015 for reasons listed below.

Model(s)	Year	VIN Range	Vehicle-Specific Equipment
A6, A7	2011 - 2013	All	Audi connect

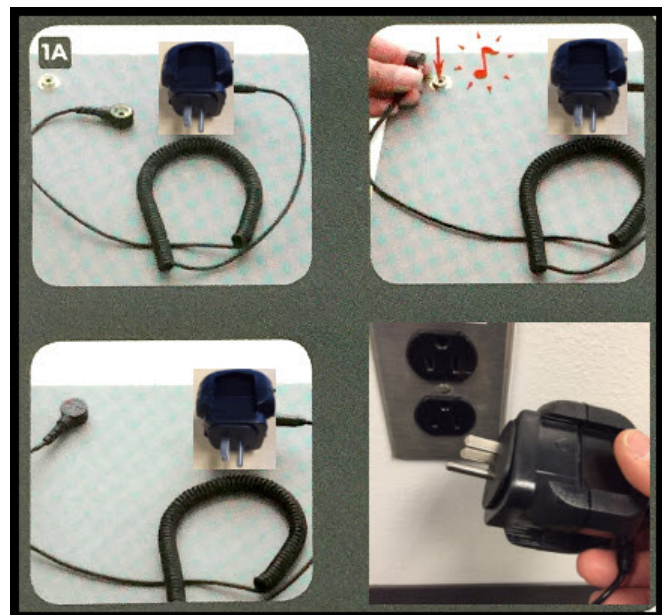
Figure 2. VAS6613 ESD work surface grounding plug.

3. Place the ESD anti-static mat onto the surface. Ensure that all three grounding straps are securely strapped to the ESD mat.
4. Ground the ESD mat by plugging the 110V grounding strap into a wall socket or power strip (Figure 2). If a power strip is used, it must be plugged into a grounded wall outlet. (See attached user instructions for VAS6613 titled “VAS6613 ESD Workspace Guide.pdf”.)

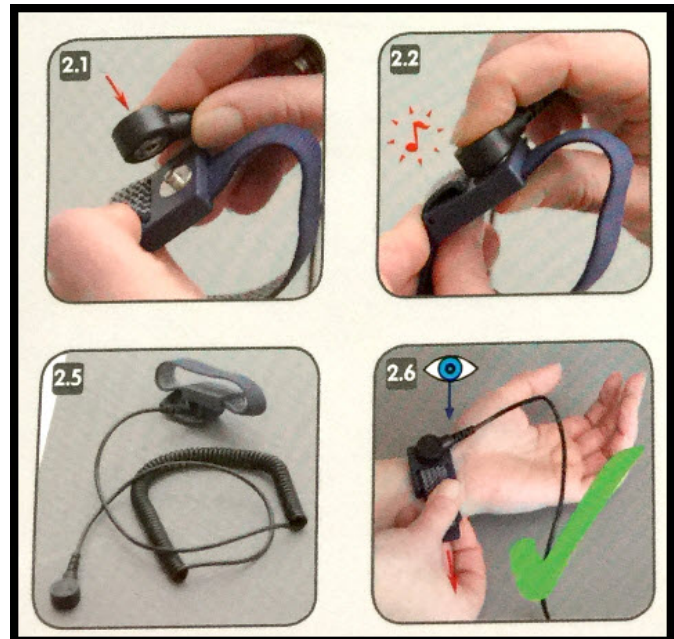
Figure 3. VAS6613 ESD work surface grounding wrist strap.

5. Ground yourself by placing the elastic strap around your wrist. Make sure it is securely touching your skin. It cannot be loose-fitting or over your shirt cuff (Figure 3).

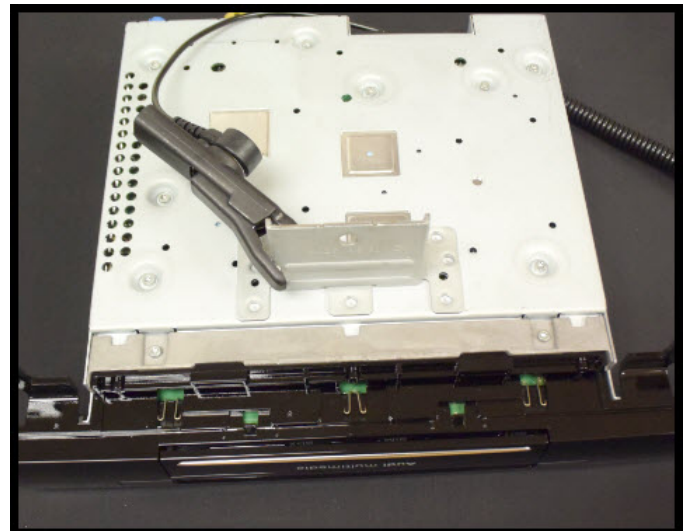
Figure 4. VAS6613 ESD work surface grounding device clip.

6. Ground the MMI main unit by placing an alligator clip on the back, ensuring that it makes contact with the metal housing of the main unit. The most secure location is at the bottom of the metal bracket (Figure 4).

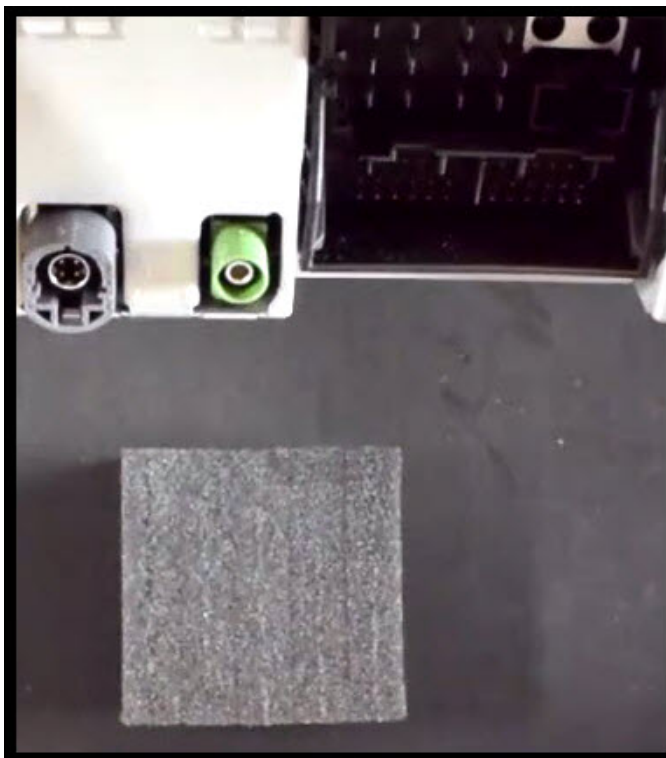
Figure 5. Foam block used as a spacer under the main unit.

A foam block can be used as a spacer under the main unit to keep the grounding strap connected (Figure 5).

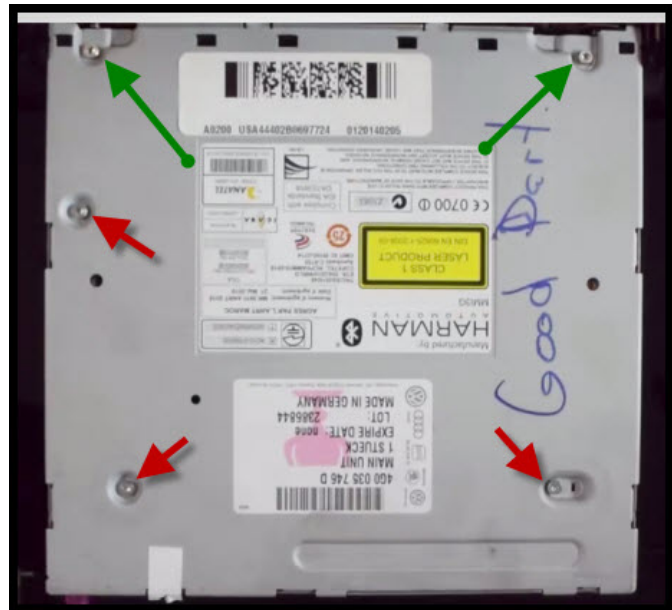
Figure 6. MMI main unit with screw locations for top cover.

7. Start by touching the screw driver to the ESD mat to discharge any static that may be built up in the tool. Next, remove the five screws that are holding the MMI top cover in place. The two screws near the faceplate (Figure 6, green arrows) are longer than the others, have thread lock on them, and may require extra effort to remove. Keep these screws separated from the others at all times.

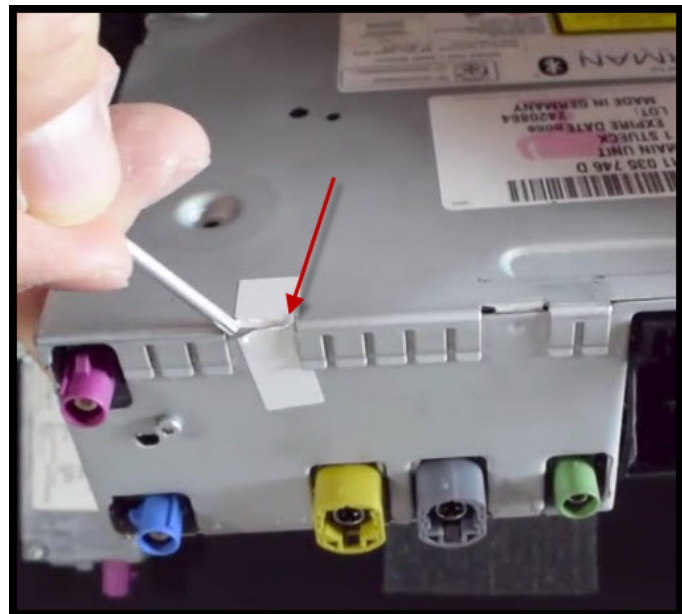
Figure 7. Break the white warranty seal.

8. Break the white warranty seal on the back of the main unit (Figure 7).

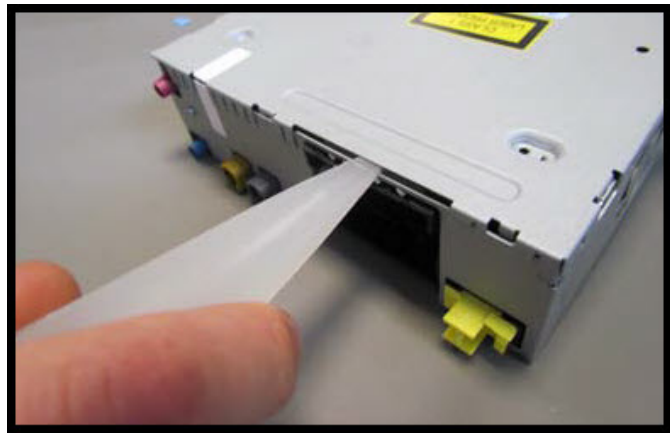
Figure 8. Pry to cover off using plastic trim wedge tool.

9. Using a flat head screw driver, your fingers or a plastic wedge trim tool, remove the top cover by prying it from the back of the cover at the location seen in Figure 8. If a flat head screw driver is used then touch the tool to the ESD mat to discharge the tool prior to touching the main unit.

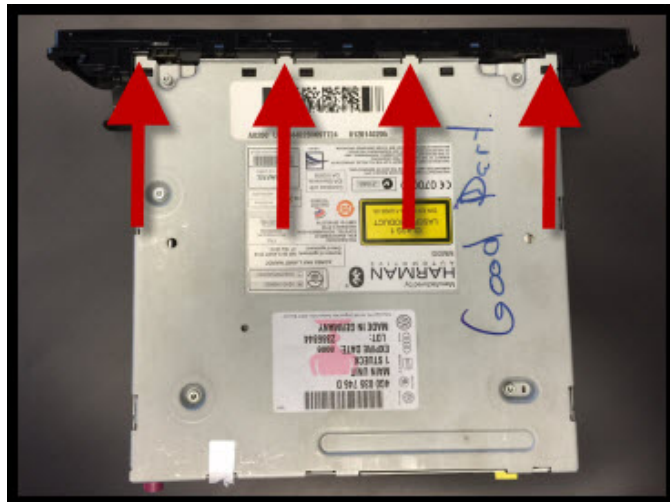
Figure 9. Top cover metal tabs indicated by the red arrows.

The top cover of the main unit has four metal tabs that are slotted into the plastic front face plate (Figure 9). Slightly lift on the rear of the cover and pull back on the cover until the metal tabs are released. Lift up on the cover and pull it away from the face plate at the same time to prevent bending the top cover's metal tabs (Figure 10). If the metal tabs bend during this process, straighten them with a pair of pliers.

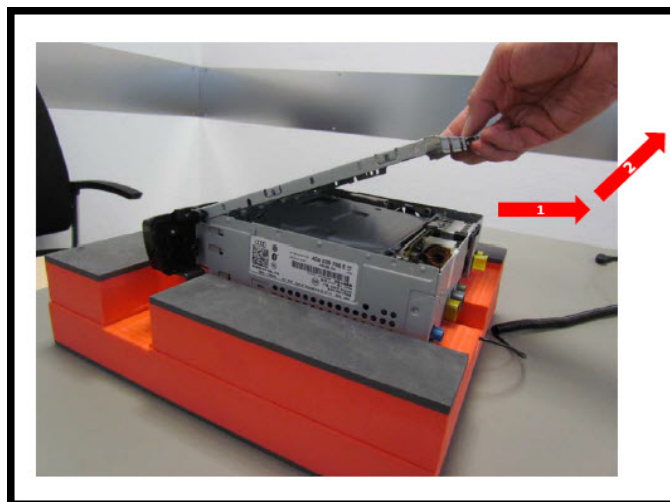
Figure 10. Pull up and back to prevent damaging the faceplate slots (Note: the orange/black holder is not required).

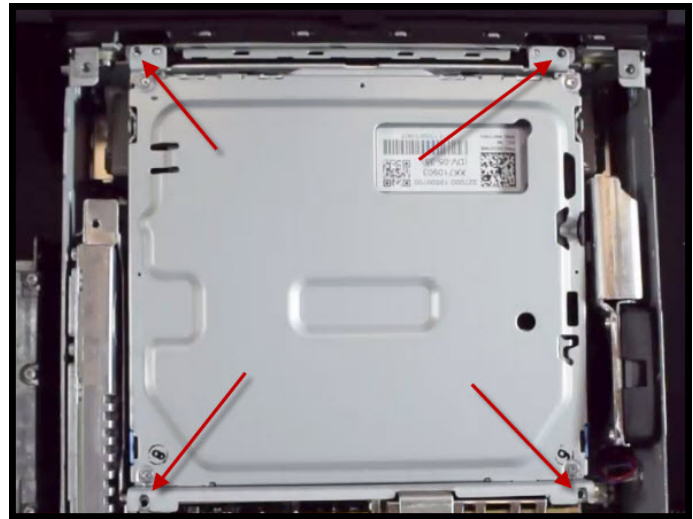
Do not flip the main unit over at this point. The CD drive, which was held in place by the top cover screws, is no longer secured. If the CD drive moves significantly, the ribbon cable can detach from the circuit board and disable the CD drive's functionality (Figure 11).

Figure 11. CD drive mounting points are now free.

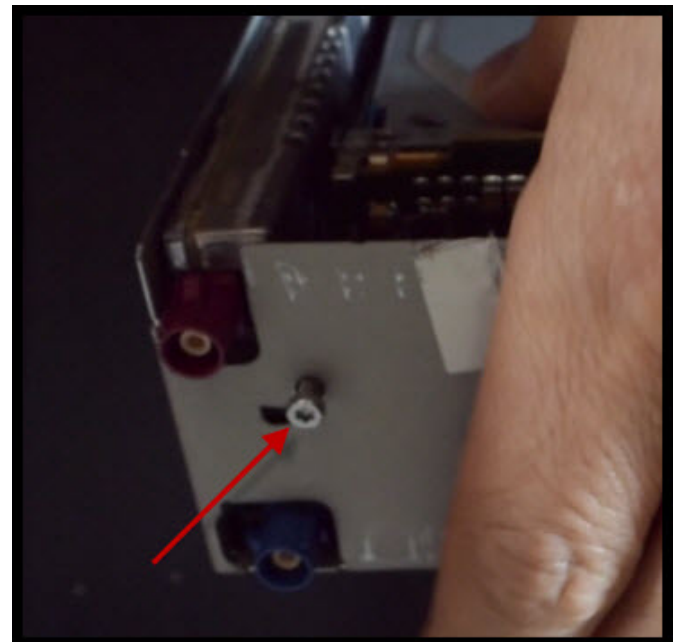
Figure 12. Telephone module retaining screw indicated by the red arrow.

10. On the back of the main unit, remove the retaining screw that holds the telephone module in place (Figure 12).

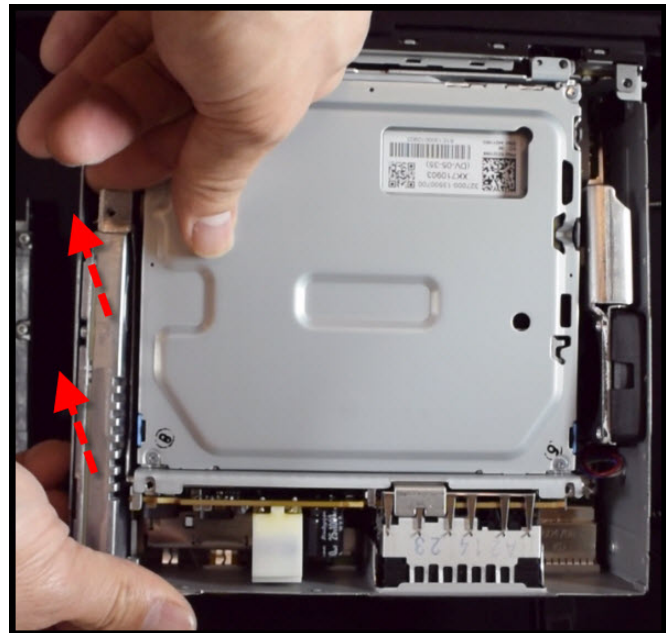
Figure 13. Lift up on both ends of the telephone module as indicated by the red arrows.

- Carefully lift up the telephone module, using both ends as points of contact when pulling up (Figure 13). The module is held in place with a computer socket-type attachment and will release when enough force is used.

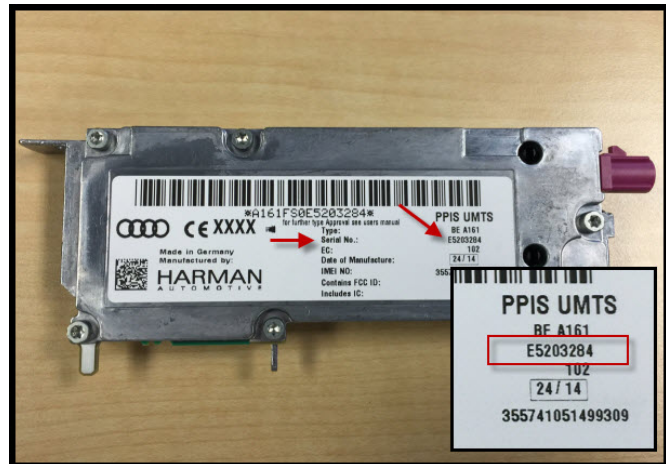
Figure 14. Serial number of the PPIS UMTS telephone module indicated by the red arrows and red box.

- Before proceeding, write down the serial number of the new replacement UMTS telephone module (Figure 14).

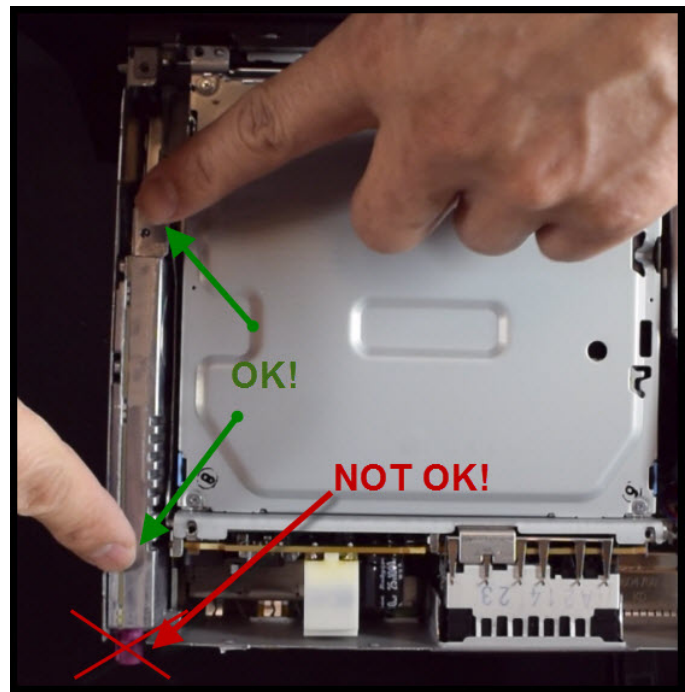
Figure 15. Do not press down using the purple FAKRA connector.

13. Place the new UMTS telephone module into the socket, making sure it is level before snapping it into place. Use both ends of the telephone module when pressing it into place. Do not press down using the purple FAKRA connector (Figure 15).

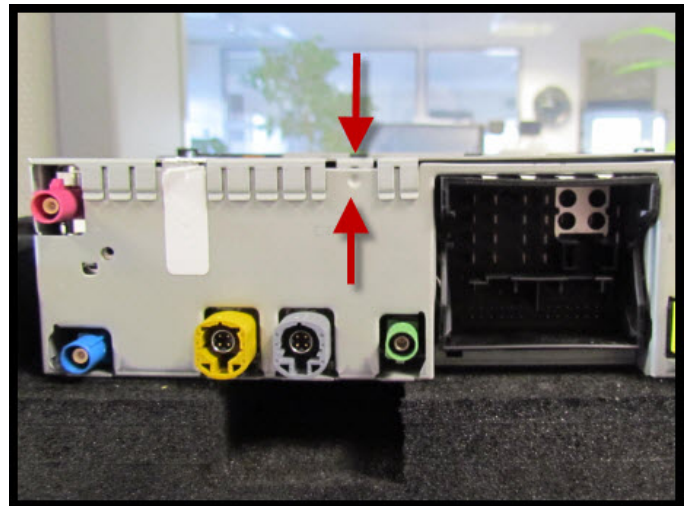
Figure 14. Place the new warranty seal over the location indicated by the red arrows.

17. Place the new warranty seal from the retrofit kit next to the original warranty seal (Figure 14).

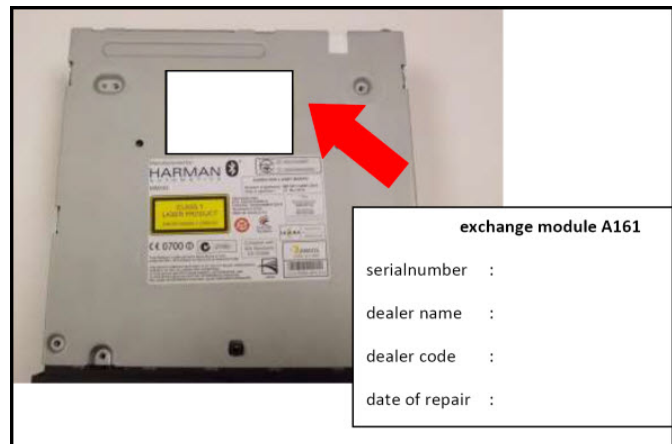
Figure 15. The white area indicates the suggested location for the repair label on the top cover of the main unit. Do not cover any existing part number labels or the laser warning.

18. Place the repair label on the top of the main unit cover. Do not cover any part number label with the repair label and do not cover the yellow laser warning (Figure 15). Fill out all fields on the repair label.

Do not cover the yellow laser warning label. The repair label may need to be placed on sideways due to space limitations
