# Special Bulletin

# SP15-16

## REAR JUNCTION BOX INSPECTION AND COLOR GUARD APPLICATION

Prevost vehicles

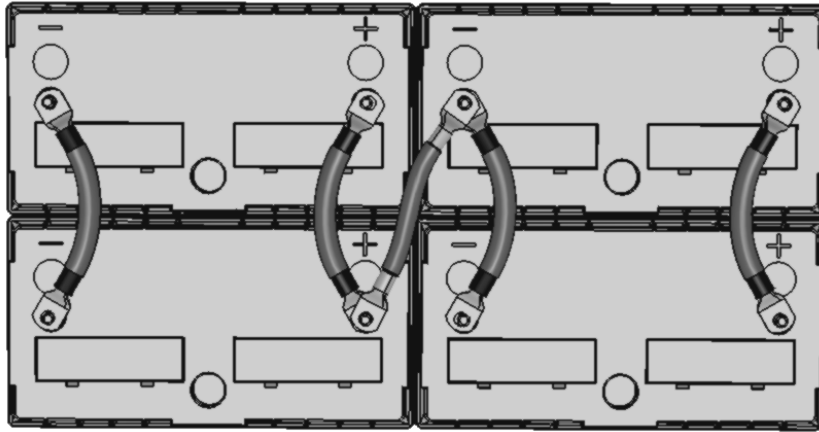
- 1) Open the battery compartment, disconnect and remove the batteries (negative terminals first).

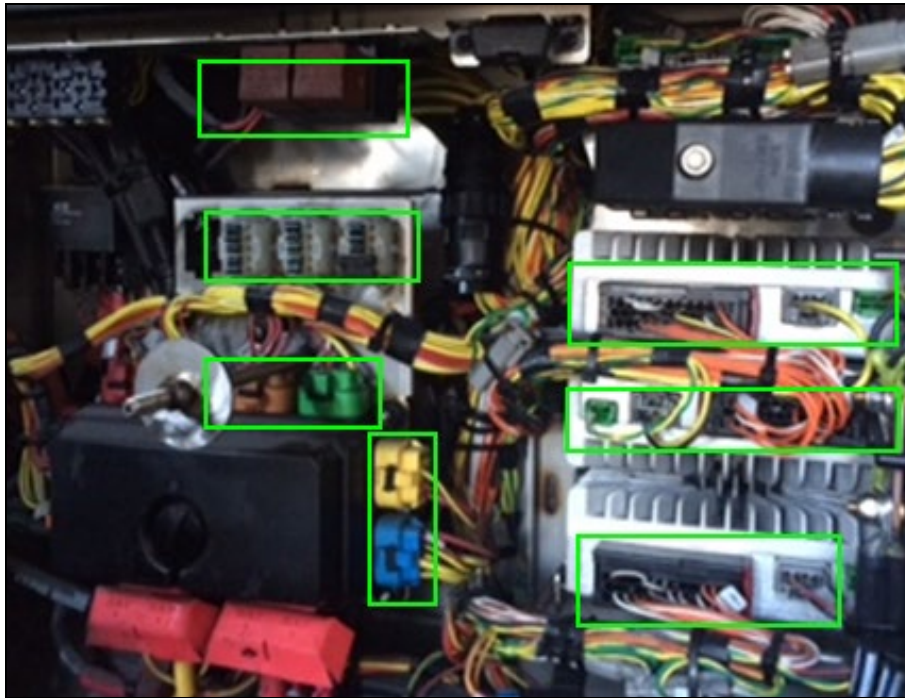
- 2) Open the vertical junction box compartment and locate the connector at the back of the different relays and modules.

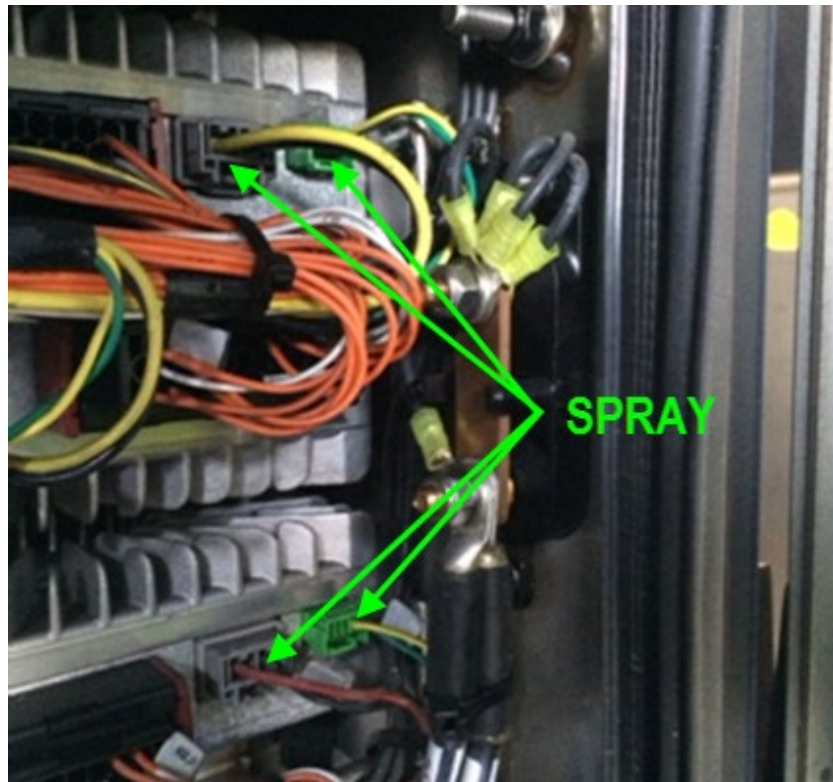
- 3) Spray the back of each connectors with **Termin8R lubricant**

Do not unplug the connectors to spray them with Termin8R lubricant. Application of Termin8R inside the connectors can prevent electrical contact to the modules.

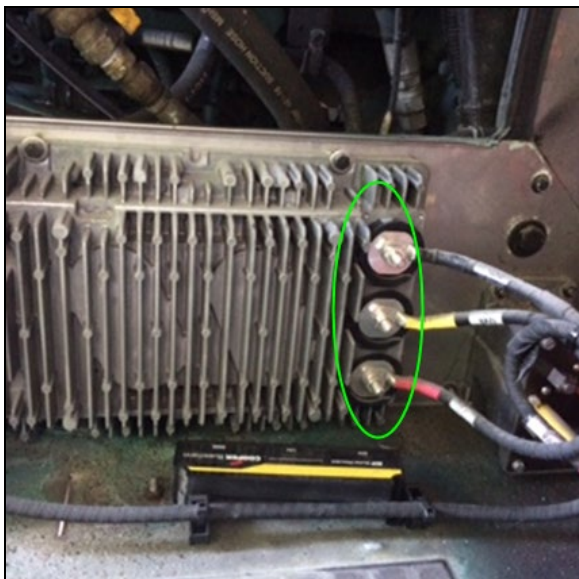
**Battery Equalizer terminals**

- 4) All the following connections must also be sprayed with Termin8R lubricant.

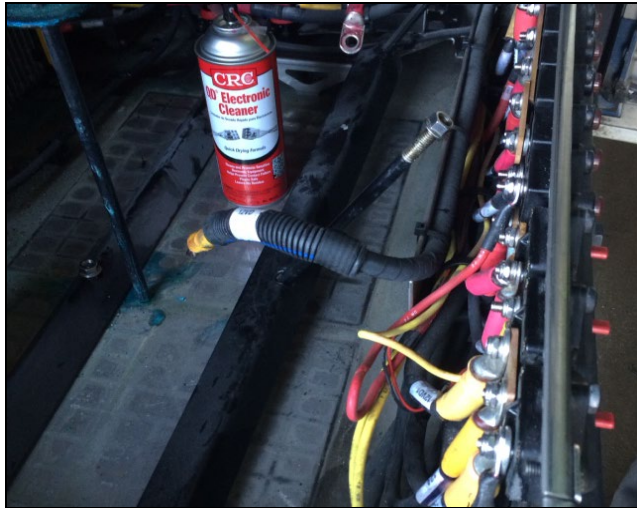
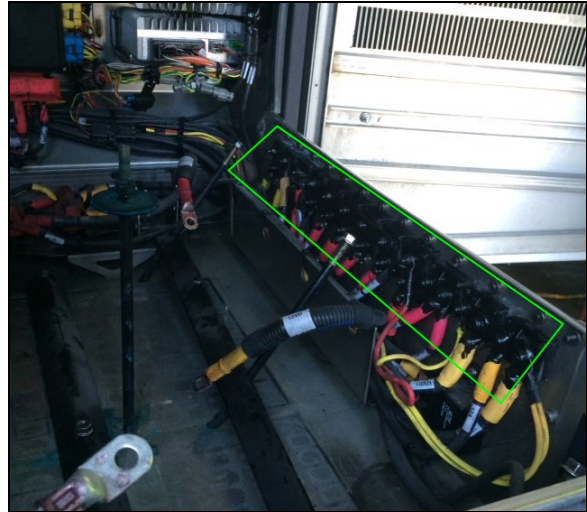
Back of all circuit breakers

- 5) All the screw type connections in the following images must be **first cleaned with CRC Lectra-Motive Electrical Part Cleaner and cleaning brushes**. Let the cleaner dries and then **apply 2 coats of black Color Guard** (wait 20 to 30 min. between each coat) on all connections.

*If the terminals are showing heavy signs of corrosion they must be disassembled before being cleaned.*

*Clean both side of the terminals, also clean studs threads and hex nuts. Ensure that all traces of oxidation in the surrounding area are removed before reinstallation.*

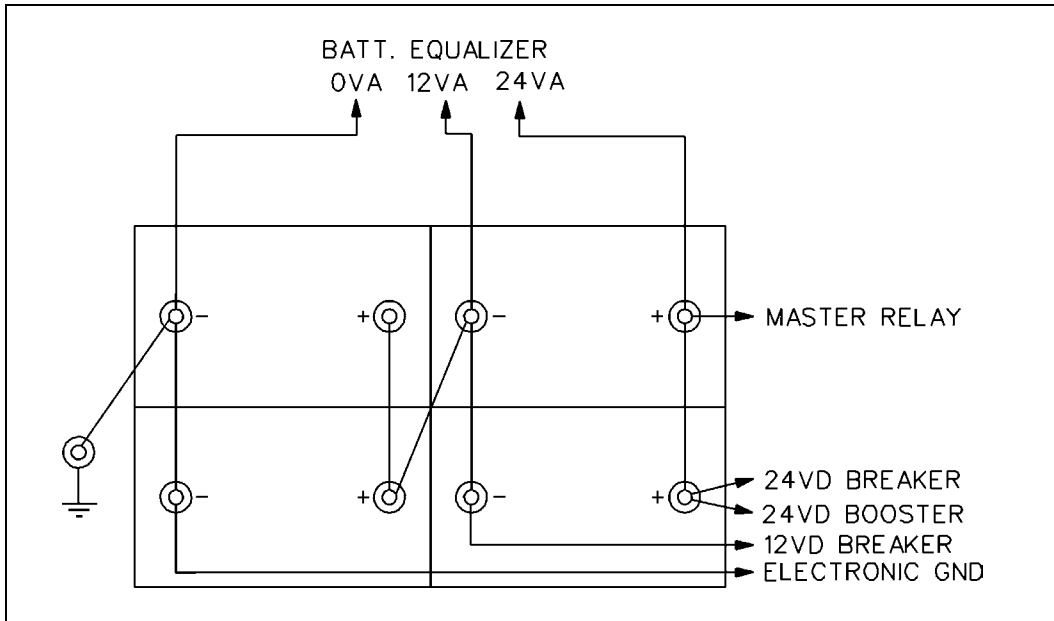
- 6) Reinstall the vehicle batteries.
- 7) Clean the battery posts and terminals and reconnect the batteries (positive terminals first).

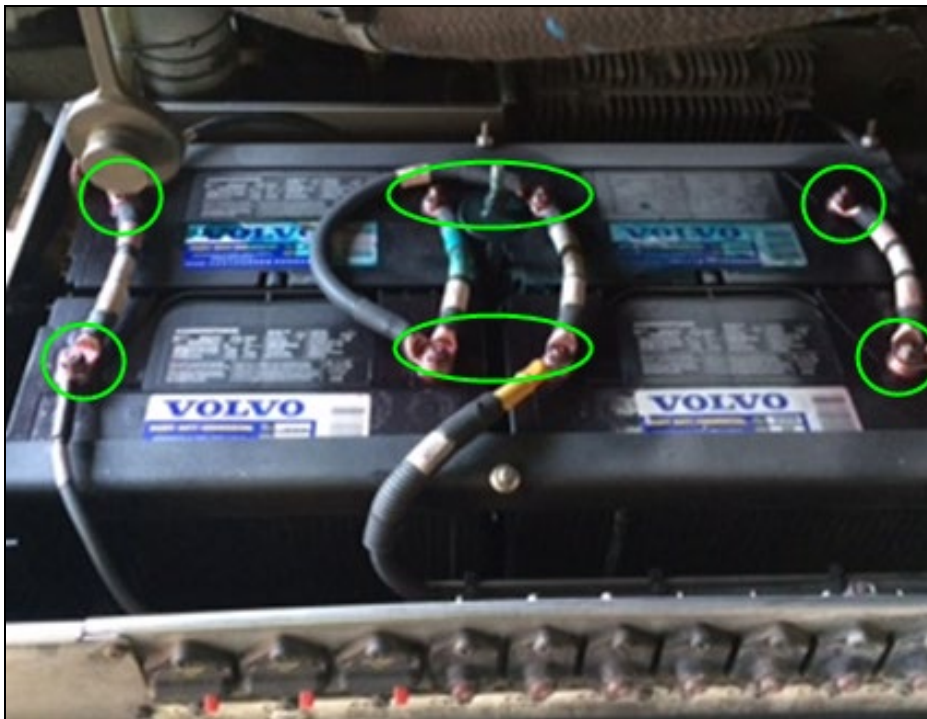
- 8) Apply **Termin8R lubricant** to all the battery connections.
