## EGR TEMPERATURE SENSOR REPLACEMENT AND HARNESS ROUTING

Prevost vehicles

# Special Bulletin

## SP15-322A

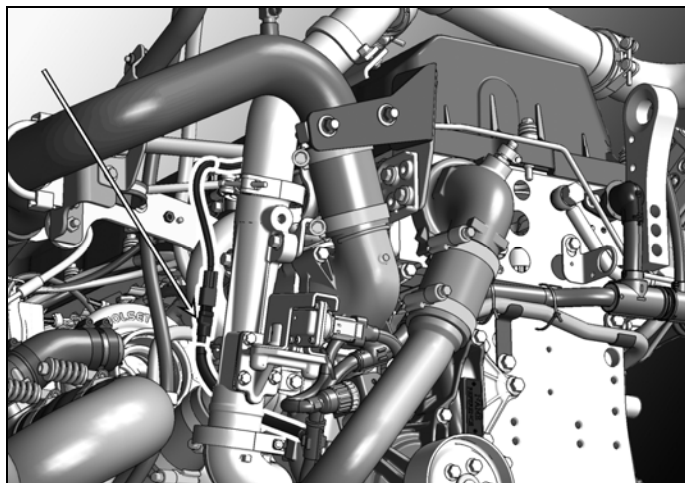
Figure 1 Location on engine.

- 1) On the engine, road side, locate this branch of the engine harness.
