Date	Expiration	Release	Page
05.2015	05.2017	1	1(4)

Release 1: This release replaces previous versions.  
 June 05, 2015 Added image for SW14.

## DASHBOARD SWITCH BACK LIGHTING Prevost vehicles

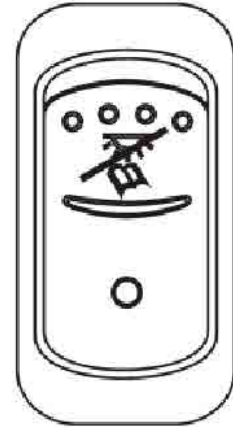
Figure 1

On the vehicles affected by this bulletin, "Fast idle" and "Cancel First Reading Lamp" switches on the dashboard may not be wired to provide back-lighting. Modify the wiring to add the feature.

### Cancel 1<sup>st</sup> reading lamp switch (Fig. 1)

1. Use yellow wire 18 ga (6 in)
2. Crimp terminal 562769
3. Insert in cavity 9 of "Cancel 1st reading lamp switch" (SW13)
4. Remove pin 9 from "Reading light test switch" (SW5)
5. Cut off the existing terminal on this wire
6. Crimp new terminal 562769 with new wire *and* wire from SW5
7. Re insert in cavity 9 of SW5

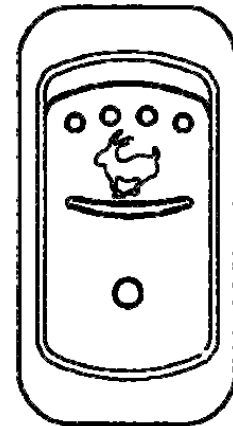
Figure 2

### Fast idle switch (Fig. 2)

8. Use yellow wire 18 ga (6 in)
9. Crimp terminal 562769
10. Insert in cavity 9 of "Fast idle switch" (SW14)
11. Remove pin 9 from switch 4 (SW4)
12. Cut off the existing terminal on this wire
13. Crimp new terminal 562769 with new wire *and* wire from SW4
14. Re insert in cavity 9 of SW4

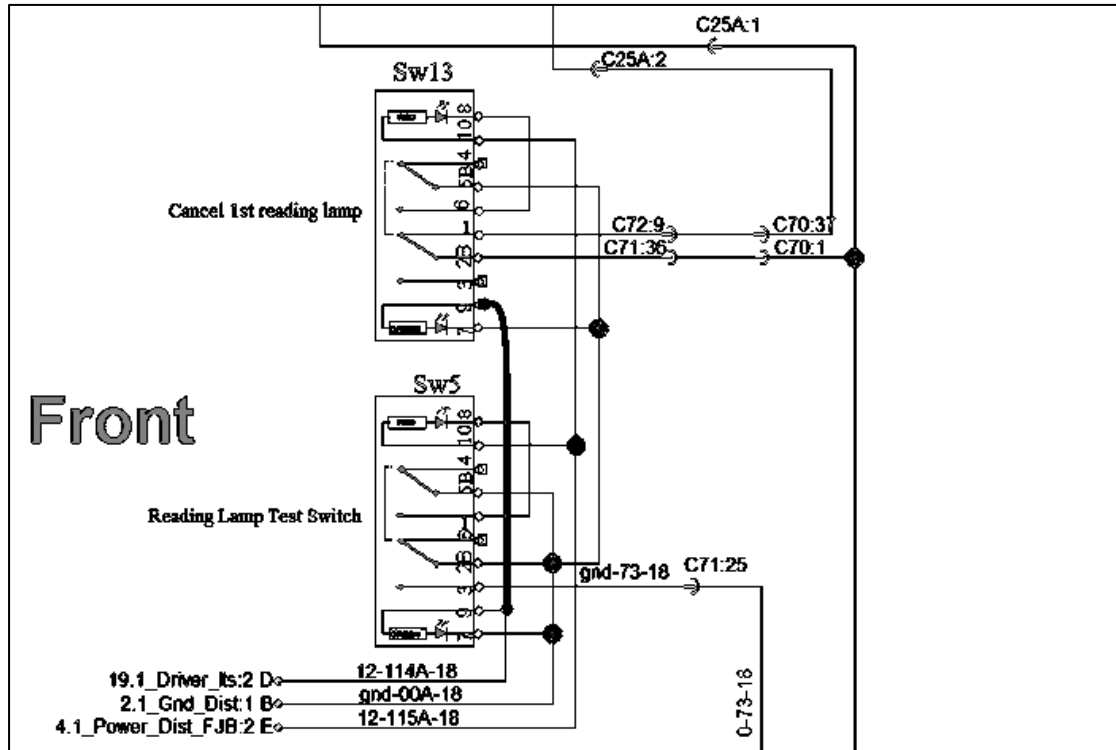
Figure 3 SW13 re wiring

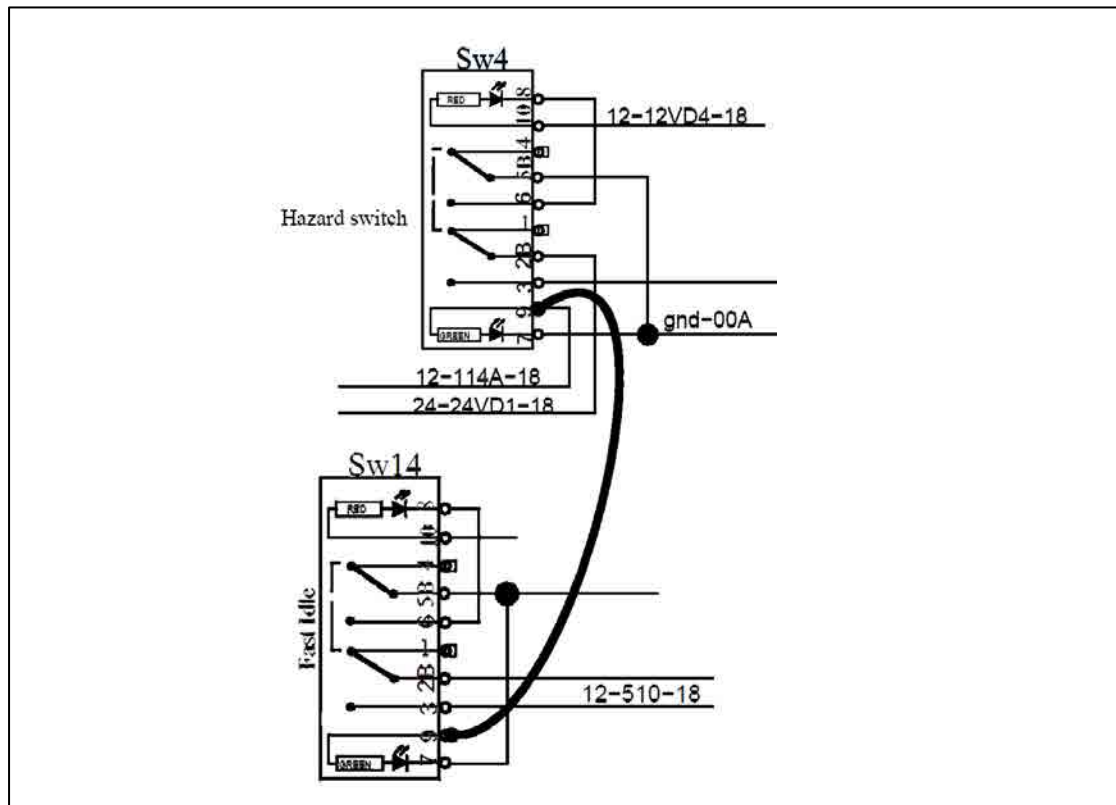
Figure 4 SW14 re-wiring
