Sept 2015

## SWAY BAR CLAMP HARDWARE REPLACEMENT

Prevost vehicles

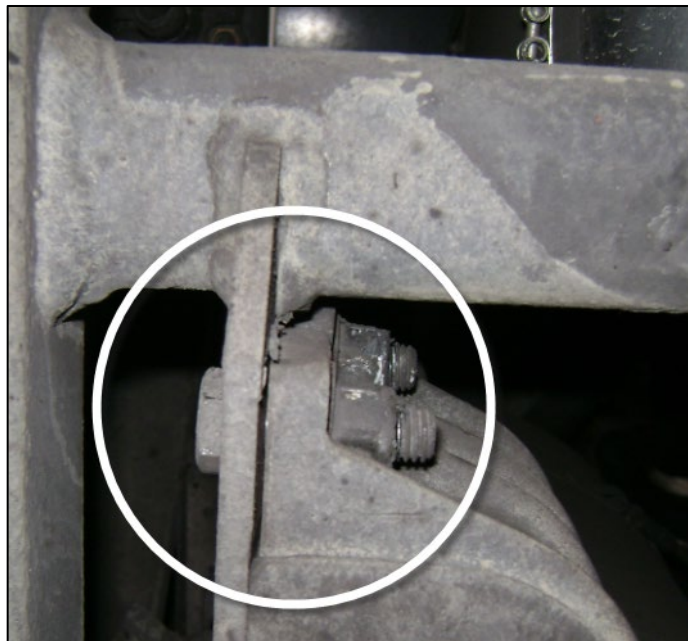
Figure 1

Make sure that there is no welding or gravel guard accumulation interfering with the contact surface. (the surface between the clamp base and structure) (Fig. 1)

Clean the area under the support to remove welding projections, weld bead interferences and gravel guard.
