# Special Bulletin

# SP15-331A

## AUXILIARY EQUIPMENT DECAL REPLACEMENT

Prevost vehicles

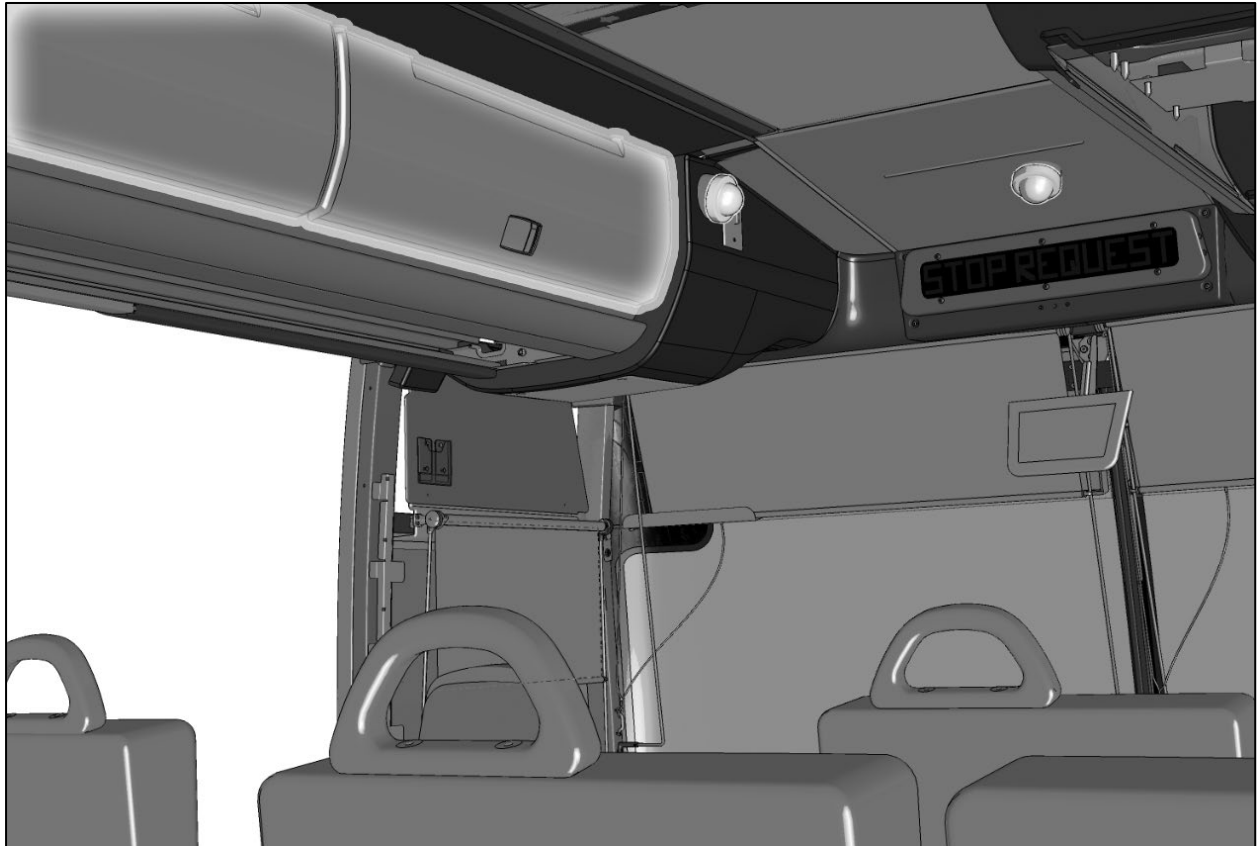
Figure 1

- 1) Locate the road side parcel rack compartment.(Fig. 1)
