Rev C: This version supersedes any previous versions.  
Sept 24, 2015 English version.

## 16500 LB I BEAM SUSPENSION INSPECTION Prevost vehicles

Inspect vehicles involved to clarify the scope of the potential issue. Bulletin involves **X3-45 & H3-45 built after January 17 2014 (after E-2610 H Series or E-5636 X Series)**.

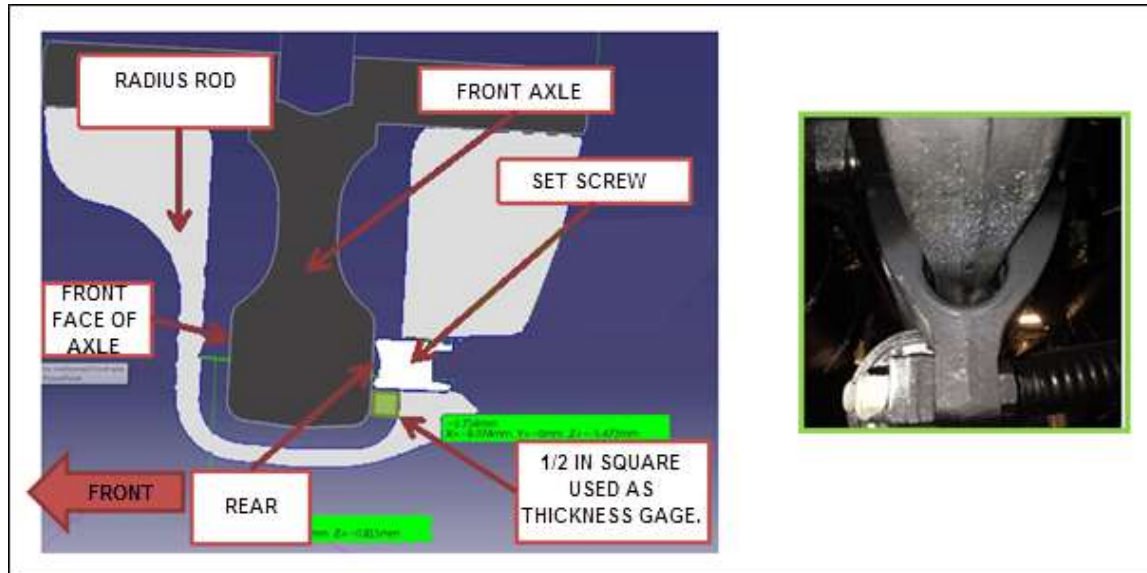
Figure 2

Find a 1/2 in square tubing or bar and use it as a thickness gage. Insert the tube or bar behind the front axle right side radius rod support as shown in fig. 2.

If the 1/2 in gage can be inserted, but the front of the axle appears to touch the radius rod support, confirm this is the case by performing the following inspection:

- Attempt to slide a 0.100 in thickness gage between the front of the axle and the radius rod support. Perform this inspection on both sides of the support. Remove any gravel guard thickness preventing the inspection of a gap.

If the tube cannot be inserted and the rear of the axle does not touch the radius rod support, the set screw should be replaced by another set screw #5002004 M16 x 2.0 x 40mm.
