# PREVOST

## WARRANTY BULLETIN

**WB15-39**

DATE :	OCTOBER 2015	SECTION :	18 - BODY
EXPIRATION:	OCTOBER 2017		
SUBJECT :	H3 VIP Entrance Door Improvement

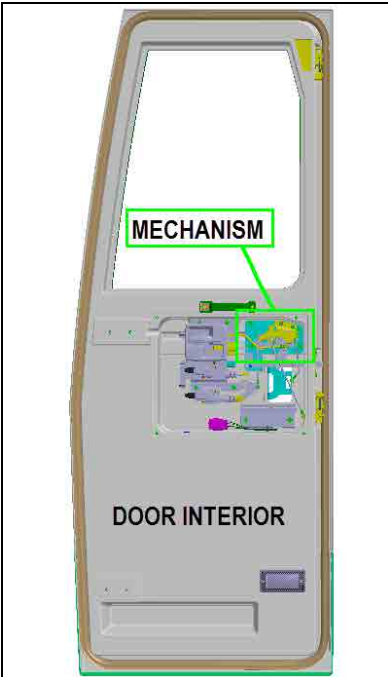
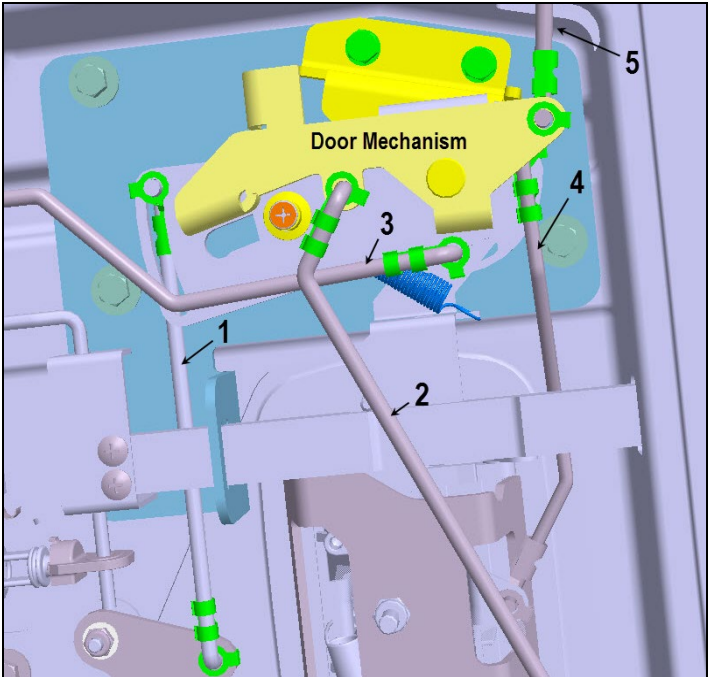
- 1. Remove the door interior trim panel (This operation will vary from vehicle to vehicles depending on their configuration).
- 2. Locate the door locking mechanism and the five actuating rods connected to it (see Fig.1 and 2 below).

- 3. Disconnect rods # 2, 3, 4 and 5 identified above at the *door mechanism* end of the rods.
