# Special Bulletin

# SP15-337B

LTD EXTENSION ON ENGINE CURBSIDE

Prevost vehicles

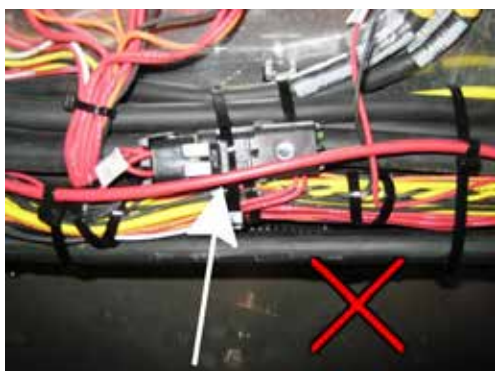
## NOT ALLOWED

Possible contact or rubbing against screws, edges, etc.

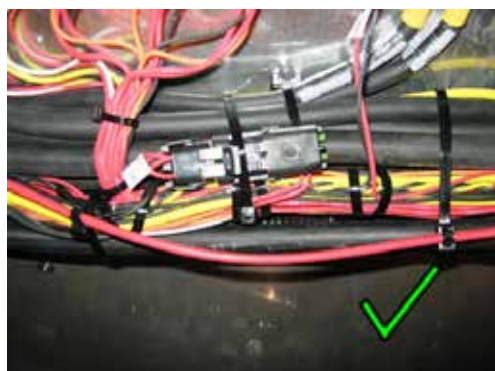
## CORRECT

LTD must be routed clear of screws, sharp edges, etc.

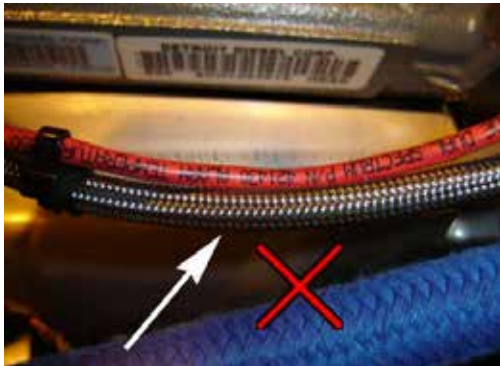
NOT ALLOWED

Rubbing or possible rubbing against abrasive surfaces

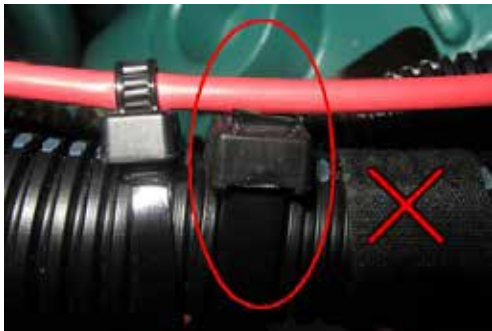
NOT ALLOWED

LTD touching cut cable tie

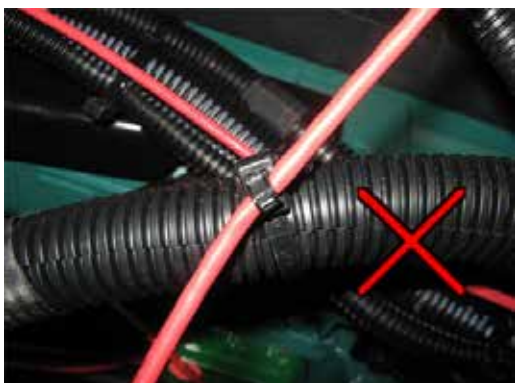
NOT ALLOWED

LTD extending slantingly from the cable tie

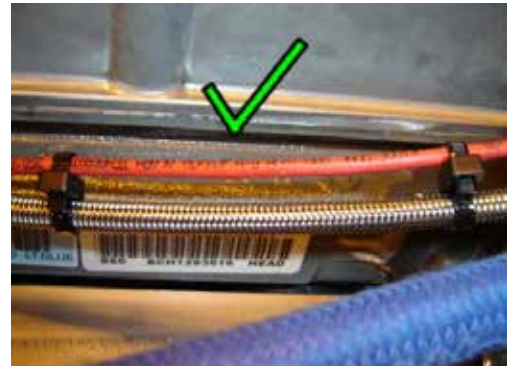
Secure with double loop cable ties. Max Distance between cable ties is 4 in (100mm)

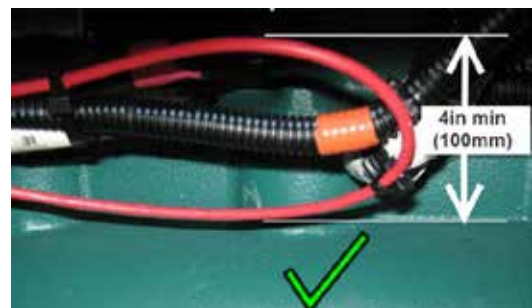
CORRECT

LTD is not a flexible harness. Avoid tight bends and kinks which could short circuit the LTD. Loops must have a minimum radii of 4 inches (100 mm)

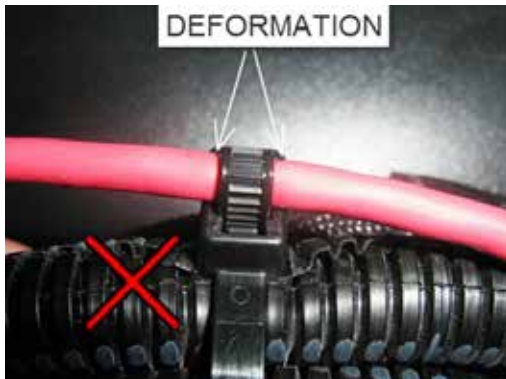
NOT ALLOWED

Cable tie tighten in excess on the LTD. Tighten cable tie on LTD by hand only. Tighten just enough to prevent LTD from slipping from once side to the other inside the cable tie loop

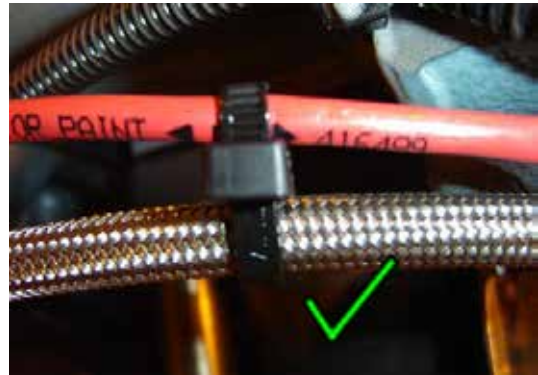
Proper tightening of the cable tie on the LTD
