PREVOST

**WARRANTY
BULLETIN**

WB15-53A

DATE :	NOVEMBER 2015	SECTION :	04 - Exhaust
EXPIRATION:	NOVEMBER 2017		
SUBJECT :	DIESEL PARTICULATE FILTER (DPF) – LOOSE PLUGS

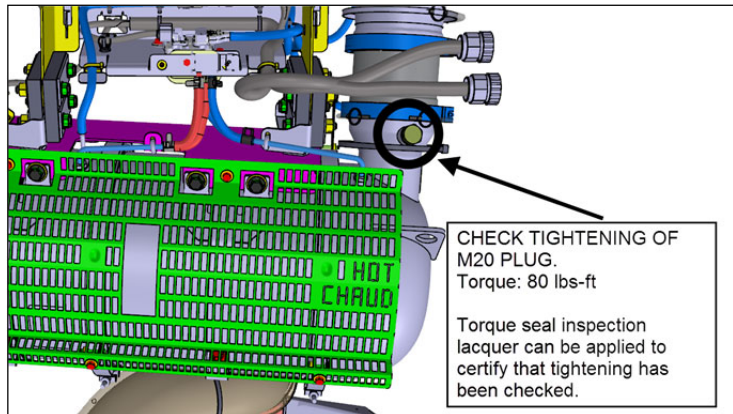
FIRST PLUG

On the vehicles covered by this bulletin, two DPF (diesel particulate filter) plugs may be loose. If a plug is loose, it may fall out under the effect of vibration. This may cause leakage of hot exhaust gases.

1. Check if the M20 hexagonal plug located to the right side of the DPF (see image at right) is properly tightened.

2. Apply a torque of **80 lbf - ft**.

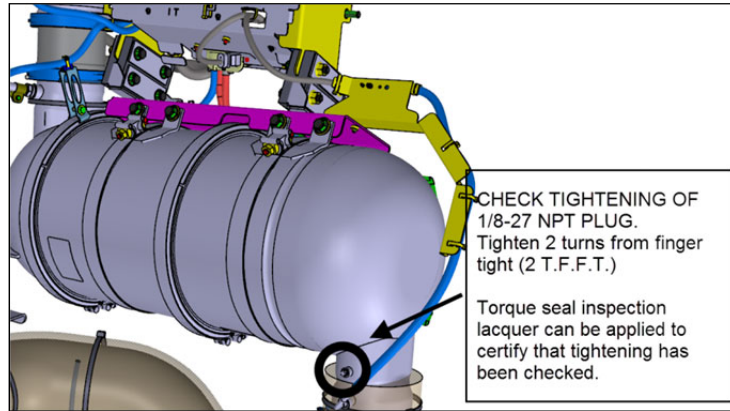
SECOND PLUG

1. Check if the 1/8-27 NPT plug located to the left side of the DPF (at the inlet of DPF) is properly tightened.

2. Tighten 2 turns from finger tight (2 T.F.F.T.).

If the plug is missing, order plug #21305581.
