## DIESEL PARTICULATE FILTER (DPF) – LOOSE PLUGS

Prevost vehicles

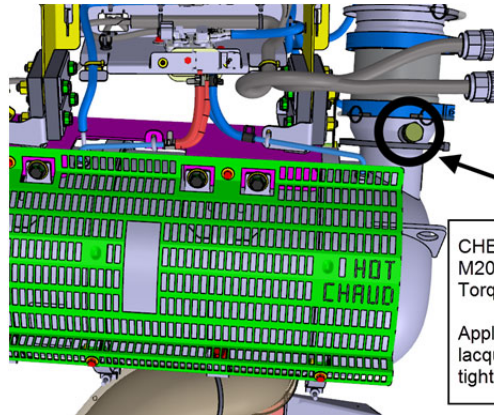
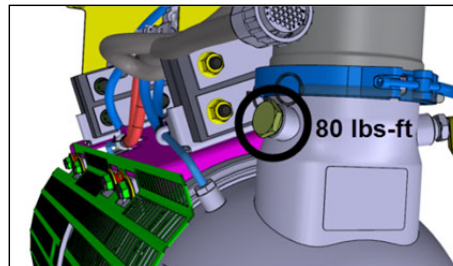
On the vehicles affected by this bulletin, two DPF (diesel particulate filter) plugs may be loose. If a plug is loose, it may fall under the effect of vibration. This may cause leakage of hot exhaust gases.

1. Check if the M20 hexagonal plug located to the right side of the DPF (see image at right) is properly tightened.

2. Apply a torque of **80 lbs-ft**.

*Note: Apply torque seal inspection lacquer to certify that tightening has been checked.*

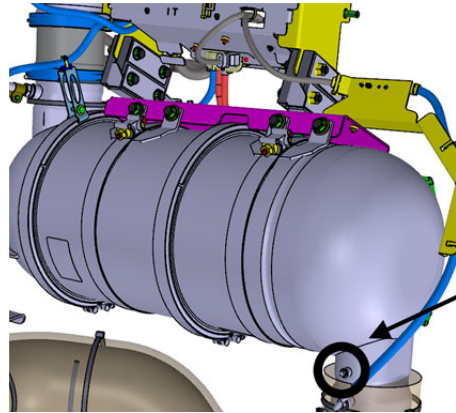
1. Check if the 1/8-27 NPT plug located to the left side of the DPF (at the inlet of DPF) is properly tightened.

CHECK TIGHTENING OF 1/8-27 NPT PLUG. Tighten 2 turns from finger tight (2 T.F.F.T.)

2. Tighten 2 turns from finger tight (2 T.F.F.T.).

*Note: Apply torque seal inspection lacquer to certify that tightening has been checked.*

Apply torque seal inspection lacquer to certify that tightening has been checked.

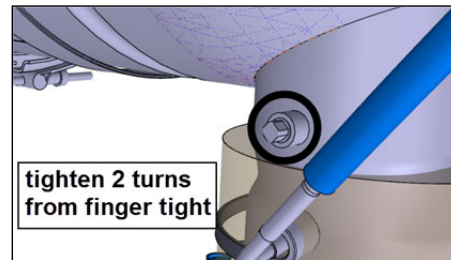
tighten 2 turns from finger tight
