19000LBS INDEPENDENT FRONT SUSPENSION INSPECTION

Prevost Vehicles

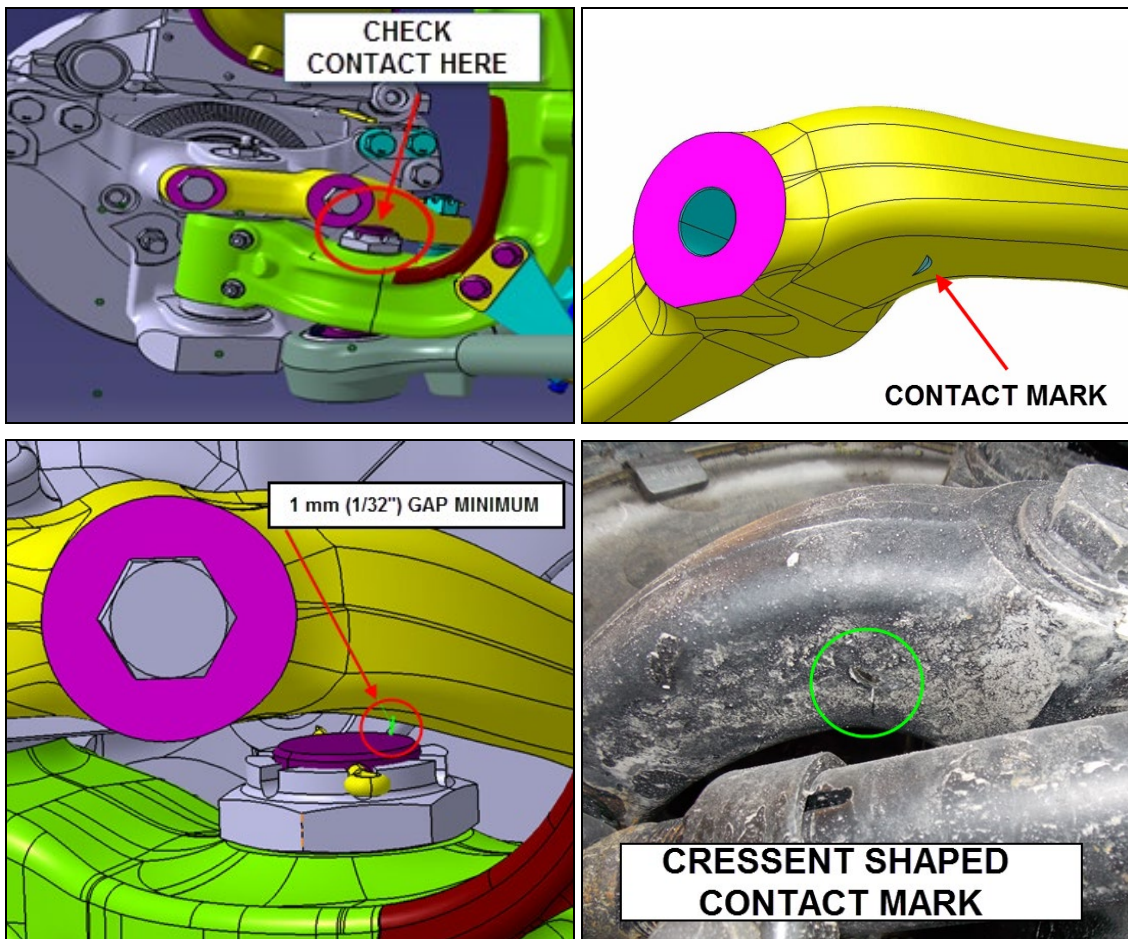
INSPECTION # 1 (ALL SUSPENSION POSITIONS)

1. Lift the vehicle by the wheels, put stands under the lower control arms ball joint and remove the lifts (see note above).
2. Turn the vehicle wheels and check to see if the top threaded part of the lower ball joint touches the steering arm when the wheels are at their maximum left or right position as shown in the pictures below.

- There should be at least 1mm (1/32") between the top of the ball joint and the steering arm.

- A contact mark may be visible on the underside of the steering arm as shown.

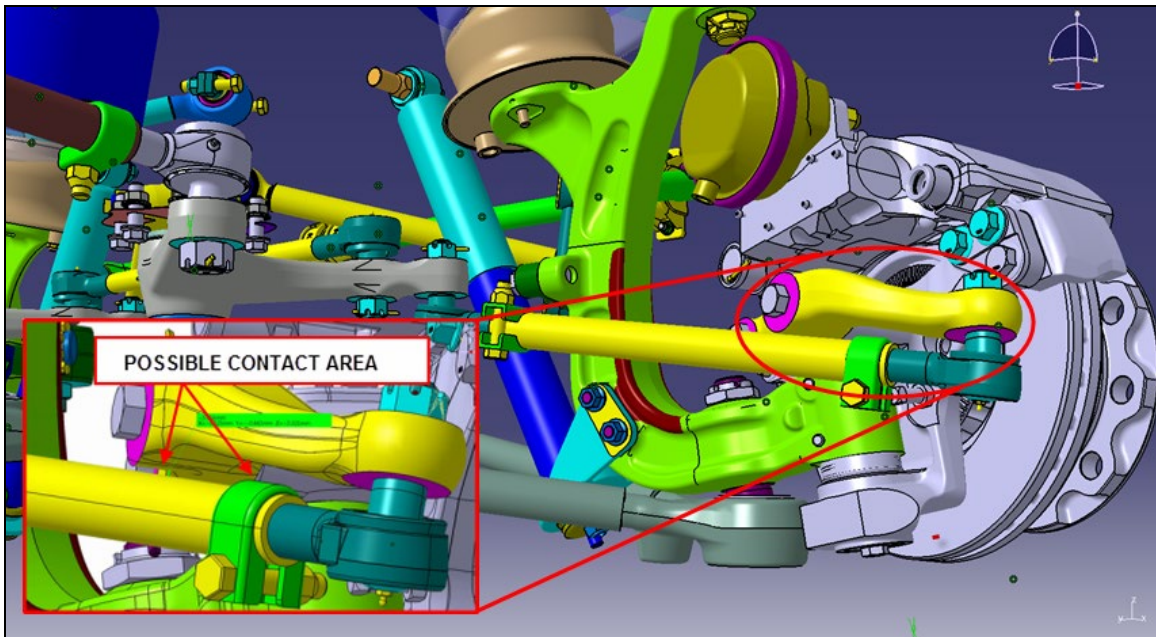
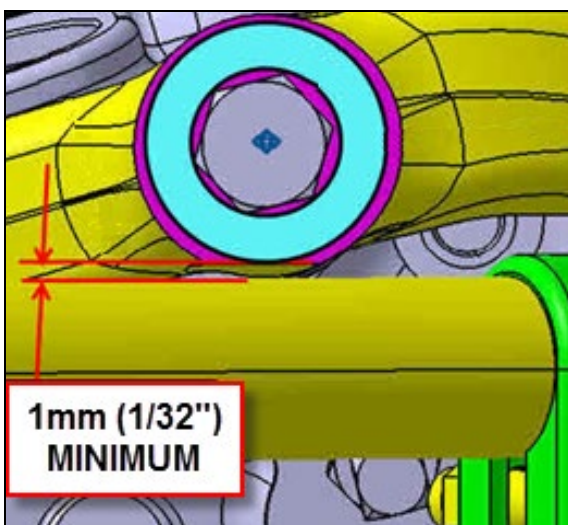
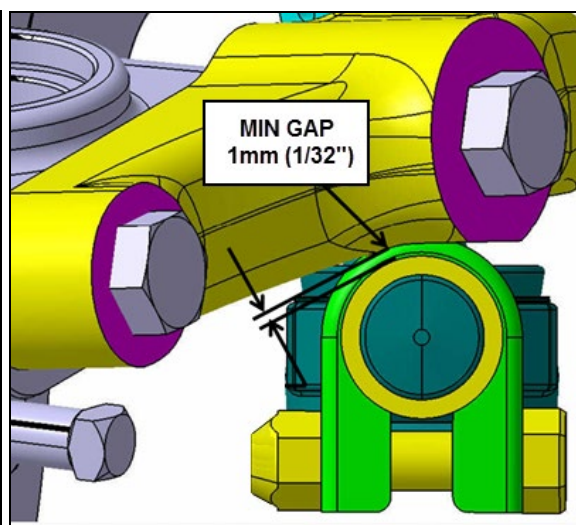
INSPECTION # 2 (SUSPENSION IN HIGH BUOY – MAX LIFT)

1. With the suspension fully lifted, turn the wheels to their maximum left and right positions to check if there is contact between the steering lever arm and the steering rod (check both possible contact points on each side as shown in the pictures below).

- There should be at least 1mm (1/32") between the arm and the rod at all points).

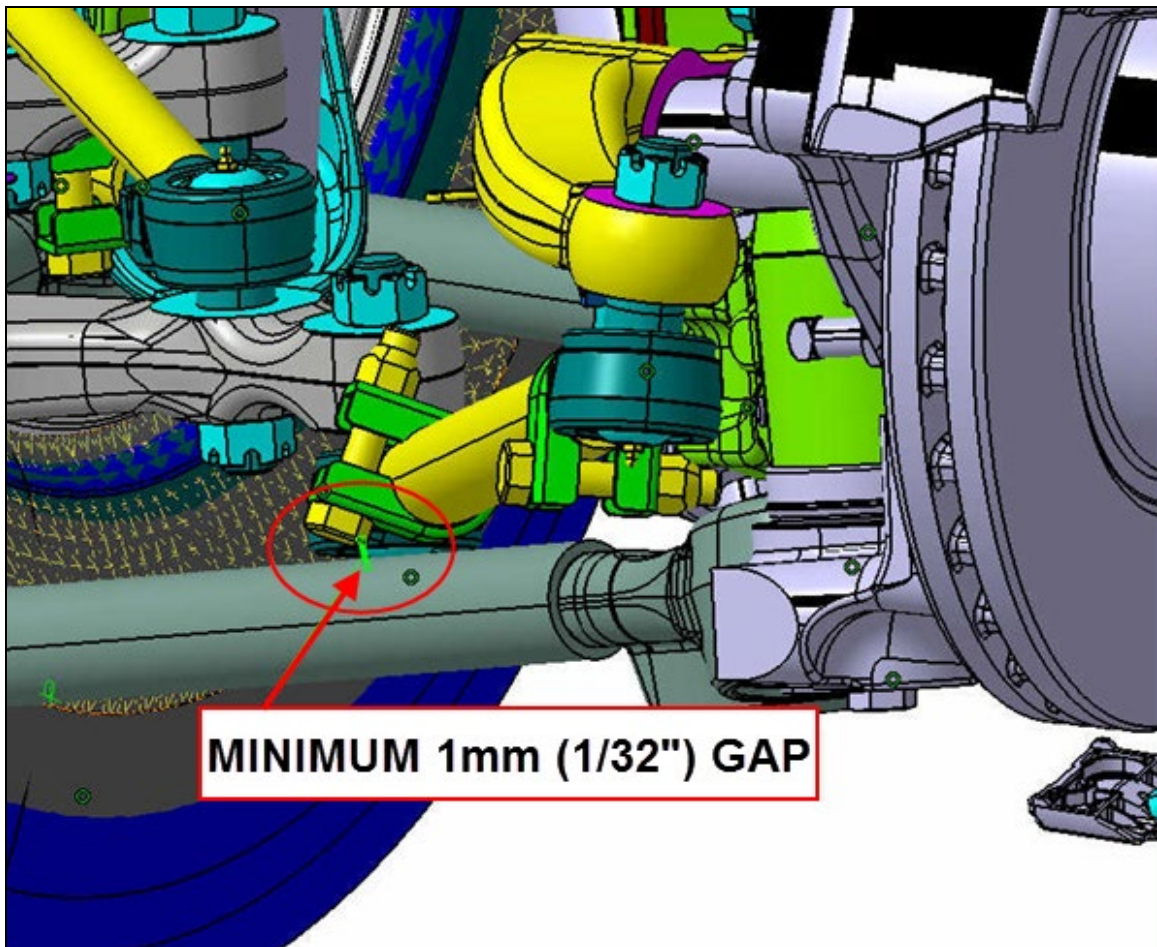
INSPECTION # 3 (SUSPENSION IN LOW BUOY – MIN LIFT)

1. With the suspension at the lowest position and the wheels completely turned to the *left* (driver side), check that there is no contact between the steering rod clamp and the lower A-arm as pictured below.

- There should be a gap of at least 1mm (1/32") between the clamp and the A-arm.

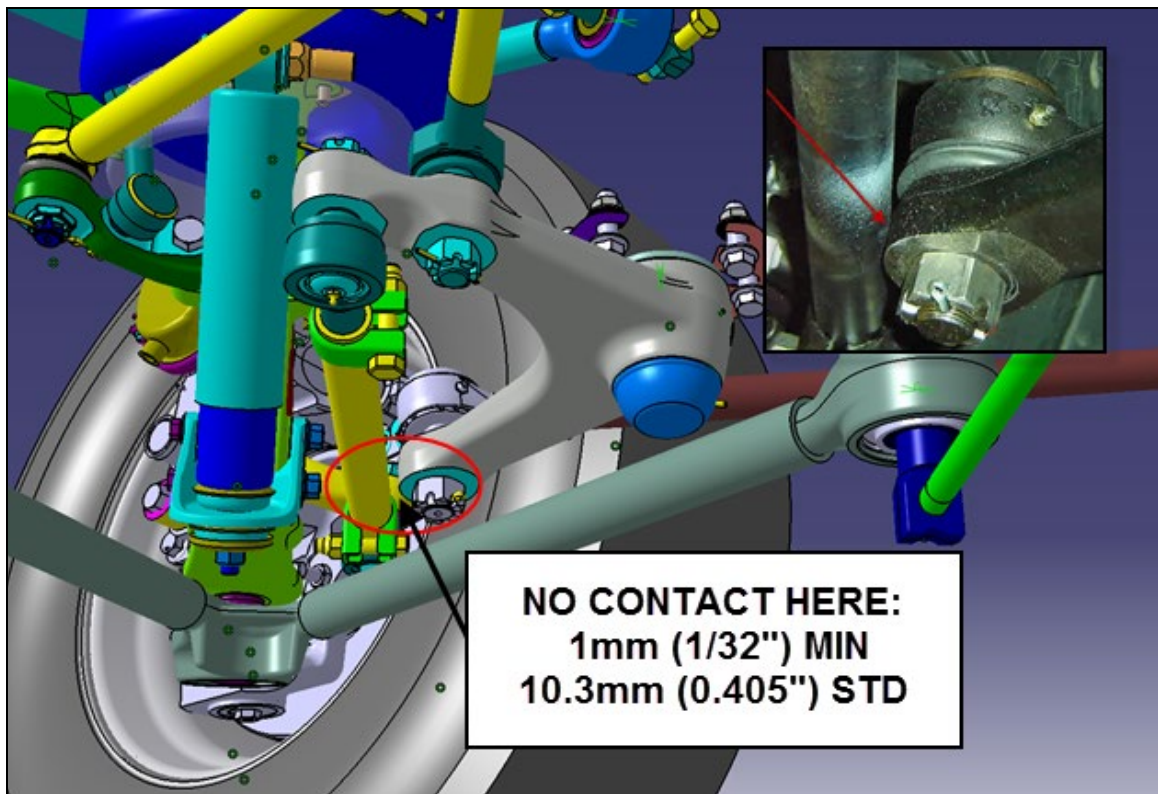
INSPECTION # 4 (SUSPENSION IN LOW BUOY – MIN LIFT)

1. With the suspension at the lowest position and the wheels completely turned to the right (curb side), check that there is no contact between the steering rod and the bell crank as pictured.

- There should be at least 1mm (1/32") of clearance between the steering rod and the bell crank.
