Special Bulletin

SP15-343D

SLIDING DOOR ADJUSTMENT AND HARDWARE REPLACEMENT

Prevost vehicles

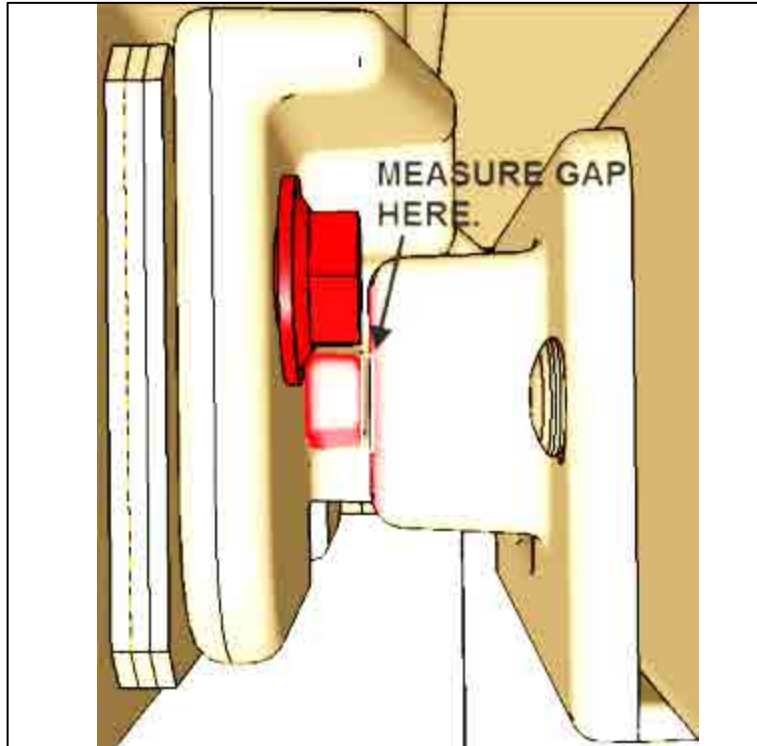
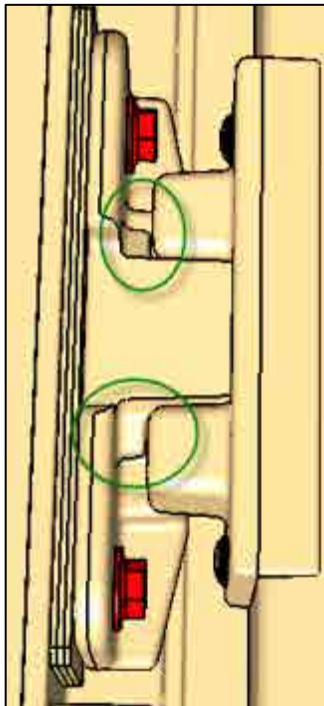
Looking at the fingers from the top. Use feeler gages to assess the gap between the small boss on the finger and the receptacle face

Min **1/64"** (0.5mm)

Max **3/64"** (1.1mm)

If gap is not within the above values, add or remove shims as required.

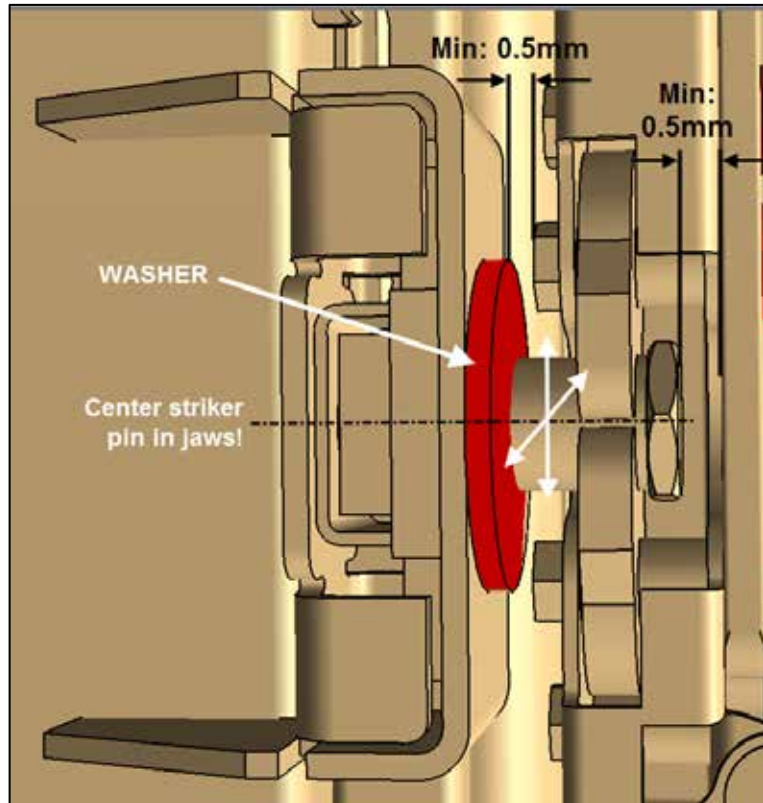
Figure 31

35. Tighten to **60 lb-ft**
36. Apply torque seal.
37. Control gaps as shown on Figure 31. Min **1/64"** (0.5mm)

No washers should be installed on the striker plate housing screw heads

If gaps are smaller, inform your Prevost Regional Service Manager (RSM).

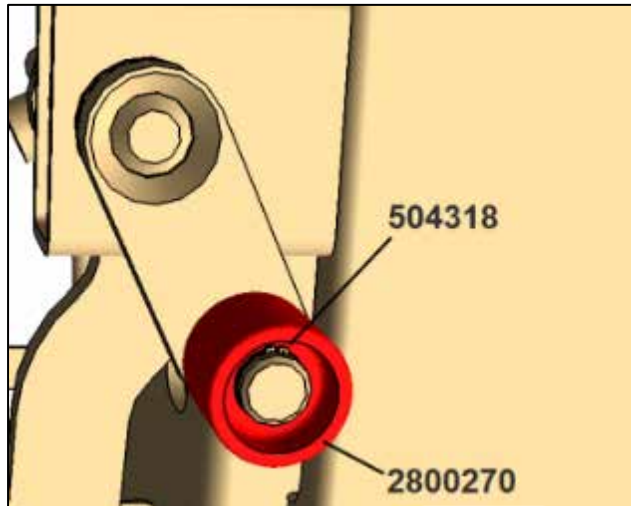
Figure 35

40. Inspect roller condition.

Rollers should be free of flats, and have a smooth surface finish.

Replace the roller as required.

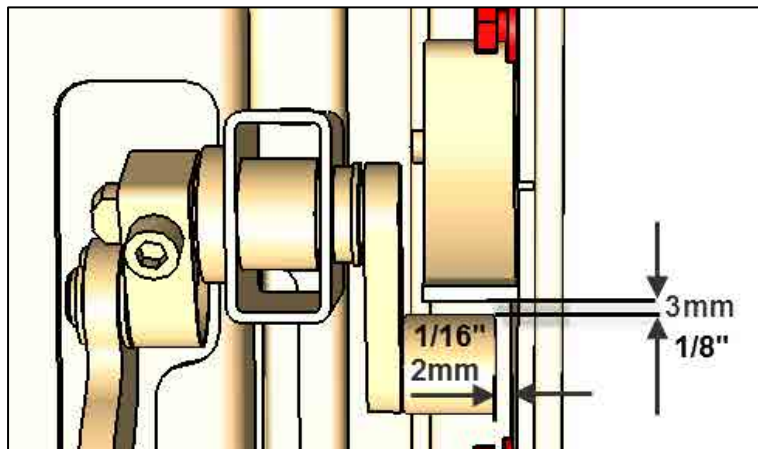
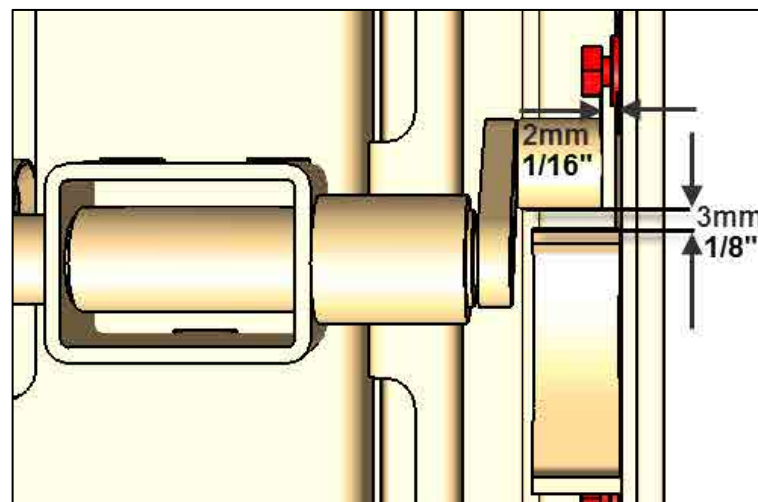
41. Distance between *roller and plate* with door closed should be **1/8"** (3mm).

42. Gap between *roller end and door* should be minimum **1/16"** (2mm).

Adjust as required on upper and lower catch plate.

Trim roller end as required to get closer the target value.

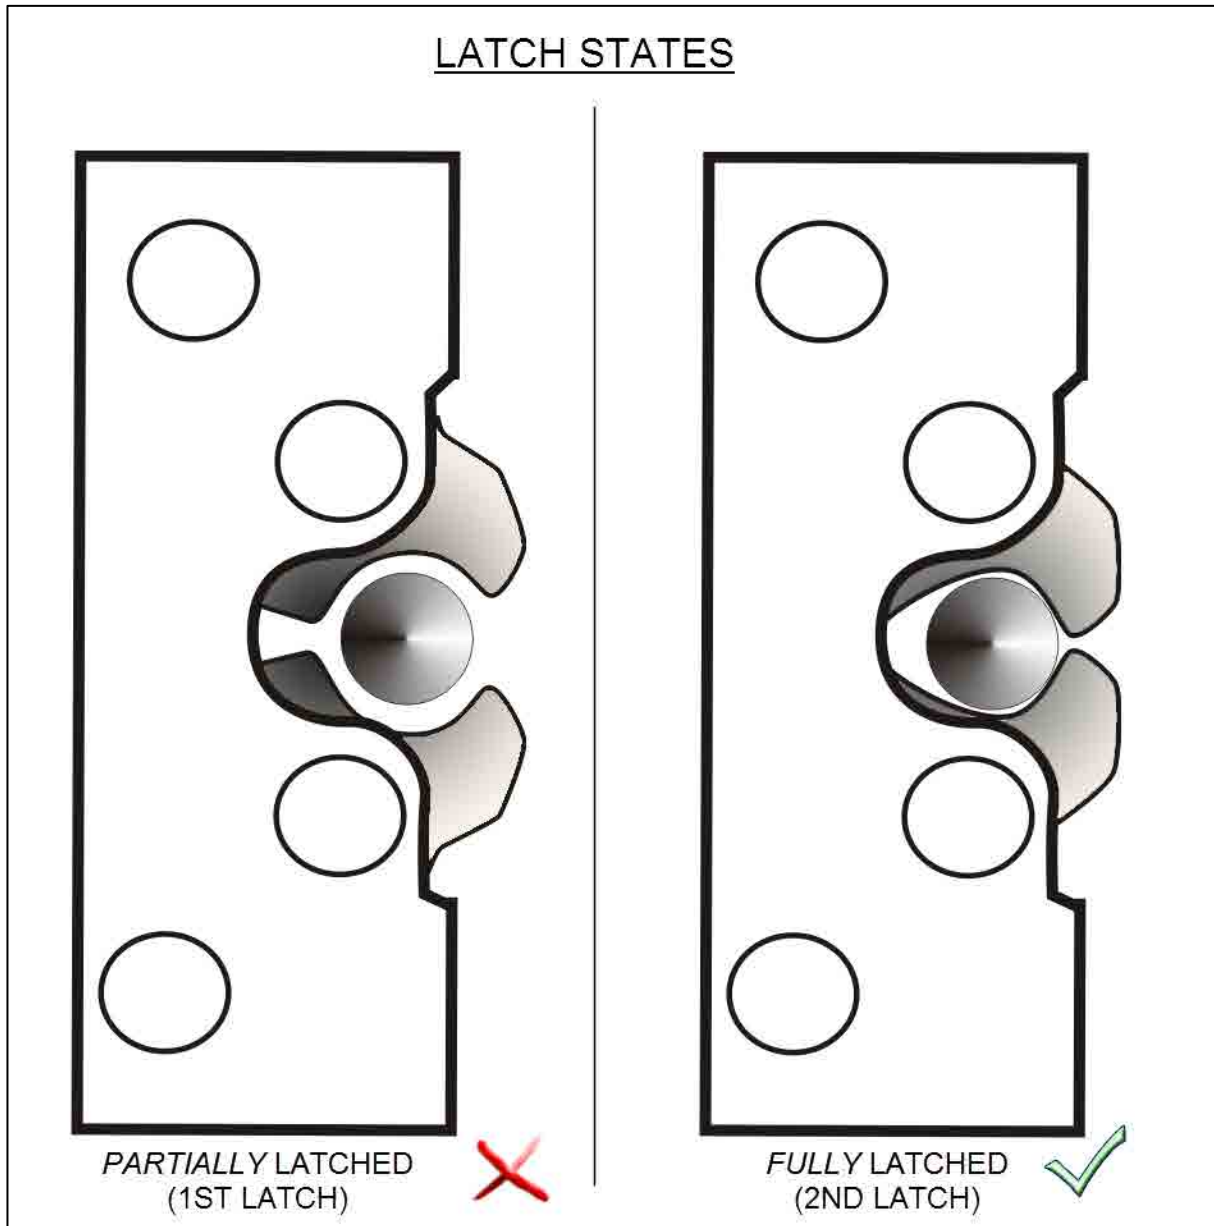
Figure 39

47. Open and close the door a few times to confirm proper operation of the lock assist sequence
48. The second latch state (Figure 39) should be applied by the lock assist mechanism alone, without any operator intervention each time the door is closed. If door fails this test, return to step 34.

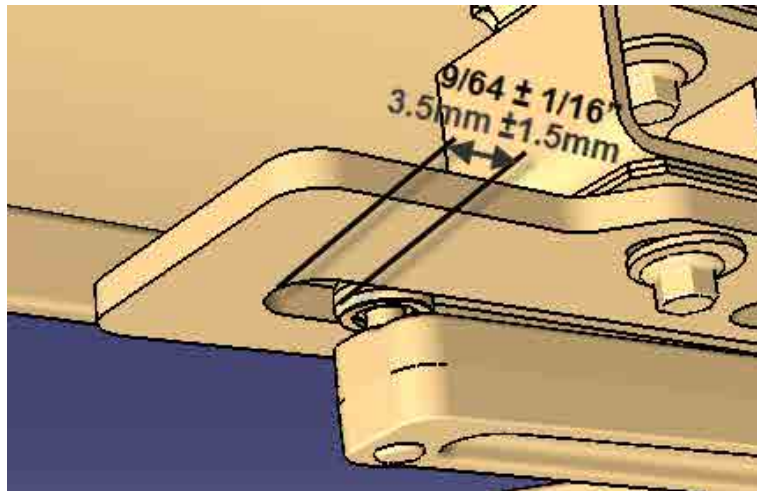
Figure 51

79. Distance between the end of both fork slots and roller should be:

9/64 ± 1/16"

3.5 ± 1.5mm

78. If required add spacer # **286421**

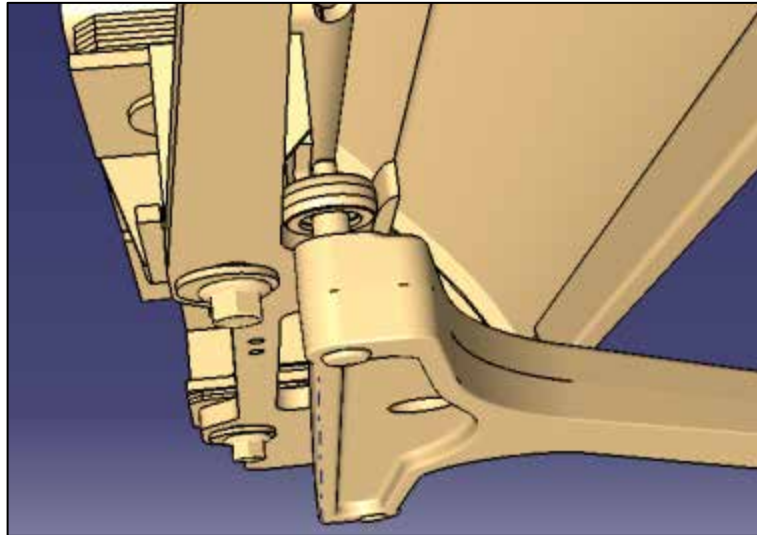
Figure 52

80. Move the door back and forth at the point of engagement of the roller in the fork. The roller should be properly centered in the slot opening without striking on either side of the fork. (Figure 52)

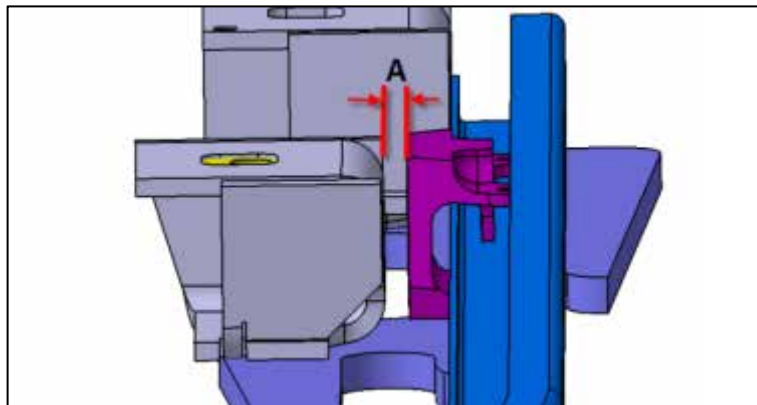
Figure 53

81. Minimum gap between the aft fork support and wheel carrier should be $1/32$ " (1mm) (dimension A)
Confirm with feeler gage. (Figure 53)

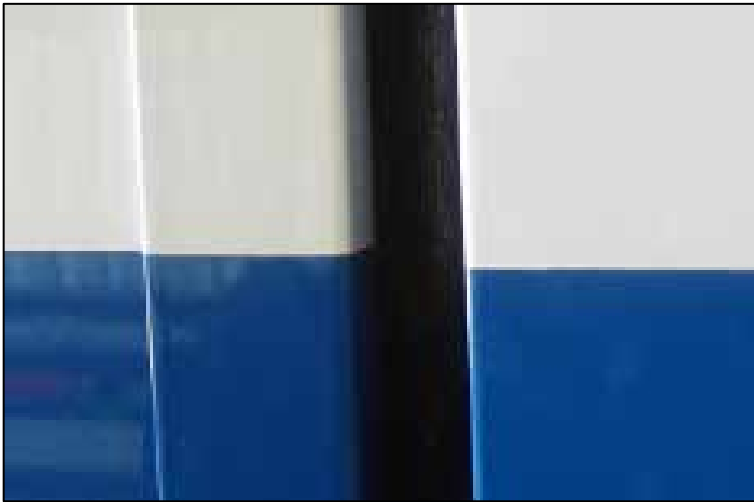
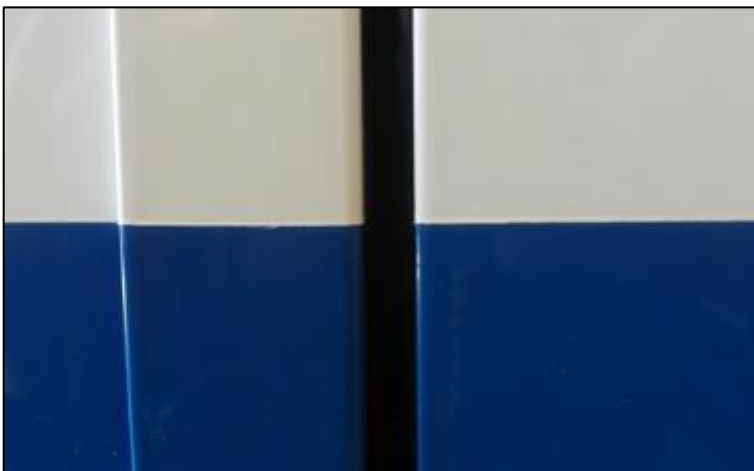
If the door is adjusted properly, you should feel a slight upward movement when closing.

86. To see the movement, stare at the paint line. As the door approaches the point of contact between the fingers and the receptacles you can see the paint line on the door move up slightly. (Figure 56 & Figure 57)

If there is no upward movement, "door fingers" will need to be adjusted vertically. Contact your RSM.

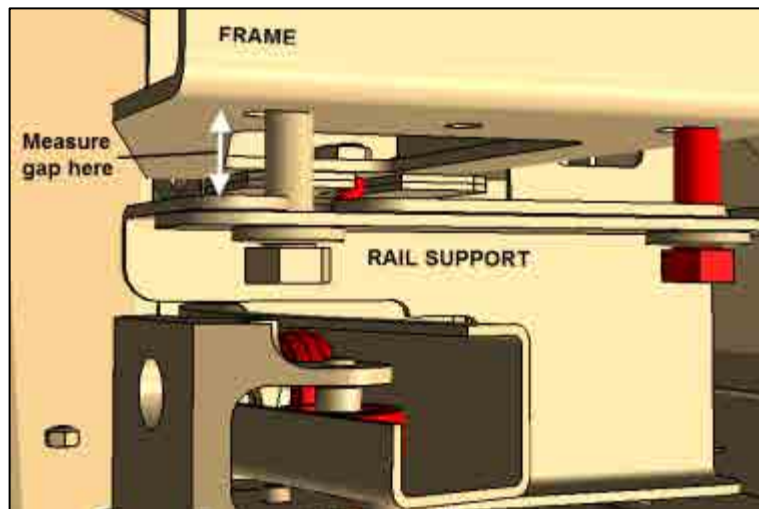
Figure 61

93. Measure the gap between the rail support and frame. (Figure 61)

Calculate the required number of #286421 shims equivalent to the gap value minus 5/32". See calculation example below.

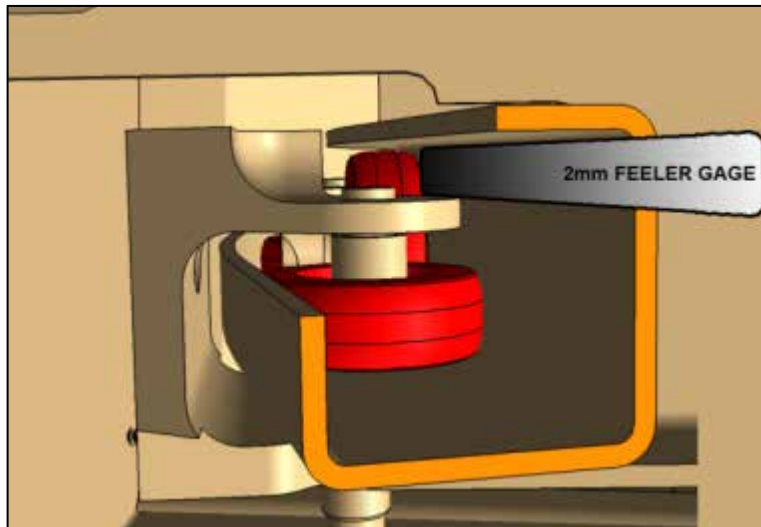
Figure 64

96. Next, apply the proper gap for the horizontal wheels. Insert a **5/64"** (2mm) feeler gage behind the vertical wheel. (Figure 64)

97. Pull on the rail support towards the inside of the bus to have the proper gap.
