## SWAY BAR CLAMP HARDWARE REPLACEMENT

Prevost vehicles

On the vehicles affected by this bulletin, replace the hardware on the sway bar clamps of the steer and drive axles.

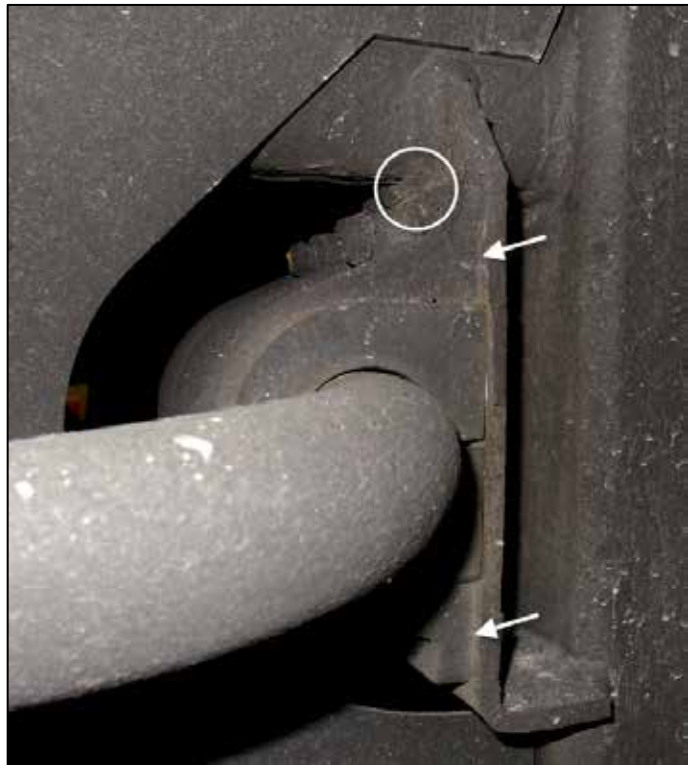
Figure 2

2. On the front steer axle *and* rear drive axle, clean the sway bar clamps around the upper bolts.
3. Perform a thorough visual inspection of the contact surfaces between the sway bar clamps and the frame support. (arrows, Fig.2)

In some cases, (circle, Fig. 2) the support weld in the upper section may prevent proper contact of the clamp with the mounting surface. Refer to following steps.

Inspect the rubber bushing for damage.

Remove any debris or gravel guard accumulation interfering with the contact surface between the clamp base and structure.
