Abnormal Entune/Navigation Operation For Display Audio (Non-HDD Type)

Service Category Audio/Visual/Telematics

Market USA

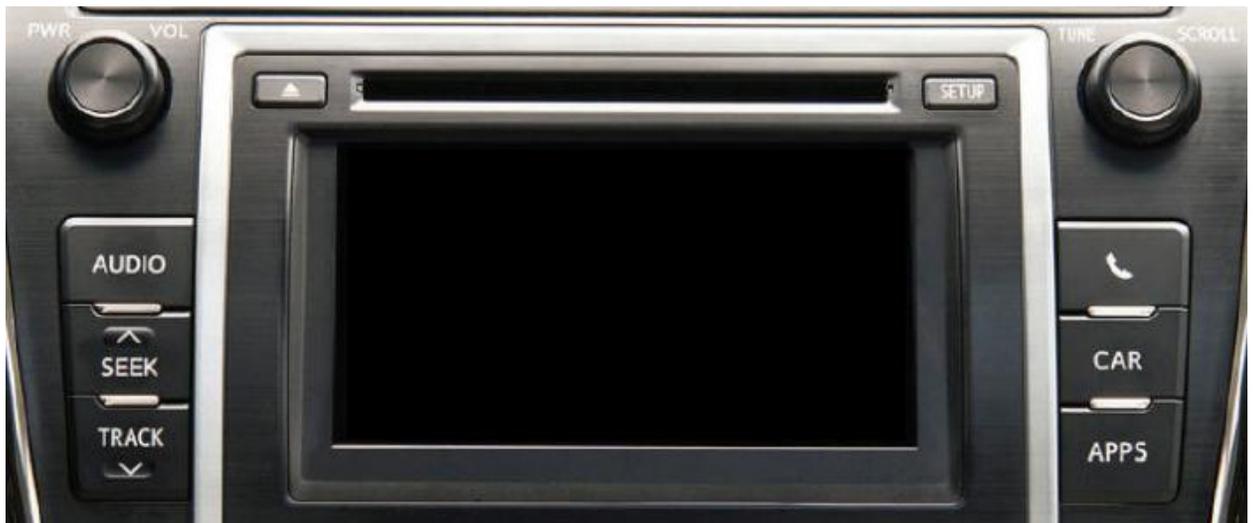
- Non-HDD Type Navigation units have a CD slot visible on the front of the radio.
- HDD Type Navigation units have a tilt-open navigation screen and CD slot behind the screen.
