Subject Unable to Update Radio Software		Market USA
Service Category Audio/Visual/Telematics	Section Audio/Video	
Applicability All Applicable Models

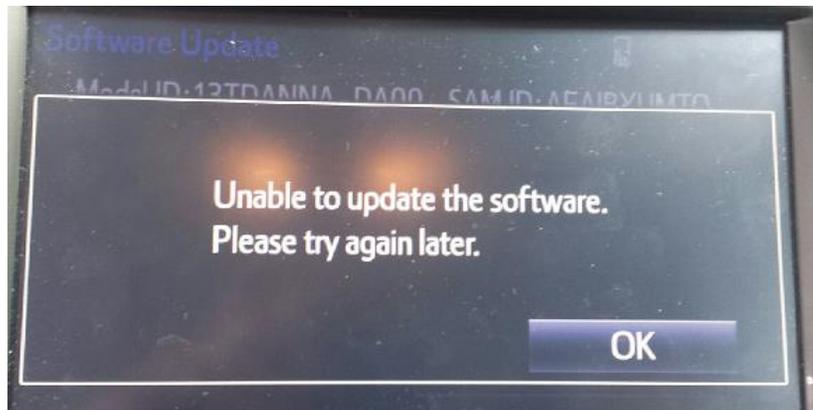
Some vehicles may exhibit an error message when trying to perform a radio software update: "Unable to update the software. Please try again later." If the following screen is seen; follow the directions below.

Turn the vehicle ignition to the ACC ON position, remove the update USB stick from the vehicle, and leave the vehicle in the ACC ON for a MINIMUM of 20 minutes. After the 20 minute ACC ON has been performed, cycle the IG and attempt to perform the radio update.
