Driver Seat Leather Worn (1794 Western Package)

Category Vehicle Interior

T-SB-0060-15 August 19, 2015 Page 3 of 5

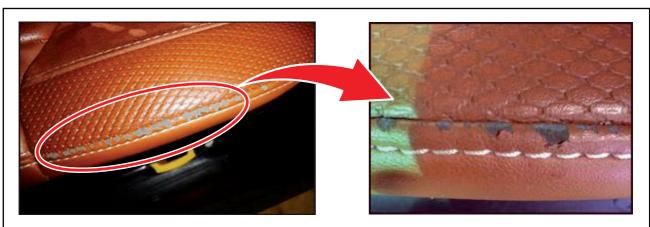
Figure 1.

Some 2014 - 2015 model year Tundra CrewMax vehicles equipped with the 1794 Western Package may exhibit premature wear of the leather seat cushion due to entering or exiting the vehicle. Follow the Repair Procedure in this bulletin to address this condition.
