# Program Bulletin

## CUSTOMER SATISFACTION PROGRAM

**SUBJECT:** ECM Wire Harness Contact

**MODELS:** 2014 Cadillac CTS  
Equipped with 3.6L Twin-Turbo Engine (LF3)

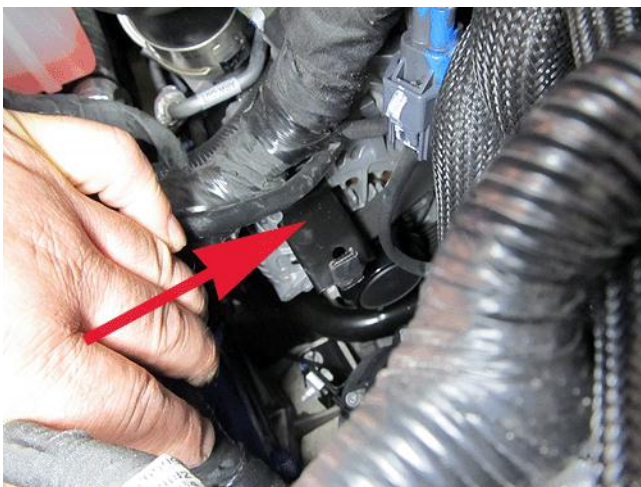
3905246

12. Inspect the wire harness conduit and insulation for damage where it contacts the bracket, repair as required. Refer to *Repairing Damaged Wire Insulation* in SI for repair instructions. The use of a mirror as, shown will, help in locating wiring damage.

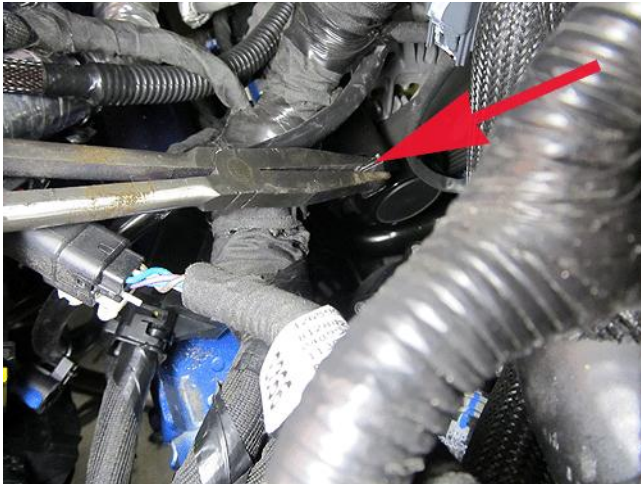
3905252

14. Inspect the position of the harness against the tab on the bracket.
