Service Bulletin

SPECIAL COVERAGE

SUBJECT: Special Coverage Adjustment – Fuel Pump Module Battery Terminal

MODELS: 2010-2014 Chevrolet Express
2010-2014 GMC Savana

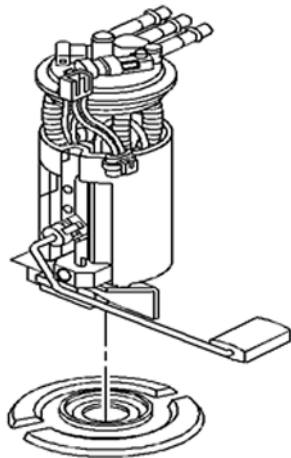
4070283

Note: Inspect the fuel pump connector and see if it shows evidence of discoloring, deformation or poor terminal tension.
