Service Bulletin

SPECIAL COVERAGE

SUBJECT: Special Coverage Adjustment – Driver Airbag Light On

MODELS: 2008-2009 Chevrolet HHR SS
2009 Chevrolet Cobalt
2009 Pontiac G5, Solstice
2009 Saturn Sky

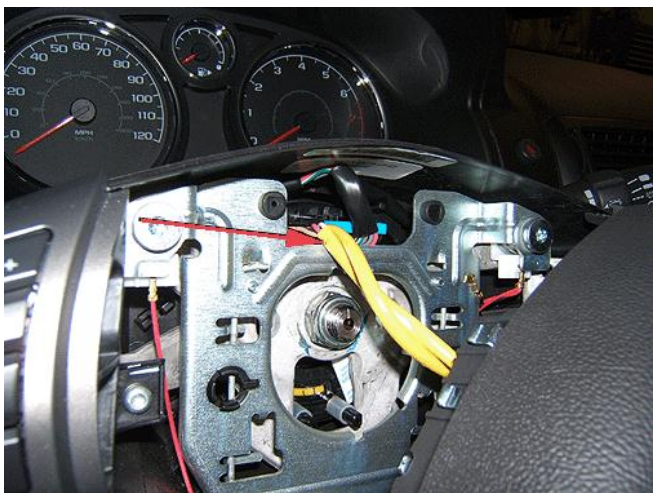
2291094

2. Inspect the yellow SIR wiring harness that connects the steering wheel inflatable restraint module to the steering wheel inflatable restraint module coil. Look for any chafing, cracks or areas where the wiring, insulation or protective wire sleeve has been damaged.
 - If the inspection of the wiring harness reveals a condition that may allow the wiring to short to ground, replace the steering wheel inflatable restraint module coil. Refer to *Steering Wheel Inflatable Restraint Module Coil Replacement* in SI for replacement procedures. Proceed to the next step and install the protective material.
 - If the wiring does not show any damage, proceed to the next step and install the protective material. Inform the customer that any additional diagnosis and repairs are not covered under this special coverage.

1. Remove the steering wheel inflatable restraint module. Refer to *Steering Wheel Inflatable Restraint Module Replacement* in SI.
